FIBER REINFORCED PLASTIC (FRP) FORUM & EXPO

Non Metallic Application Challenges and Solutions.

PP-Lined GRP Rupture.

Hommud Y. Moharrak
Engineer I, Inspection. Sipchem
October 19, 2023.

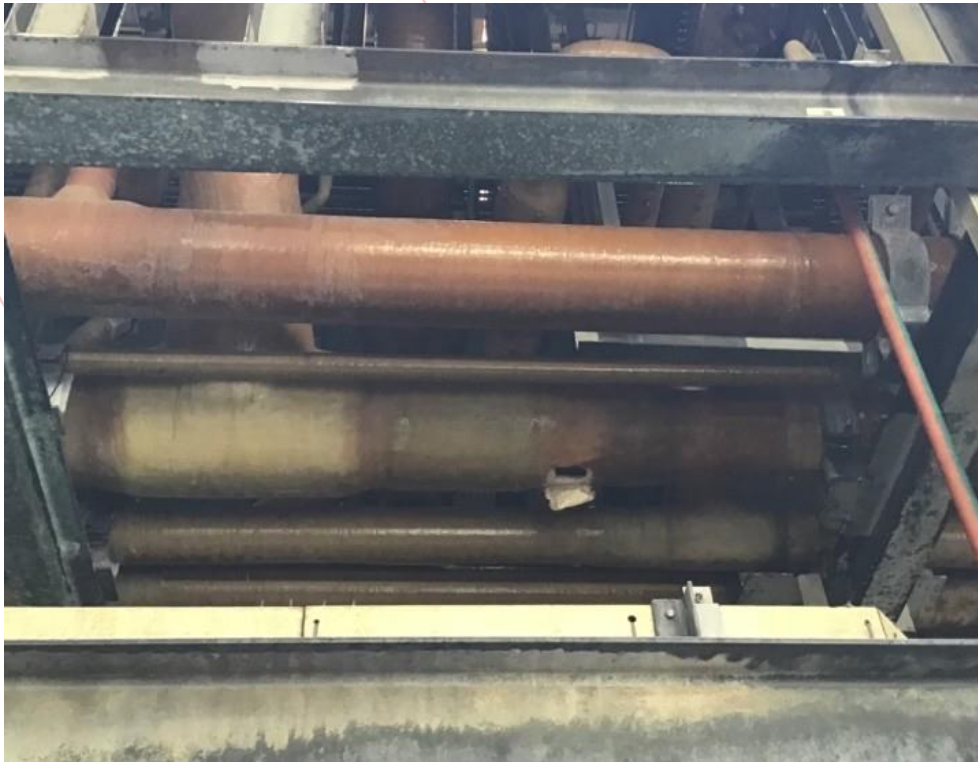
This case study explains a failure of PP lined GRP piping installed in 2014 and failed after 9 years of operations.

Failed component :
Ecc. Reducer -10"x12"

General view of failure

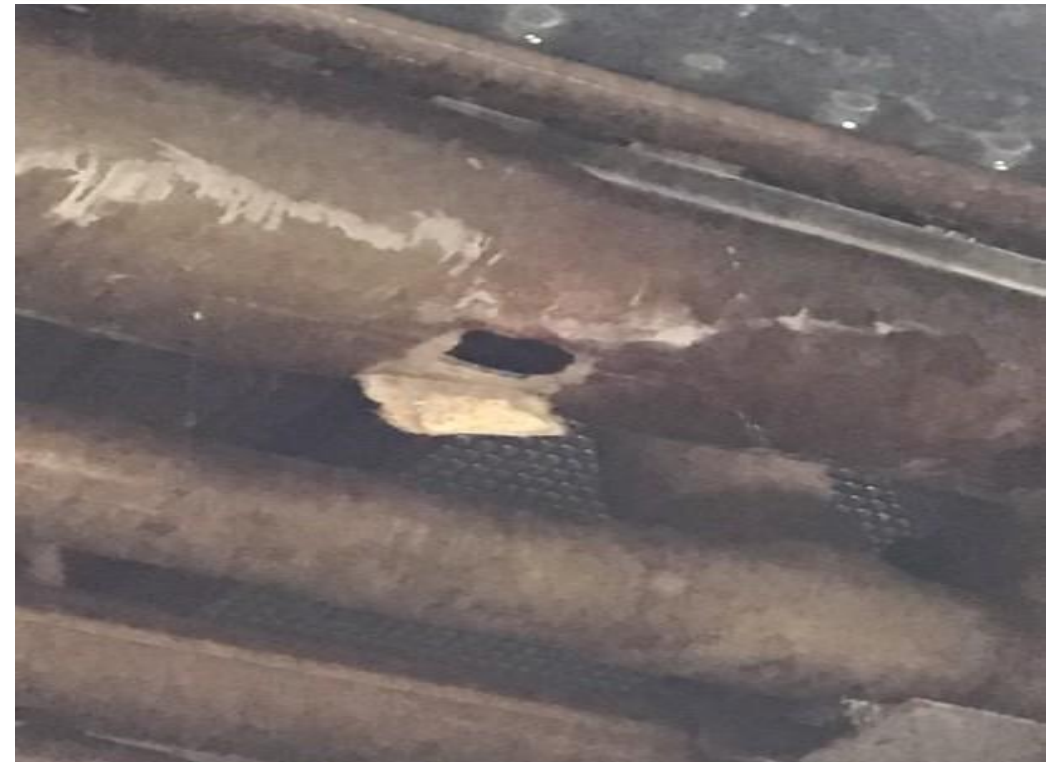
Close-up view

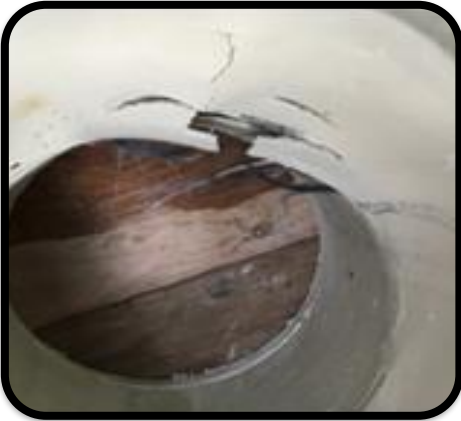
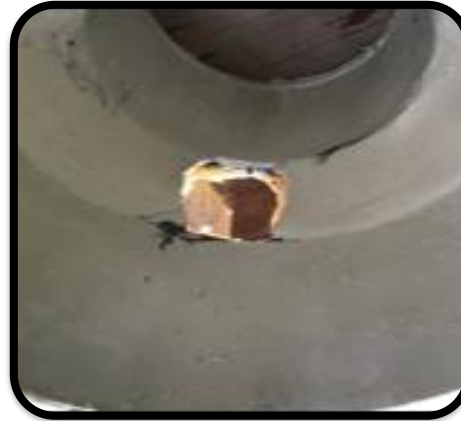
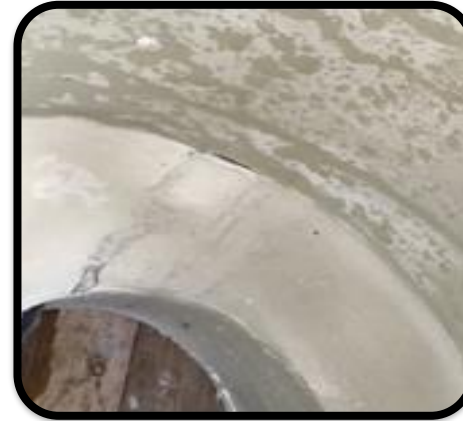
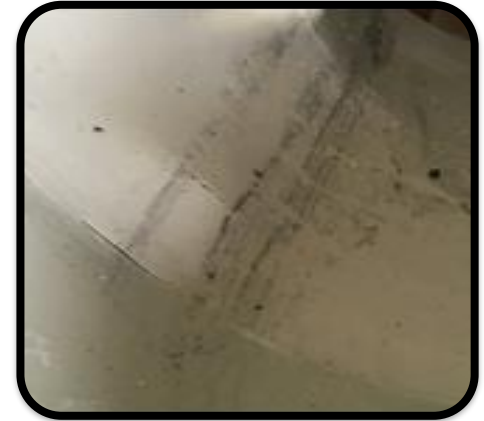
Failure#1:
@12 '0' clock
position

Failure#2:
@ 6 '0' clock
position.

Defects
observed on
PP lining
fusion welds

Cracks
observed on
the lining

Leak Occurred through Failure #2: Size : 4"X5"

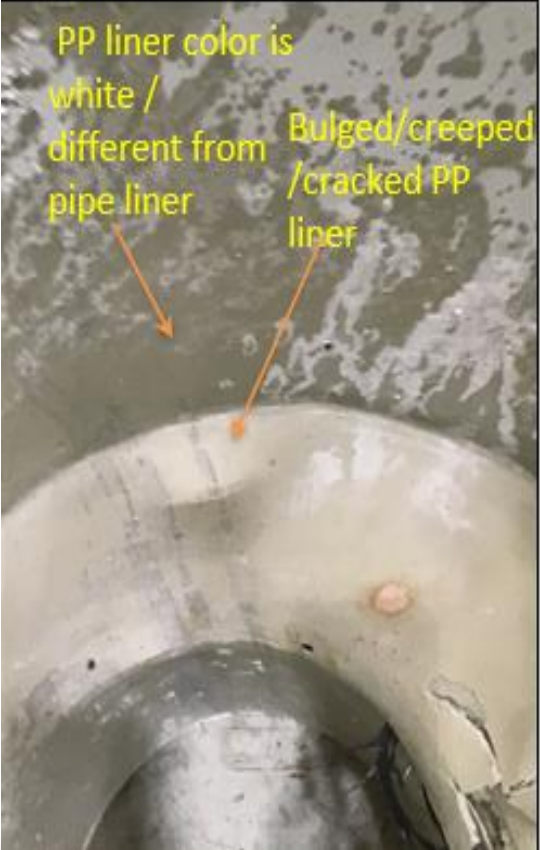
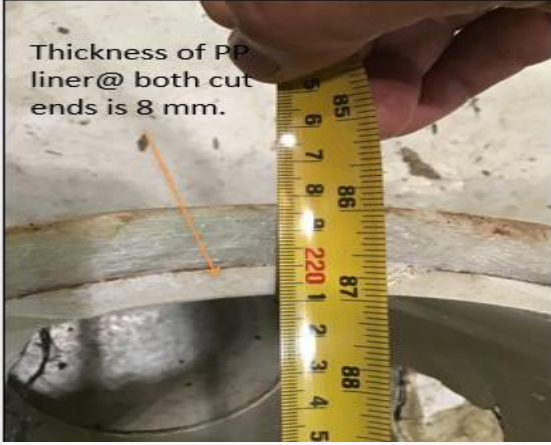
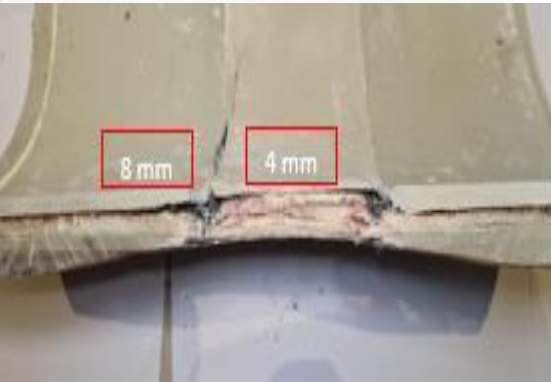
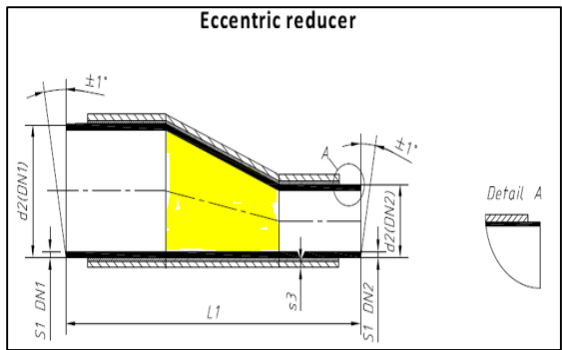
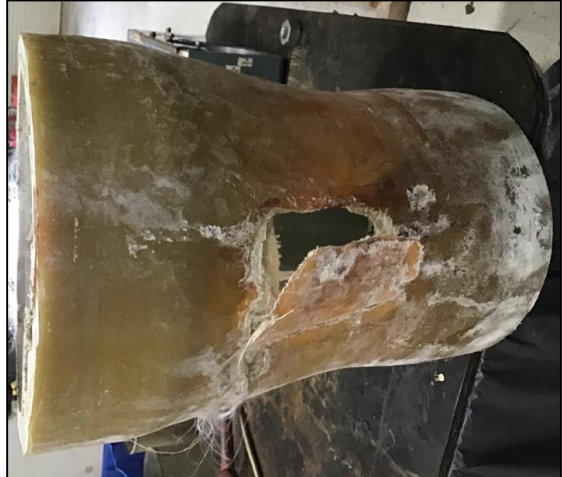
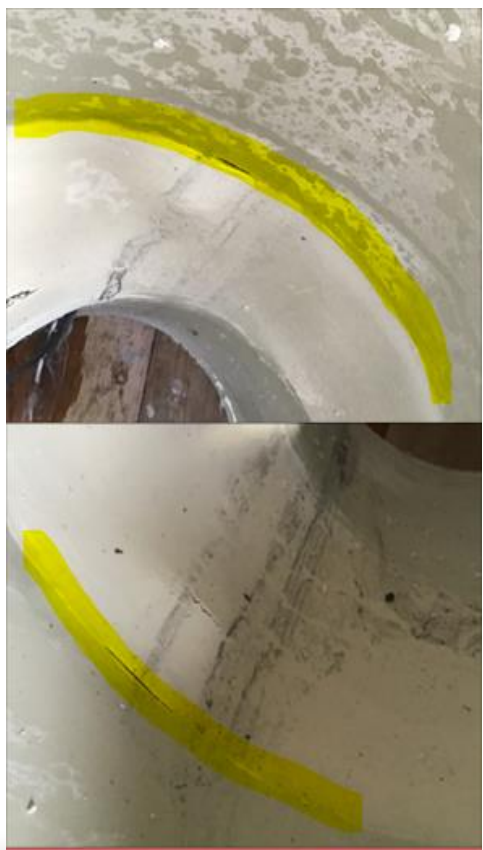
Change in Color shade

- The color of the reducer PP liner is whitish unlike the adjacent pipe which is grey.

Liner thickness

- Pipes : 8 mm
- Reducer @ ruptured area : 4 mm

Failure

- confined in between reducer liner weld fusion

Weld Visual

- No weld bead observed
- Cracks from the weld joint were observed.

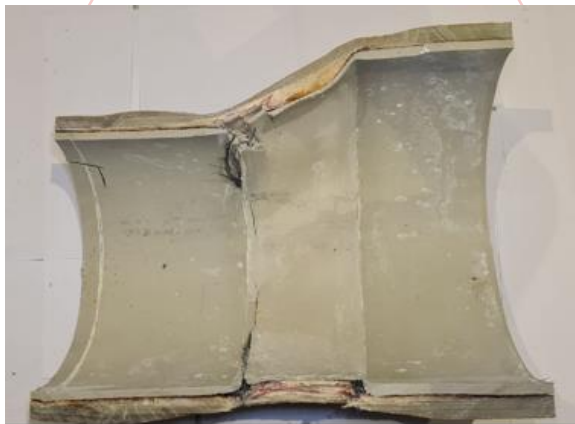
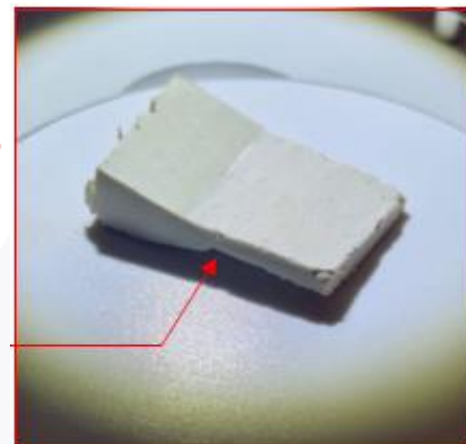
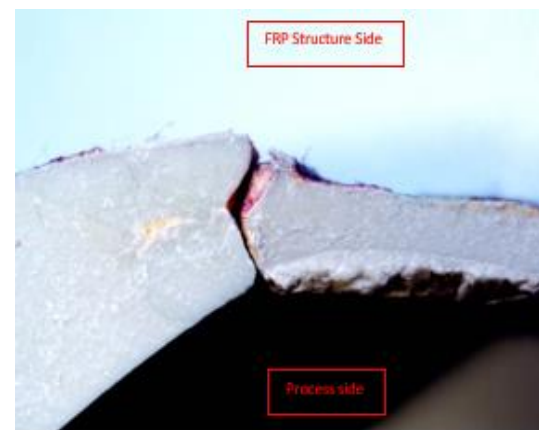
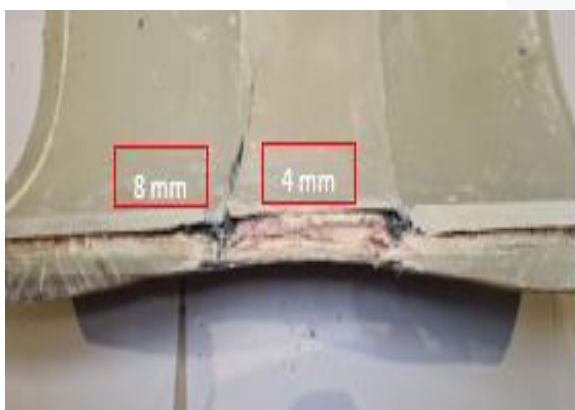
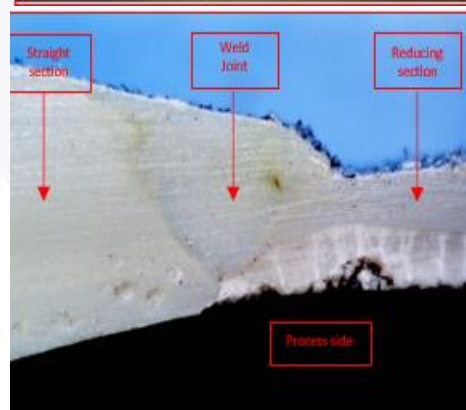
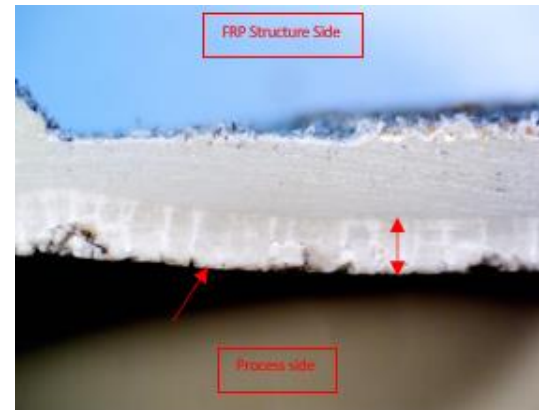
Cross Sectional view

- Variance in thickness (reducing and straight section).

Macro Examination-weld

- Cracks at the weld joints
- Several weld defects (LOF)

Micro Examination

- Lack of fusion in weld
- Degradation of PP lining

FTIR-Examination

- **Pipe:** Confirms to PP grade
- **Reducer:** Indicates degradation, Change in grade

- Lack of penetration observed on welds
- Cracks observed on PP lining material
- both sections were found with different wall thickness
- Joint offset exceeds maximum allowable offset ASME RTP-1

Excess offset in weld-joint fit-up due to low thickness reducer.

- Adequate Procedures and guidelines for Fabrication and installation of non-metallic Materials are in place.
- Welders are qualified for non-metallic fusion welding per ASME RTP-1 section M12H-40.
- Inspection and fabrication personals are qualified in nonmetallic manufacturing.
- Inspection witness and verification points are defined and followed.

Ensure ASME RTP-1 or other applicable standard guidelines are followed during manufacturing and repair.

Ensure the recommended grade of liners (PP) has been received and utilized .
