# FIBER REINFORCED PLASTIC (FRP) FORUM & EXPO

## Rupture of NaOCl FRP Pipe

Omar R. Aldulaijan  
Inspection Engineer - SIPCHEM   **AMPP™** JUBAIL  
CHAPTER SAUDI ARABIA  
October 18, 2023

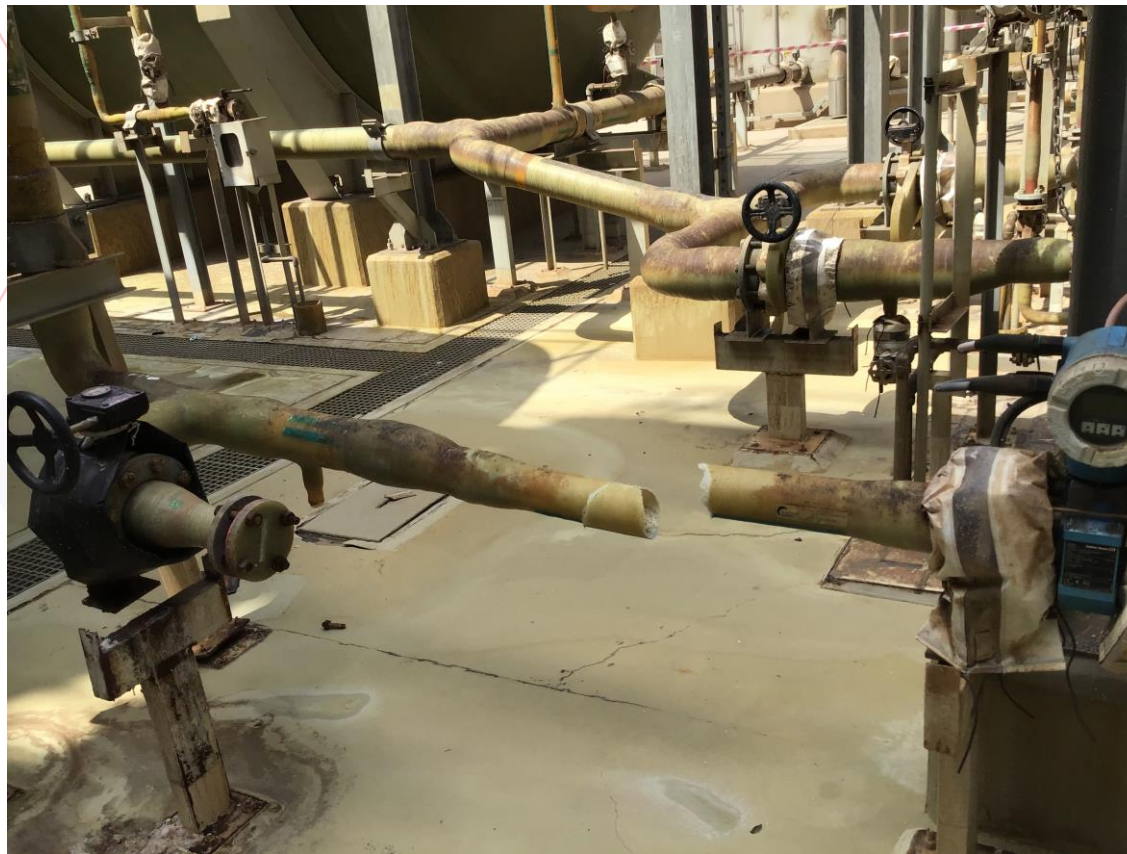
A 3" FRP pipe got ruptured after 10 years of service and while the system was isolated, and the pump in the system was offline. Investigation on the system and comprehensive lab experiments were performed on failed pipe to identify the failure mode and determine the probable causes of such severe damage and decide the forward plan.

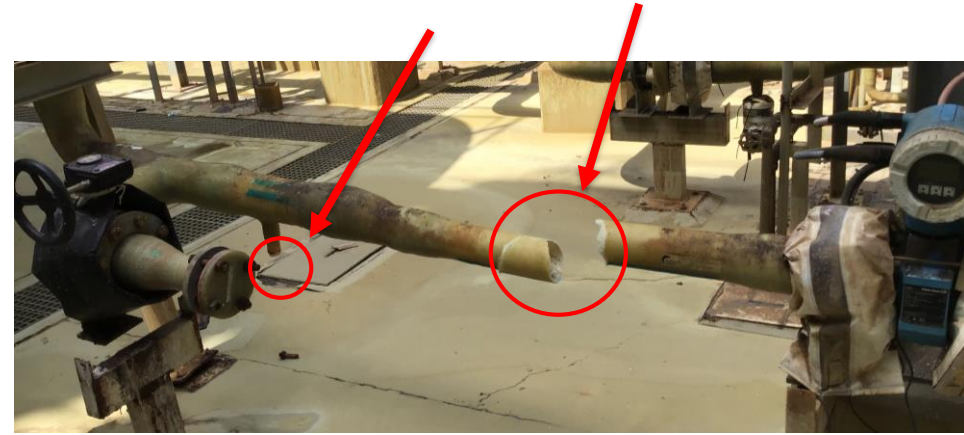
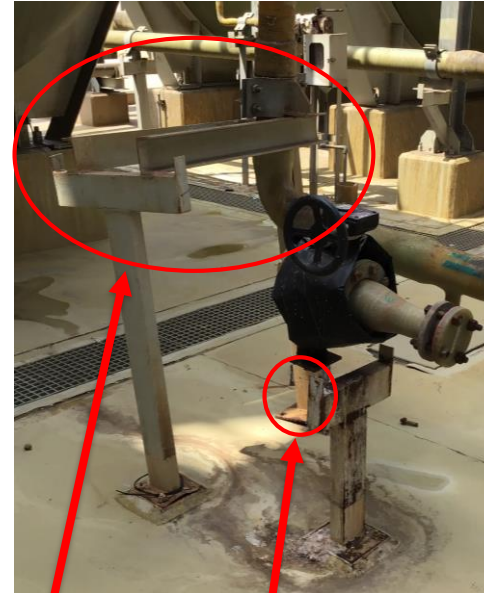
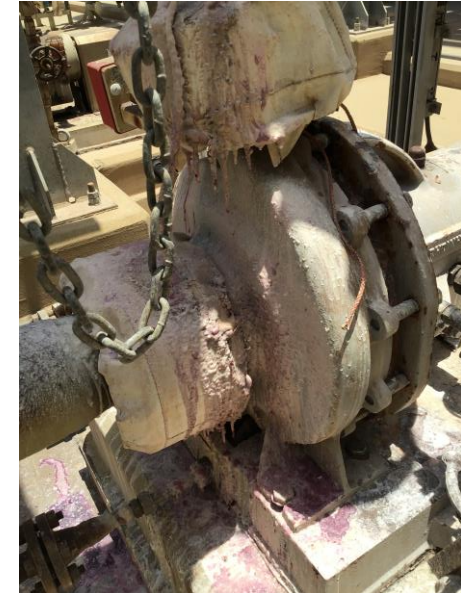
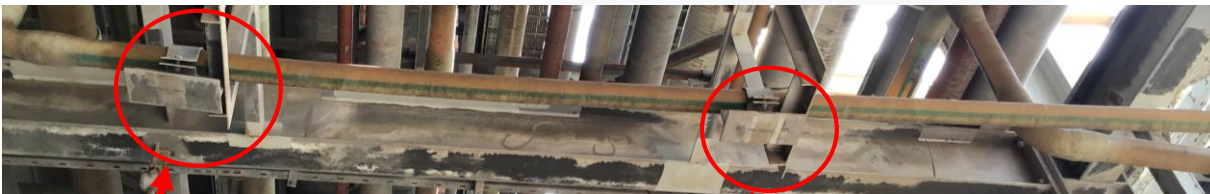
- The main 3" FRP pipe was found de attached.
- The LPD valve was broken from the drain nipple.
- The pipe and support were found dislocated from its position.
- Pipe shoe supports were dislocation from original place on pipe rake.

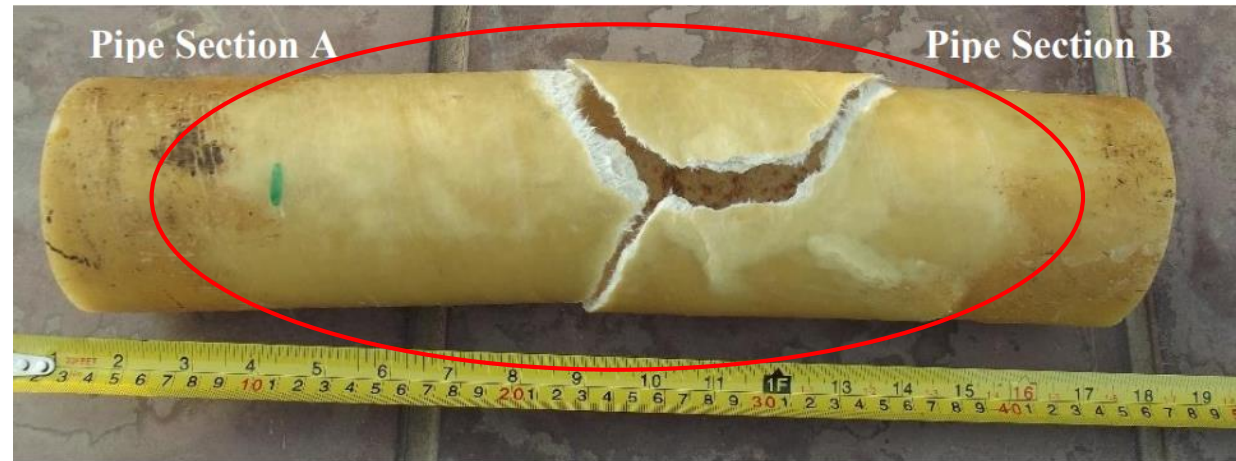
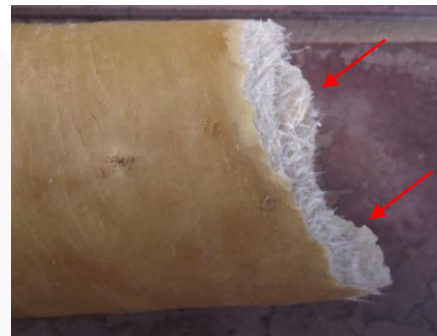
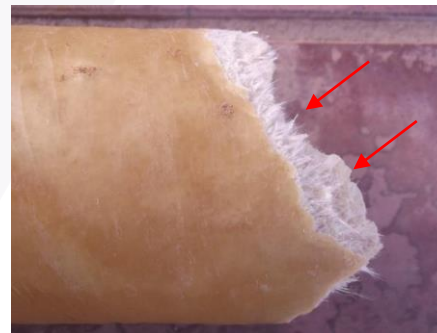
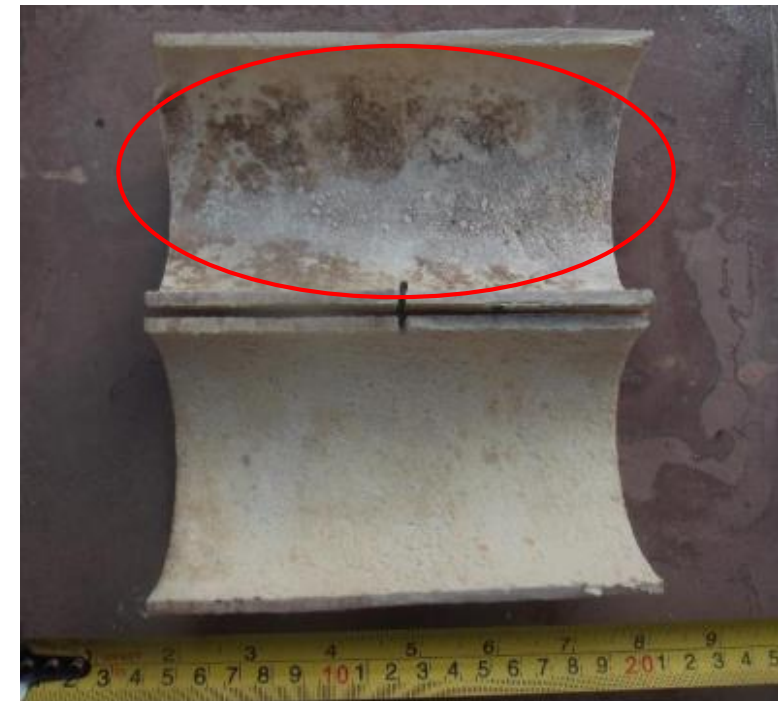
- Swelling of the pipe visually apparent.
- fracture face exhibited exposed fibers.
- White and brown scales were observed in the ID surface in 6 clock direction.

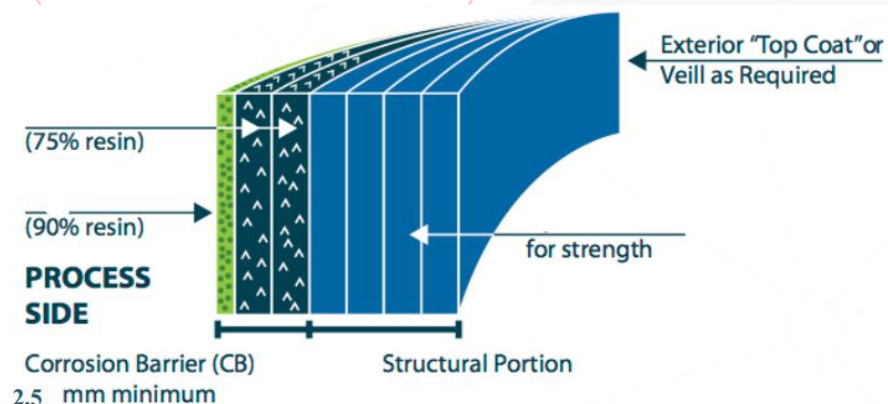
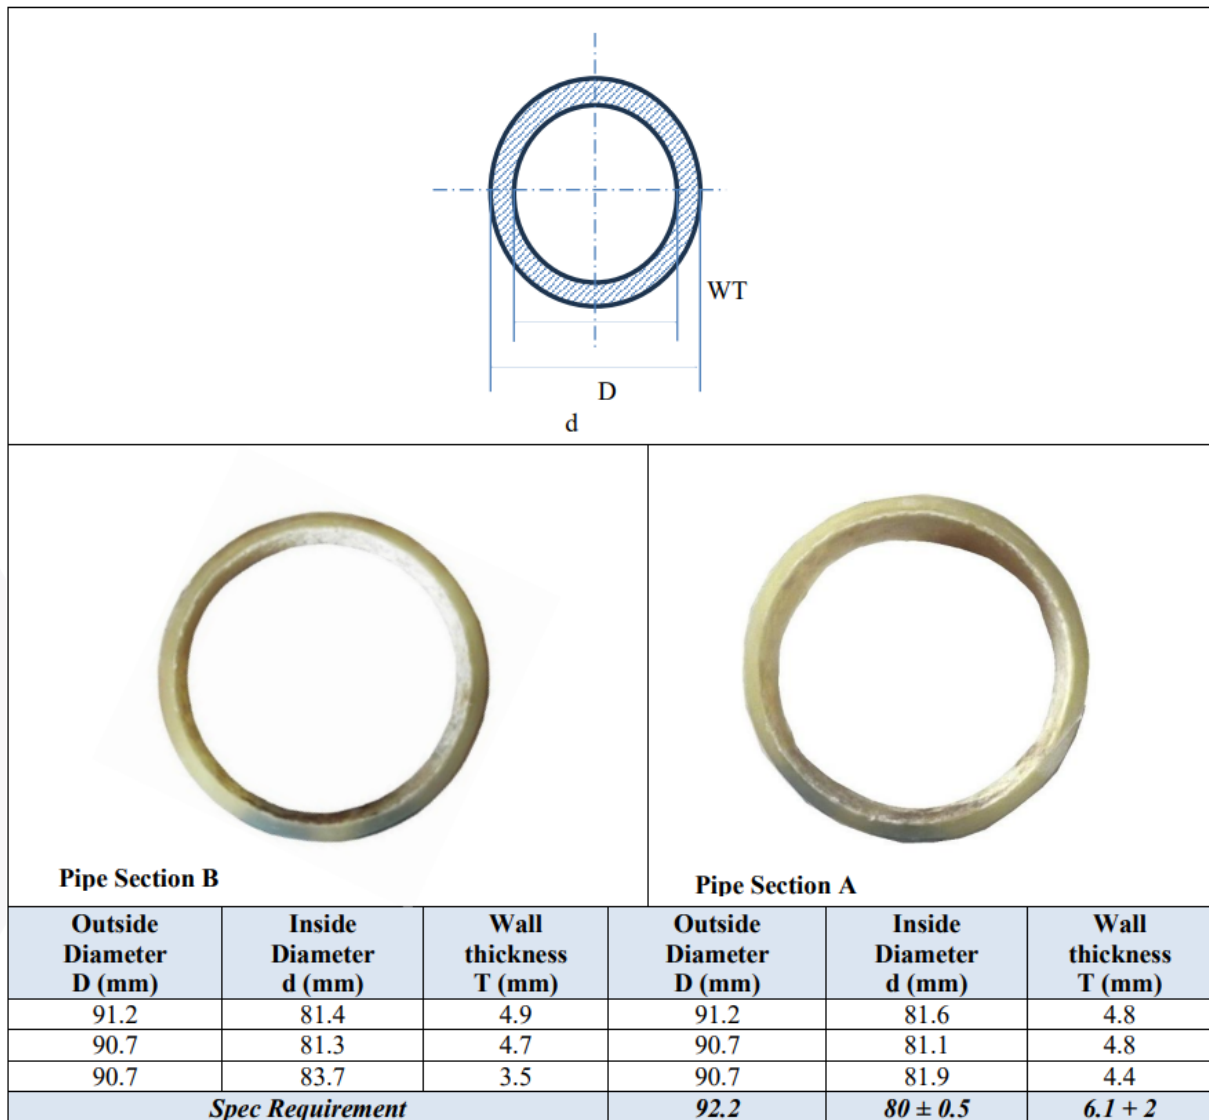
- A significant thickness reduction from the pipe interior.
- DIN-16965-5 specifies minimum thickness of internal corrosion barrier to be 2.5mm.
- The thickness reduction of 2.6mm implied that the corrosion barrier was compromised in the failed pipe sample.

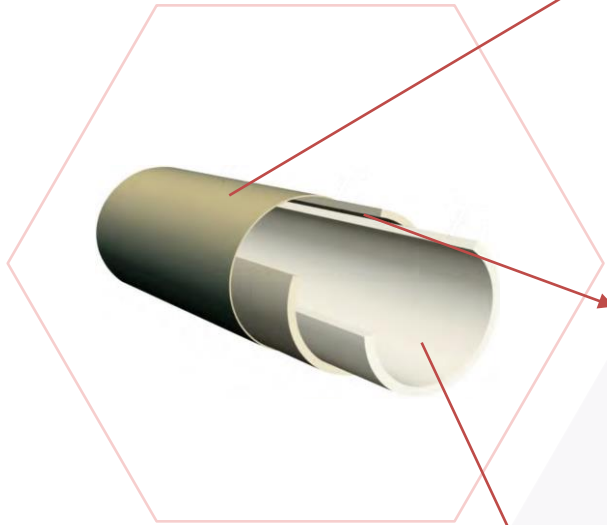
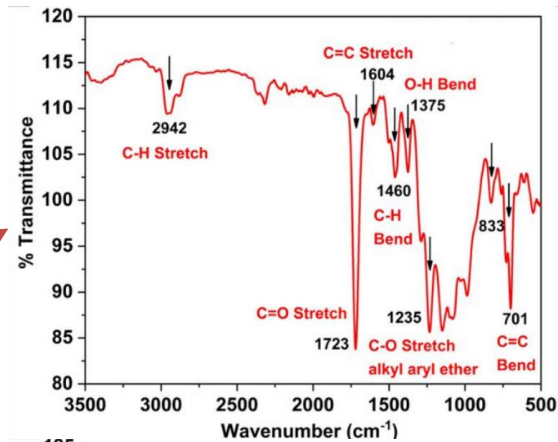
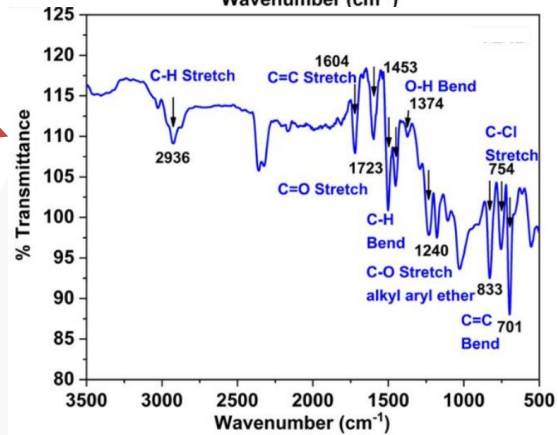
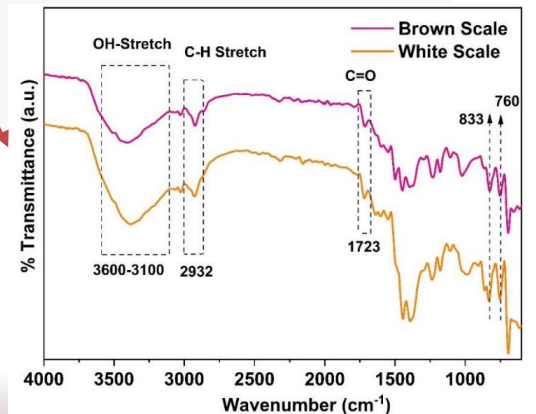
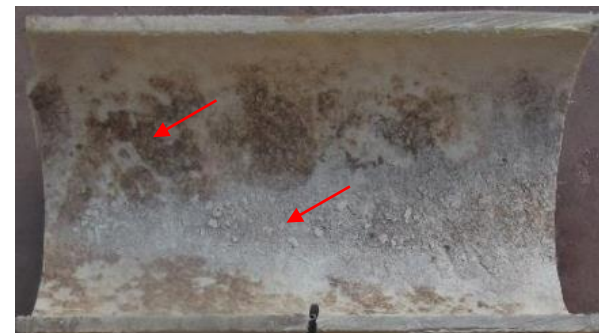
Pipe OD		
Functional Group	Wavenumber (cm <sup>-1</sup> )	Transmittance (%)
C-H Stretch	2942	109
C=O Stretch	1723	83
C=C Stretch	1604	108
C-H Bend	1460	102
O-H Bend	1375	103
C-O Stretch Alkyl aryl ether	1235	85
C=C Bend	701	88
C-Cl Stretch	-	-

Pipe ID		
Functional Group	Wavenumber (cm <sup>-1</sup> )	Transmittance (%)
C-H Stretch	2936	109
C=O Stretch	1723	107
C=C Stretch	1604	110
C-H Bend	1453	104
O-H Bend	1374	109
C-O Stretch Alkyl aryl ether	1240	98
C=C Bend	701	93
C-Cl Stretch	754	96

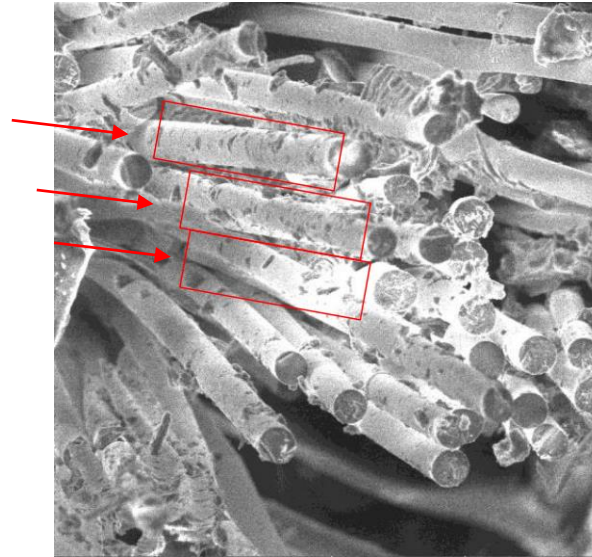
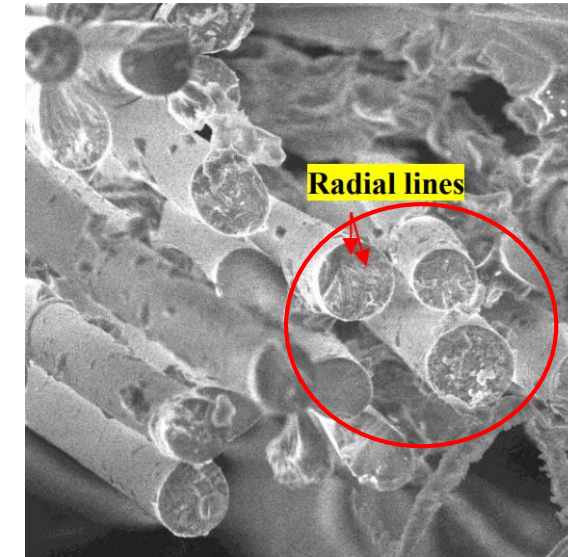
## Scanning electron microscope (SEM) of the fracture face

- Remnants of polymer matrix on the fiber surface.
- The presence of radial marks suggested a failure in tension.
- It appears that fibril like failure occurred.

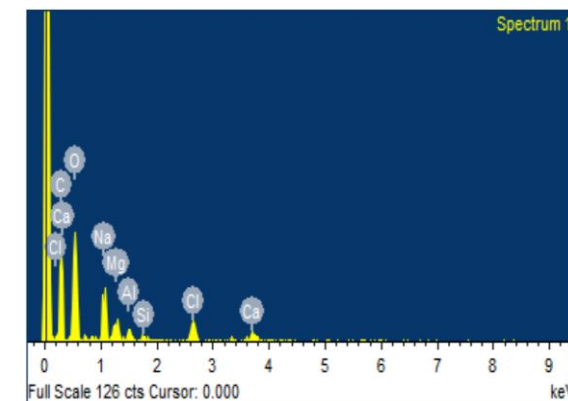
## Energy Dispersive Spectroscopy (EDS) of the scales deposit noted on the inner surface

- Carbon (C) and Oxygen (O) as the major constituents of the scale which confirms the organic nature of the scale.
- Calcium (Ca), Magnesium (Mg) are most likely due to presence of dissolved salts within the water in sodium hypochlorite solution.

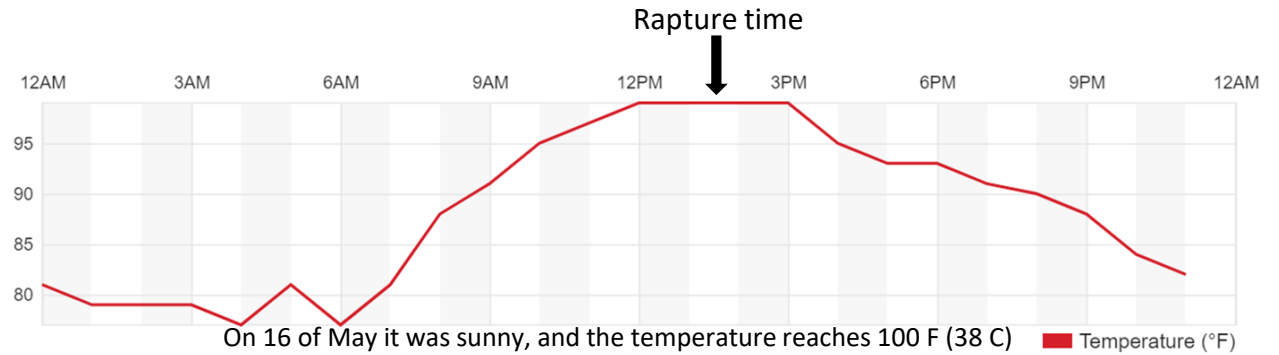
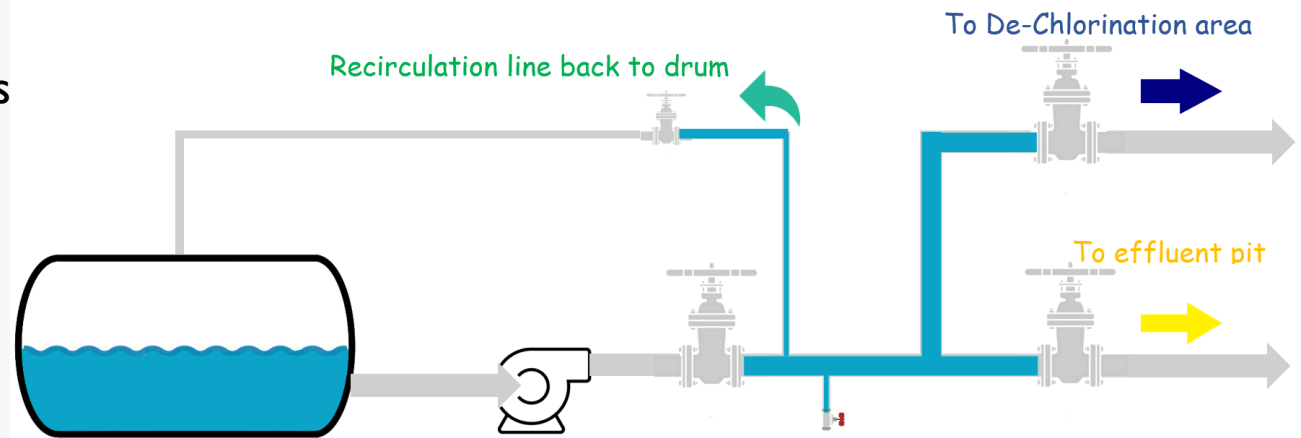
- The system was offline while process residues kept without flushing.
- All the valves in the system were kept in closed condition even the recirculation line valve.

The process was kept in the system without venting!

- Revise the SOP to include a clause that ensures venting the system in Idle condition.
- Adding a line to the system and include PSV with a rupture disk as a safety precaution.
- Establish PM for the unit piping for integrity management.
- Developing Ultrasonic based NDT techniques to assess the condition of internal corrosion barrier for the piping.
