FRETTING CORROSION IN STEAM REBOILER TUBES

Muhammad Raheel Rafique
(Lead Engineer Static Equipment)
PETROKEMYA – A SABIC Affiliate

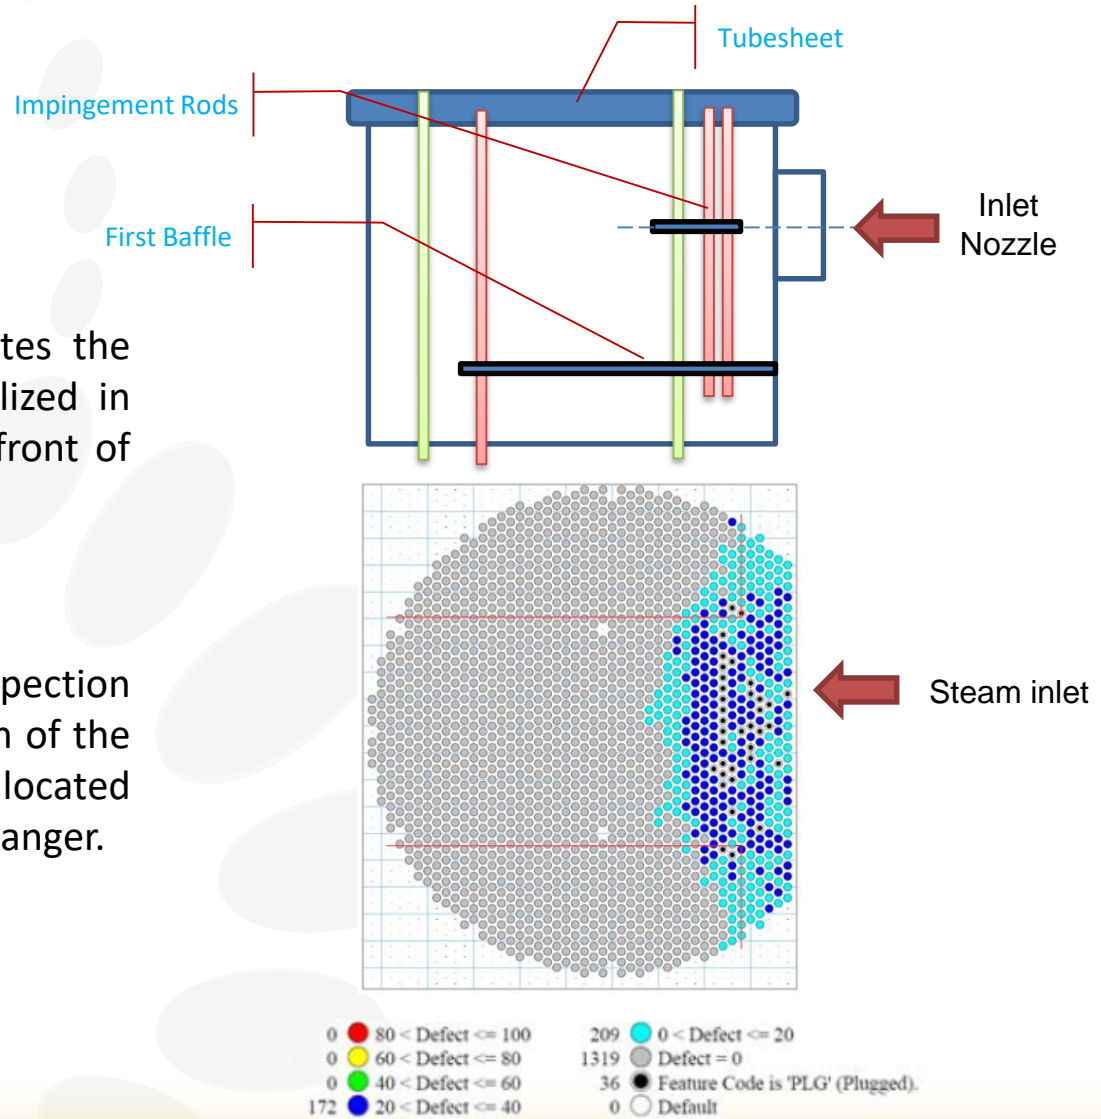
TUBE SCANNING RESULTS

- History of tube scanning indicates the high rate of thickness loss localized in the tubes which are located in front of the inlet nozzle.
- Magnetic Flux Leakage (MFL) inspection performed throughout the length of the tubes, identified the flaws located nearby the first baffle of the exchanger.

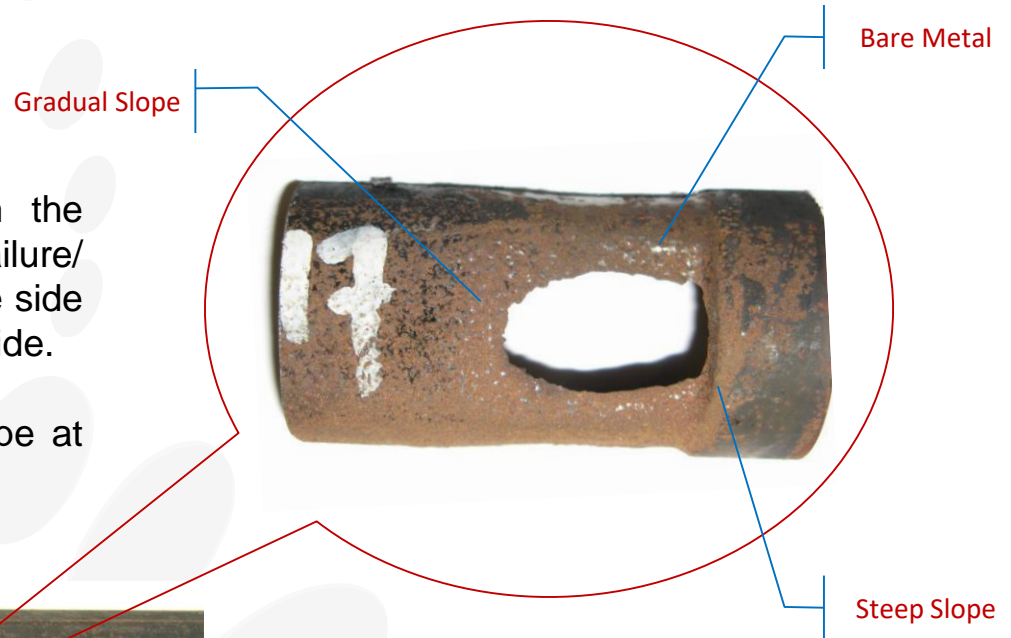
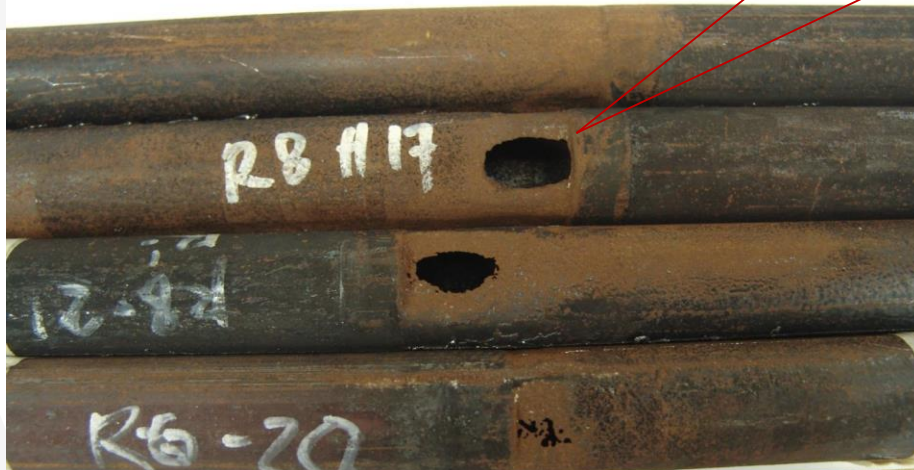
TUBE SAMPLES

- ❑ Tube samples were collected from the failed tubes, and found that the failure/maximum thickness loss is on the one side of the tube, with no loss on the other side.
- ❑ Failure location depicted a steep slope at one end of the opening.

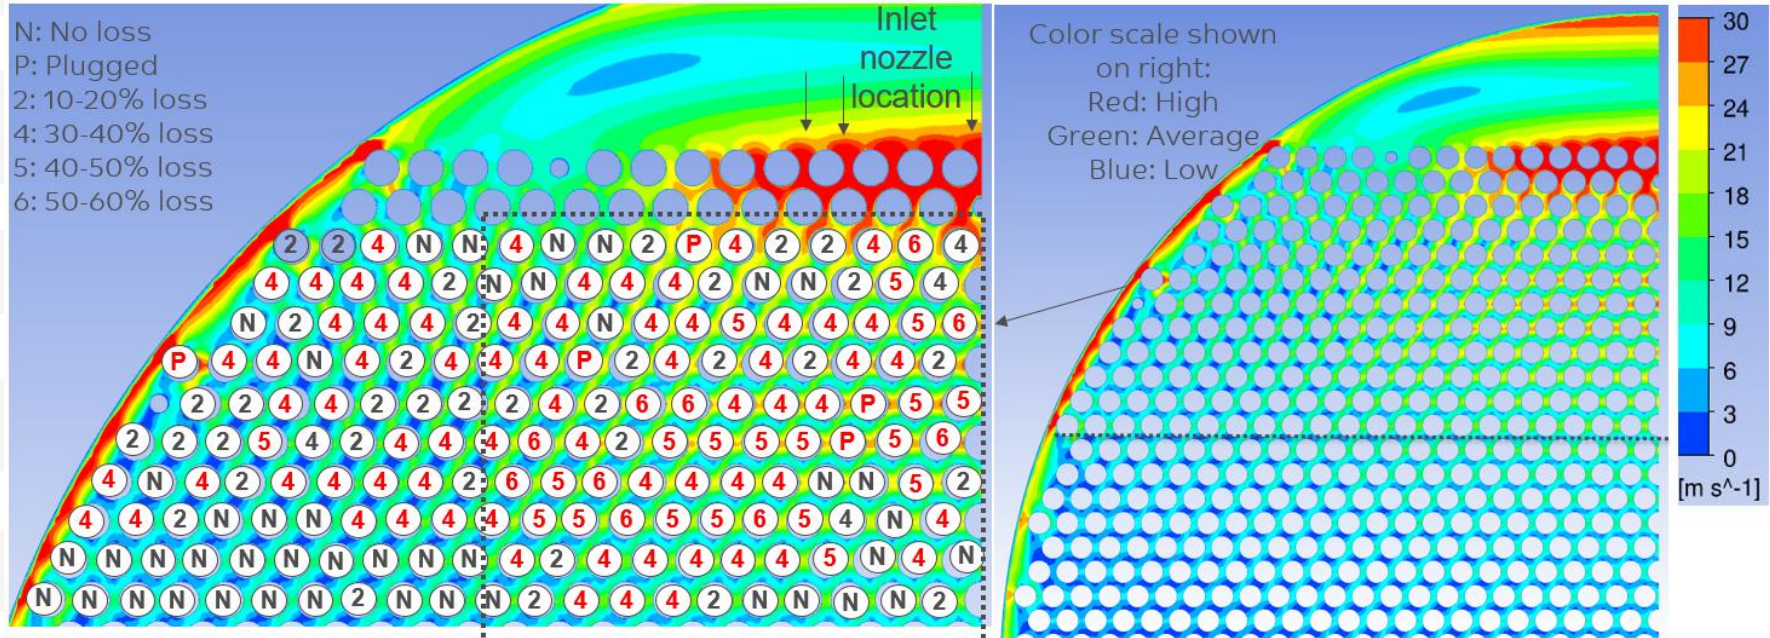
CFD – VELOCITY TRENDS

Computational Fluid Dynamics (CFD) Analysis performed to check the flow morphology and determine the flow velocity at the inlet nozzle. Below are the results:

- CFD results are superimposed with tube thickness reduction from inspection report.
- Most tube damage is on tube rows close to the inlet and once directly below inlet nozzle.
- No wall thickness loss is observed, once the velocity is reduced beyond 15-20 tube rows.

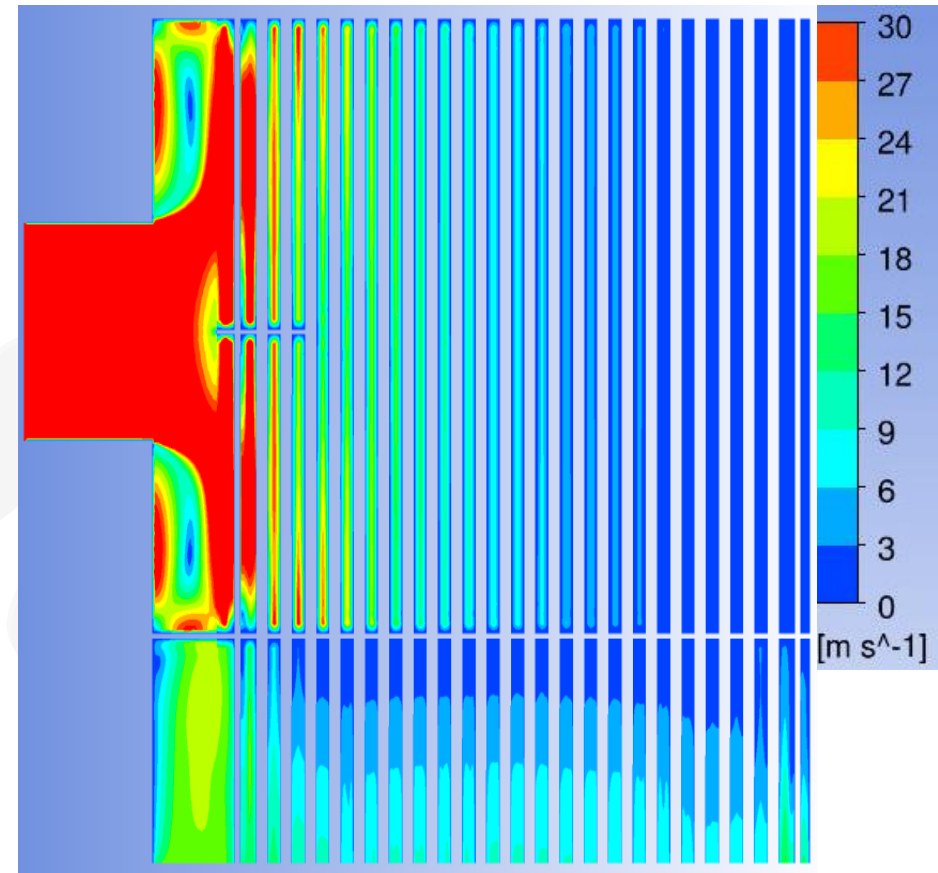
CFD - VELOCITY TRENDS (SYMMETRY PLANE)

- ❑ High velocities observed close to the inlet nozzle.
- ❑ Velocity distribution becomes uniform approx. 10 – 15 tubes below.

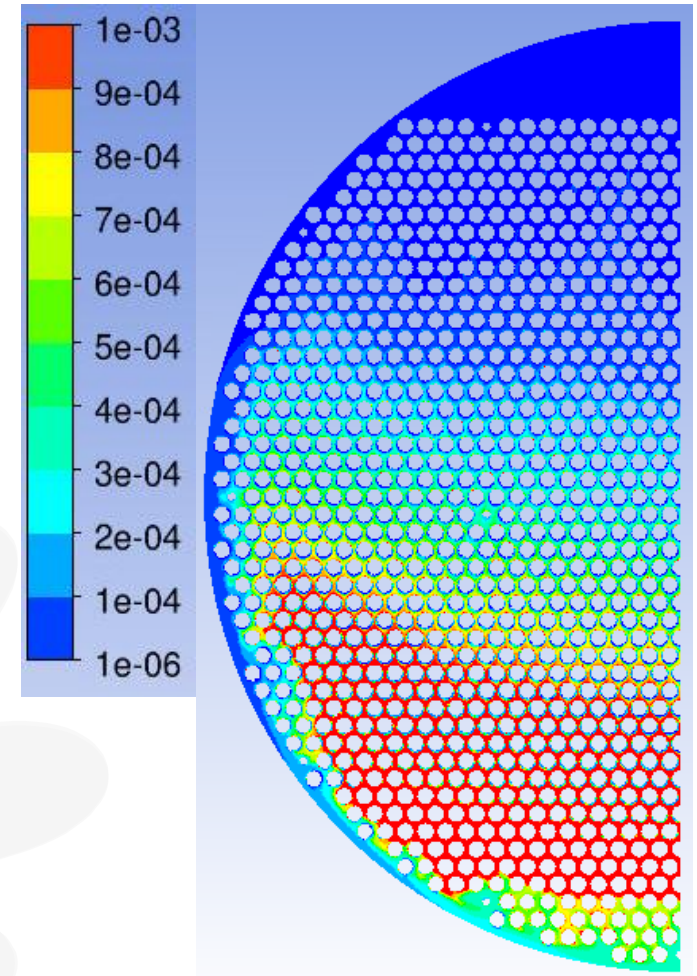
CFD – CONDENSATION PLOT

- ❑ Volume Fraction of condensed water as per CFD Analysis.
- ❑ Most damage seems to be concentrated in regions of no or low condensation close to the inlet.
