Deterioration of Reinforced Concrete Structure with Built in Cathodic Prevention System

Saad Alshehri, SABIC

Background: Cooling Tower Details & Problem

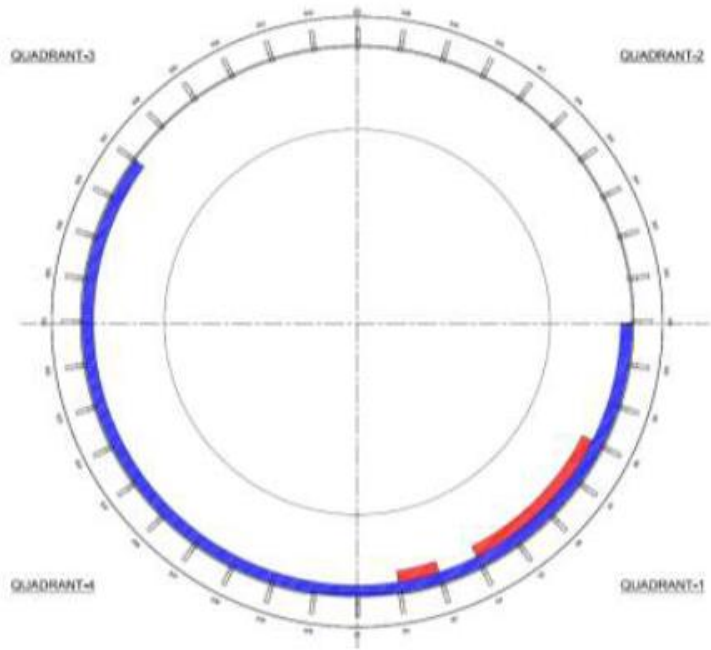
- Unsound concrete detected in Survey Section in Lift 1

- Unsound concrete detected in Survey Section in Lift 2

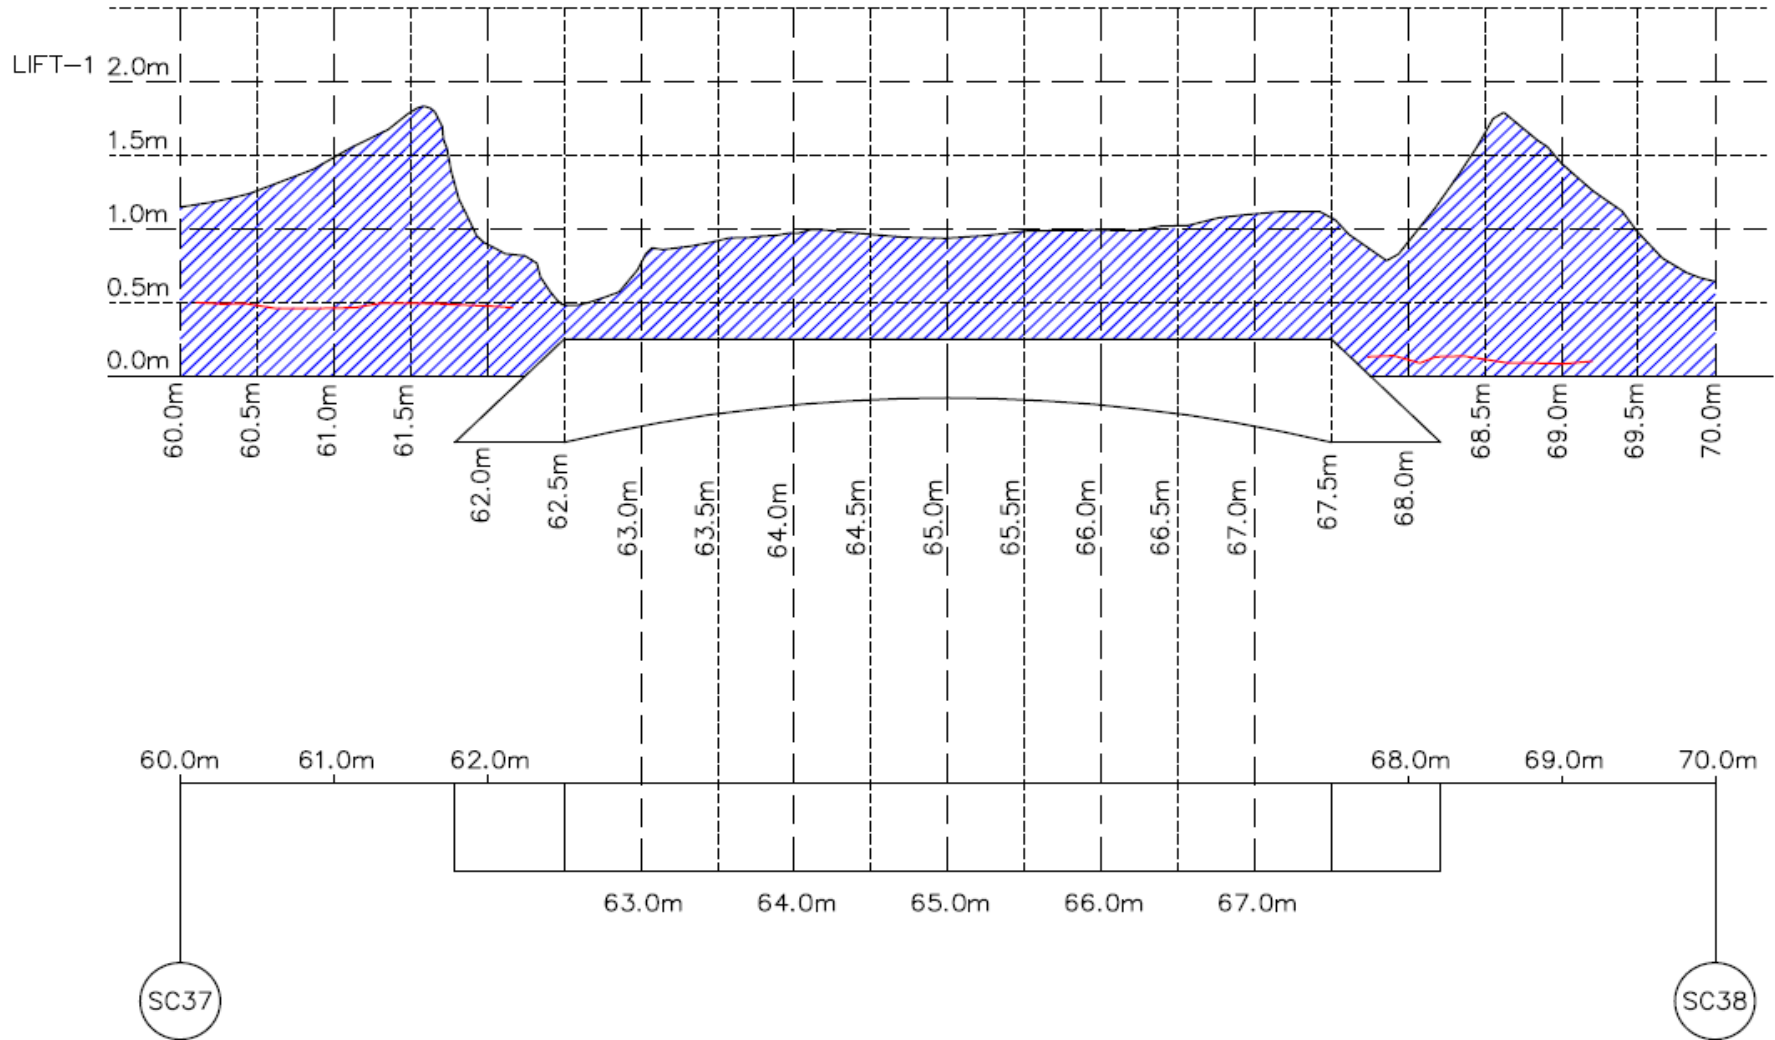
Stage I: Condition Assessment- Hammer Tap survey

Quadrant	Approx. survey surface area (m ²)	Approx. surface area of unsound concrete (m ²)			Approx. quadrant surface area of unsound concrete (m ²)
		Lift 1	Lift 2	Lift 3	
1	257	123	2	-	125
2	257	-	-	-	-
3	257	26	-	-	26
4	254	70	-	-	70
Total approx. surface area of unsound concrete (m²)					221

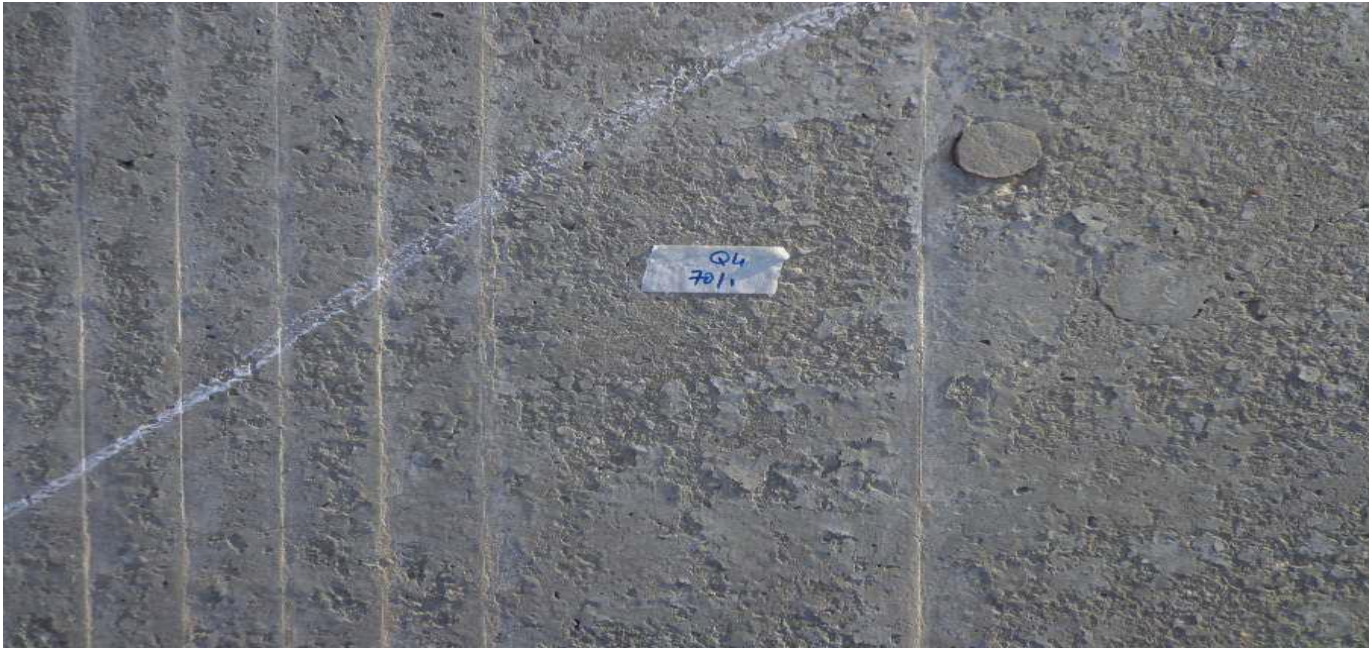
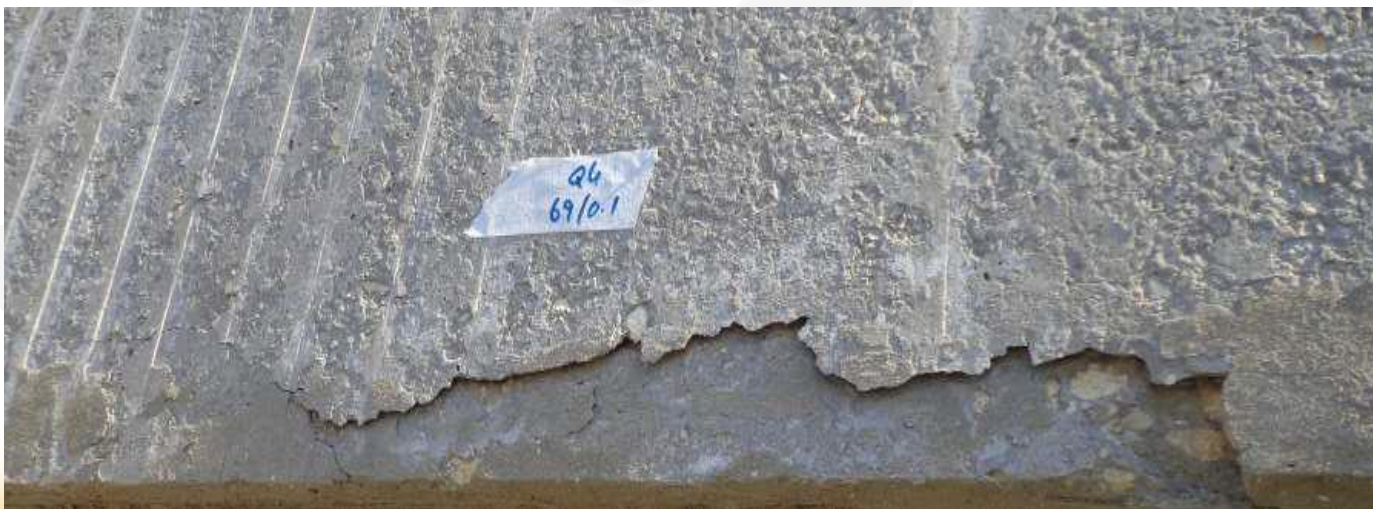
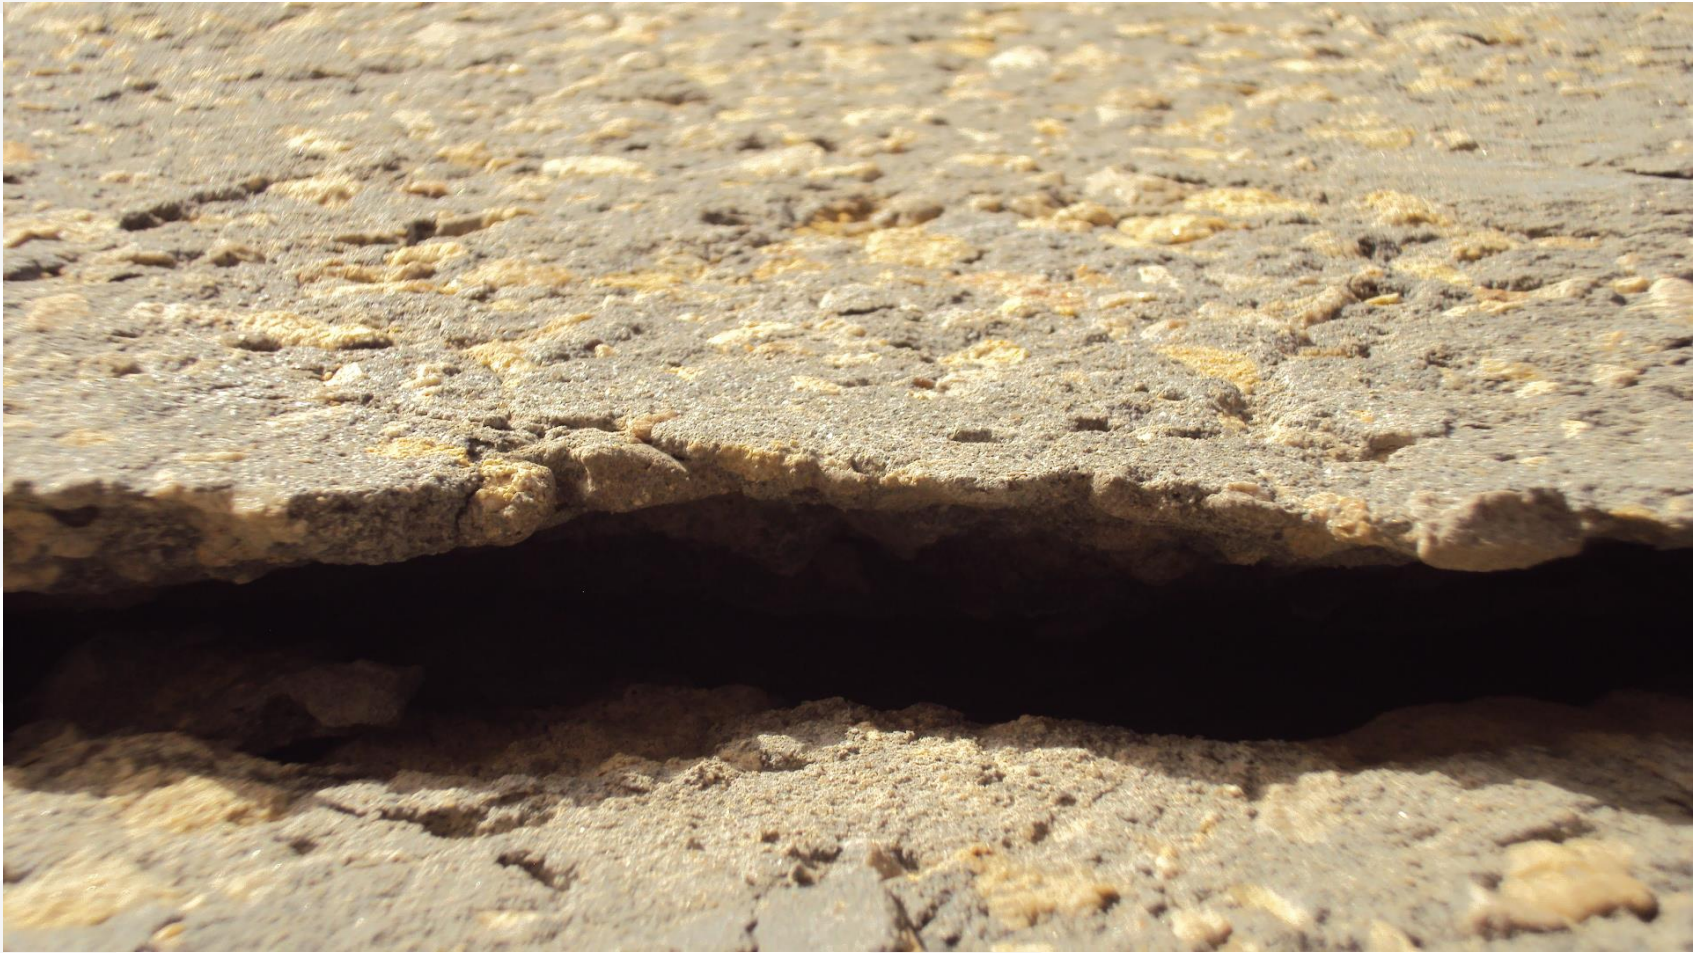
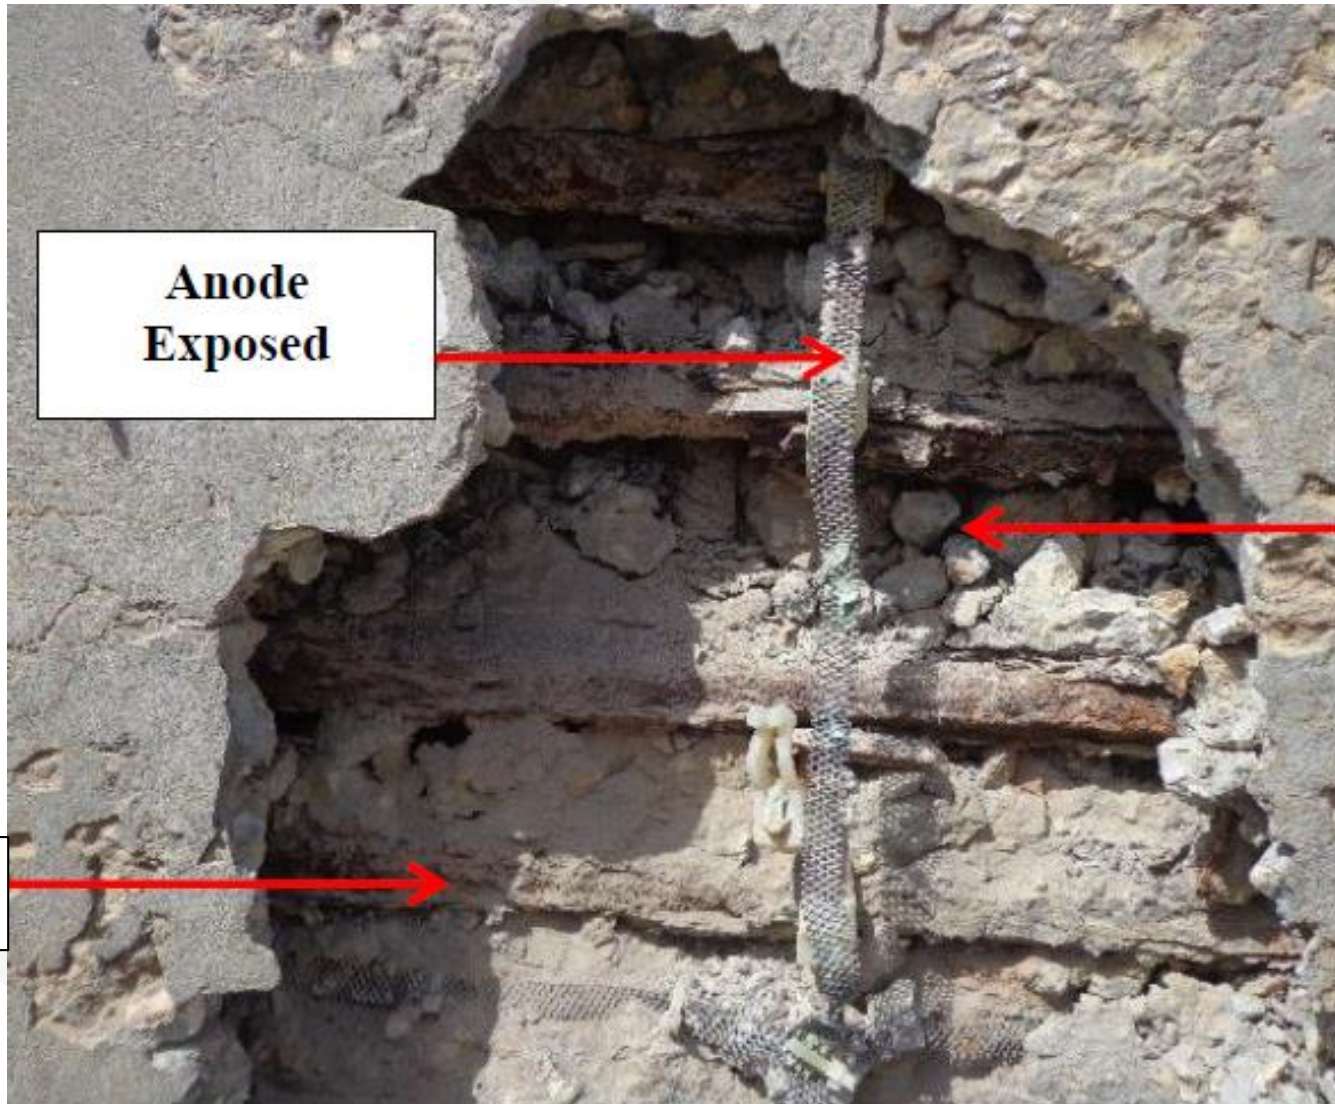
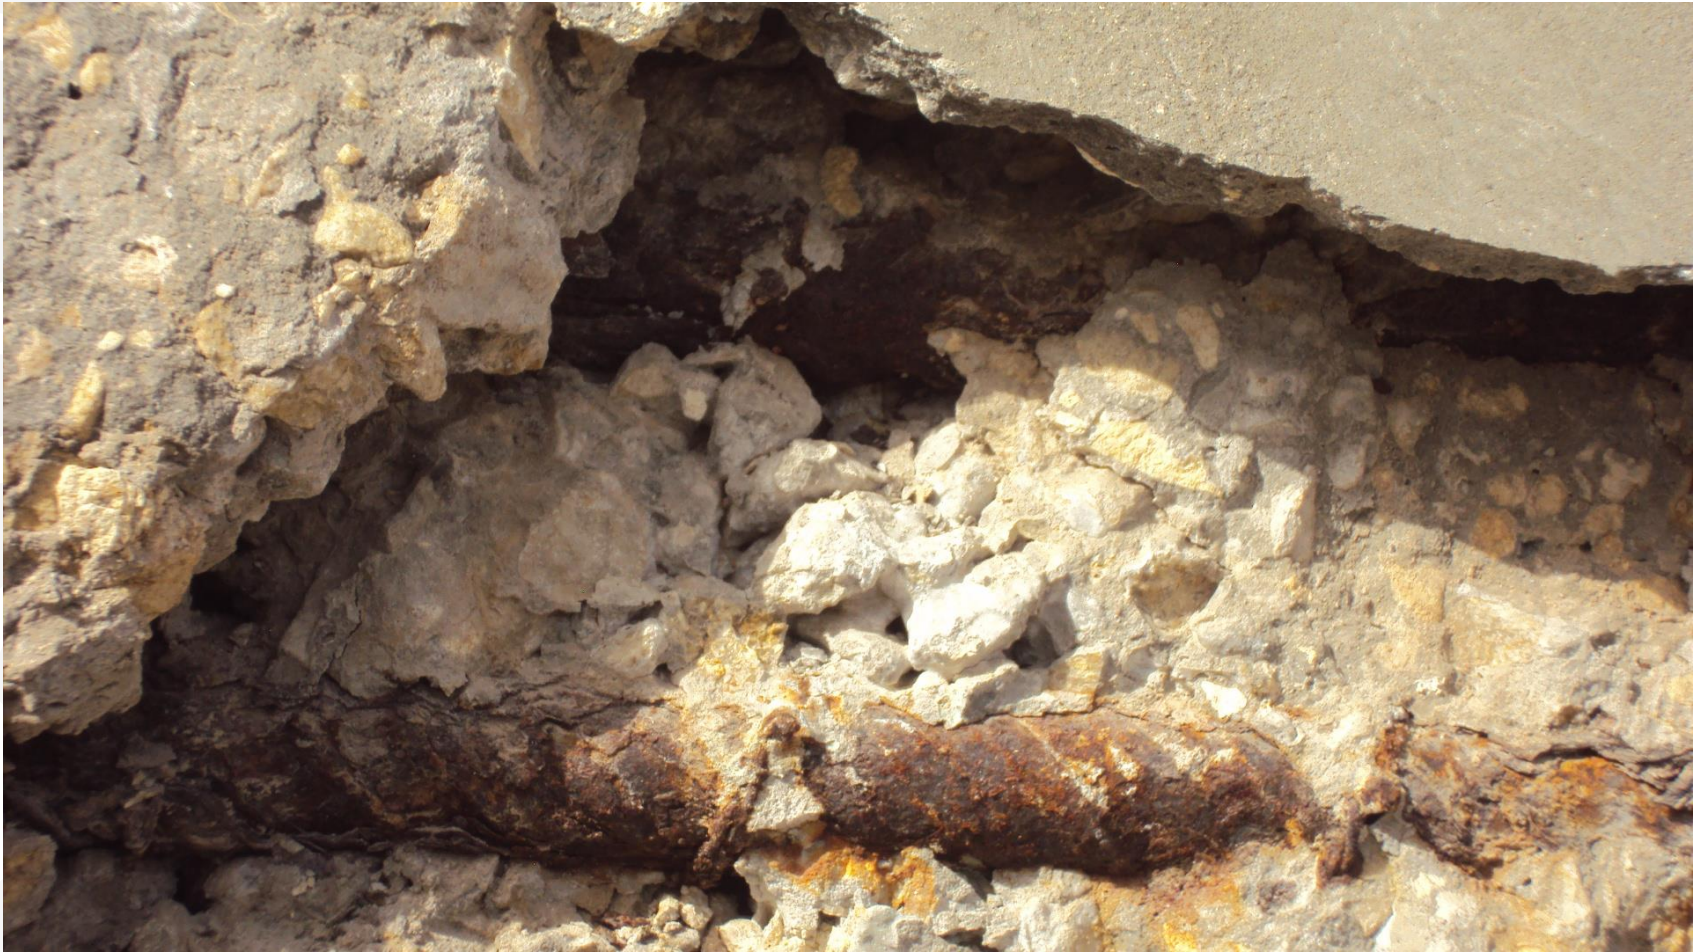
Visual Inspection: Delaminated Areas

Anode Exposed

Loose Concrete

Corroded Steel

- Cracking and delamination of the FAN foundation, 1st & 2nd lifts resulted due to chloride-induced corrosion of the reinforcing steel
 - (lift 1 at Quadrants 1, 3 & 4 are in bad condition. While Lifts 2 & 3 for all quadrants appear to be good condition.)
- Concrete cover at Lift 1 is lower than design. The cover in Lifts 2 & 3 in all compliant with the civil design.
- Reinforcing steel underneath the sound concrete is actively corroding across most of the inspected parts of structure.
- Ongoing corrosion of the reinforcing steel would eventually result in further cracking and delamination of concrete which would lead to loss of serviceability and integrity of the structure.
- Absence of suitable coating accelerate the chloride ingress to the concrete.

Stage 2: Repair Method-Patch Repairs & Cathodic Protection

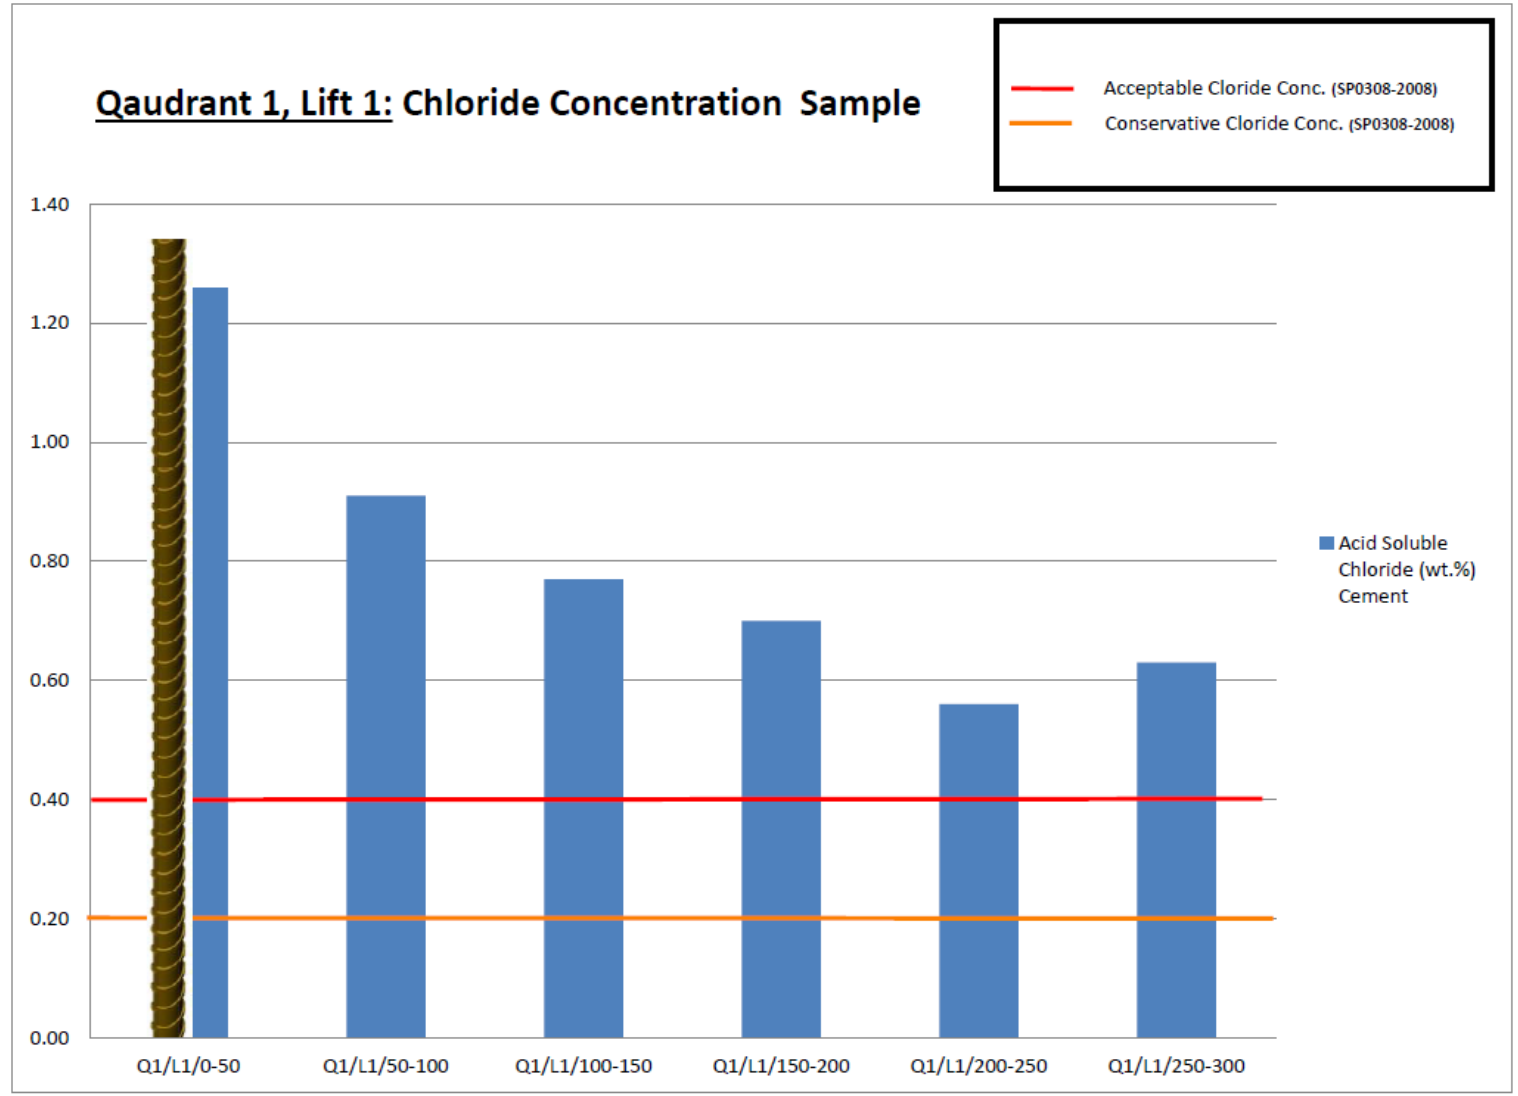
Stage I: Condition Assessment- Chloride concentration

Quadrant	Lift	Chloride limit for corrosion of steel in concrete exceeded? (Yes/No)					
		0-50mm	50-100mm	100-150mm	150-200mm	200-250mm	250-300mm
1	1	Yes	Yes	Yes	Yes	Yes	Yes
	2	Yes	Yes	Yes	Yes	Yes	Yes
	3	Yes	Yes	Yes	Yes	Yes	Yes
2	1	Yes	Yes	Yes	Yes	Yes	Yes
	2	Yes	Yes	Yes	Yes	Yes	Yes
	3	Yes	Yes	Yes	Yes	Yes	Yes
3	1	Yes	Yes	Yes	Yes	Yes	Yes
	2	Yes	Yes	Yes	Yes	Yes	Yes
	3	Yes	Yes	Yes	Yes	Yes	No
4	1	Yes	Yes	Yes	Yes	Yes	Yes
	2	Yes	Yes	Yes	Yes	Yes	Yes
	3	Yes	Yes	Yes	Yes	Yes	Yes
