Crevice Corrosion of Chlorine Recuperator Tubes

Faisal S. Al-Otaibi

Section Head, Inspection – Sipchem

February 28, 2022

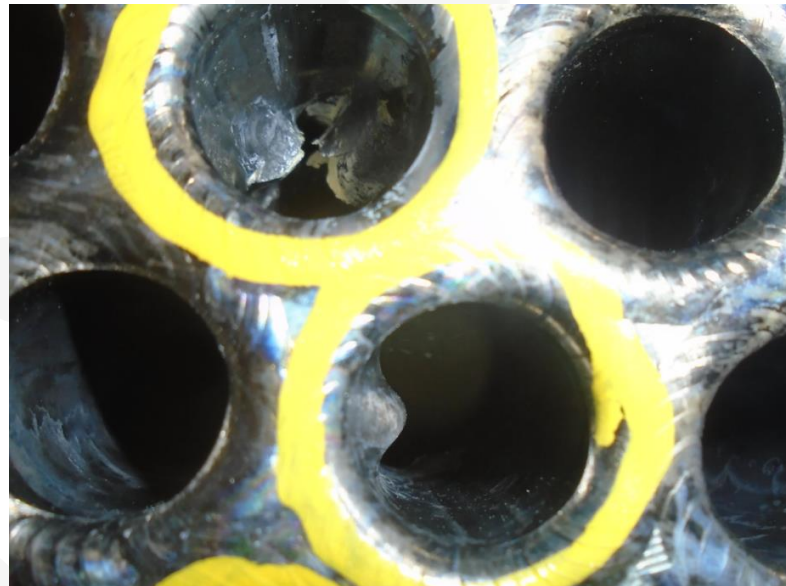
A Titanium heat exchanger tubes (Gr. 12) had experienced severe corrosion after less than 6 years of service in Chlor Alkali plant. During plant turnaround maintenance the exchanger was opened for cleaning and inspection and severe deformation on the tubes (toward inner diameter) were noticed on 7 tubes at the tube to tubesheet area. The tubes were preserved for the purpose of analysis and investigation.

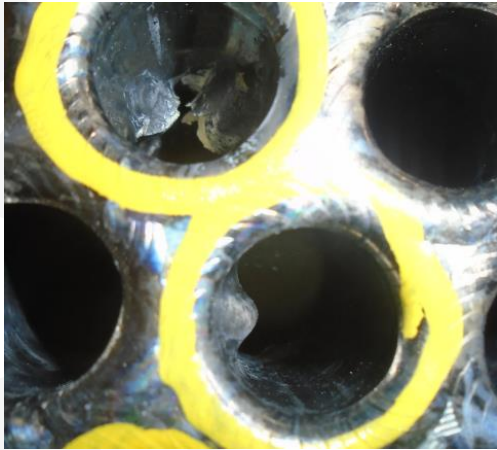
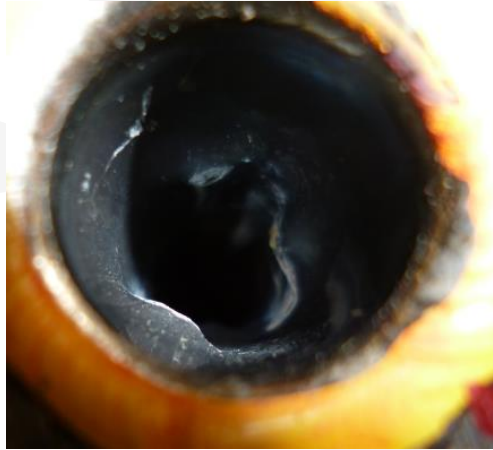
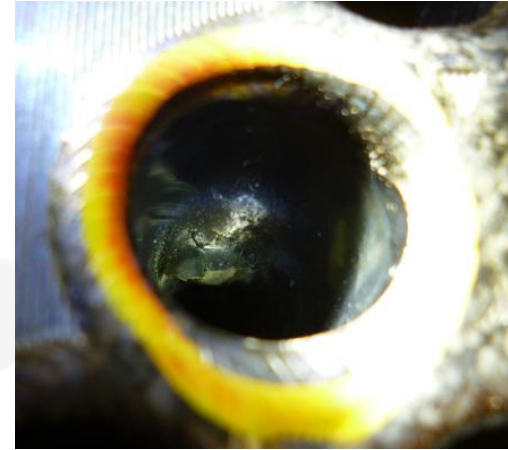
- The exchanger was commissioned in 2013.
- The first tube inspection attempted was on April 2019.
- During this period, there were two Turnaround maintenance opportunities, and the exchanger was opened for cleaning only.
- The bends were discovered with the first visual inspection and tube ECT.

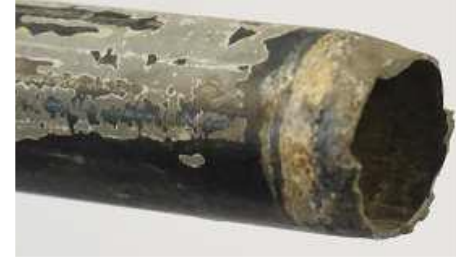
Severe deformation and white deposits on the tube to tubesheet portion.

- Titanium alloyed with palladium (Gr. 7 & 11) has been proven by other end users to be excellent in crevice corrosion resistance in brine services.
- Passivation by palladium oxides has been proven to be effective and have lower cost. However, in exposed to abrasive regions (such as tube-to-tubesheet region) the passivation layer might get disconnected. Therefore, this option was not recommended.
- After discussion with subject matter experts in reliability and process, and consultation with the licensor, we have decided to proceed with upgrading tubes material with Palladium alloyed Titanium tubes.

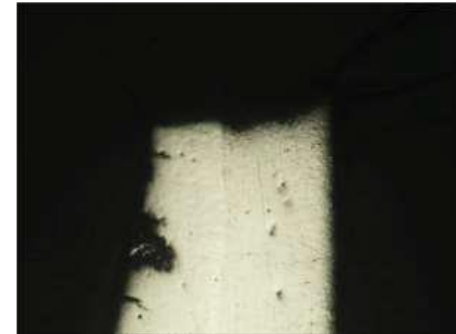
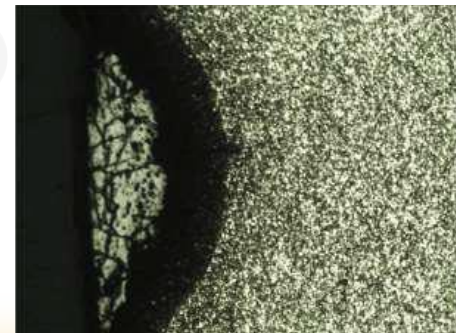
On the outer edge, pitting was observed along with pitting filled with deposits.

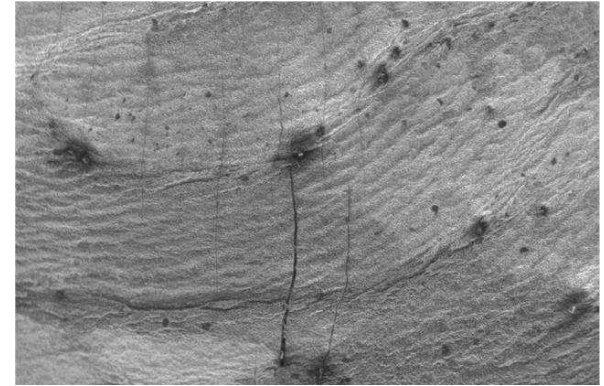
SEM was conducted at fracture surface to showed cracks and metal wastage at different locations.

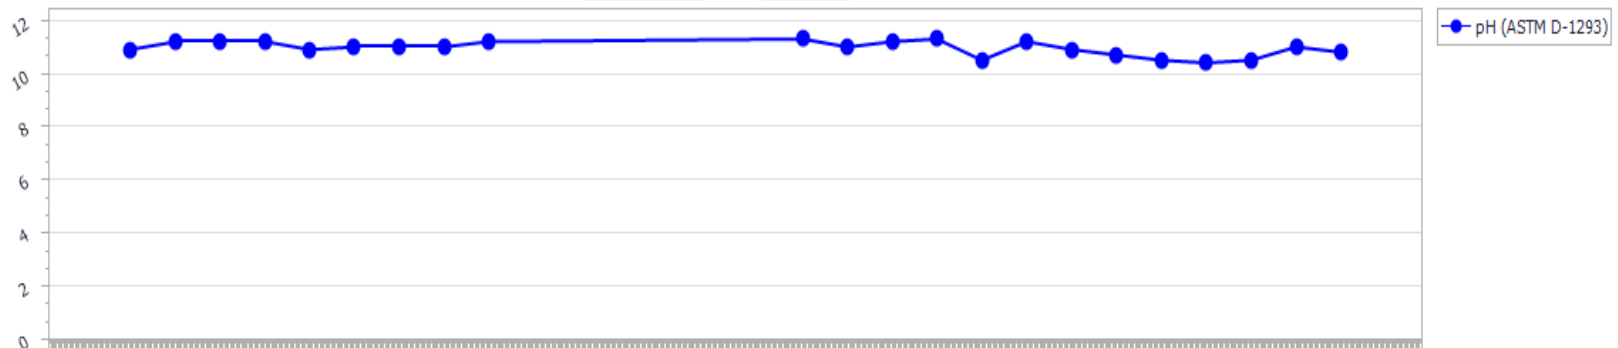
Sample of pH value during 2018

For titanium Gr.12 to corrode in crevice area, the solution within the crevice must become and remain significantly acid (~1). As per lab analysis, the pH of the polished brine (the inlet process to shell side) have usually remained in the range of 10-11 pH.
