Jubcor Presentation

IMPROVED COMPRESSOR IMPELLER DESIGN TO
OVERCOME SULPHIDE STRESS CRACKING (SSC)

Presented By:
Ahmad AlNasser

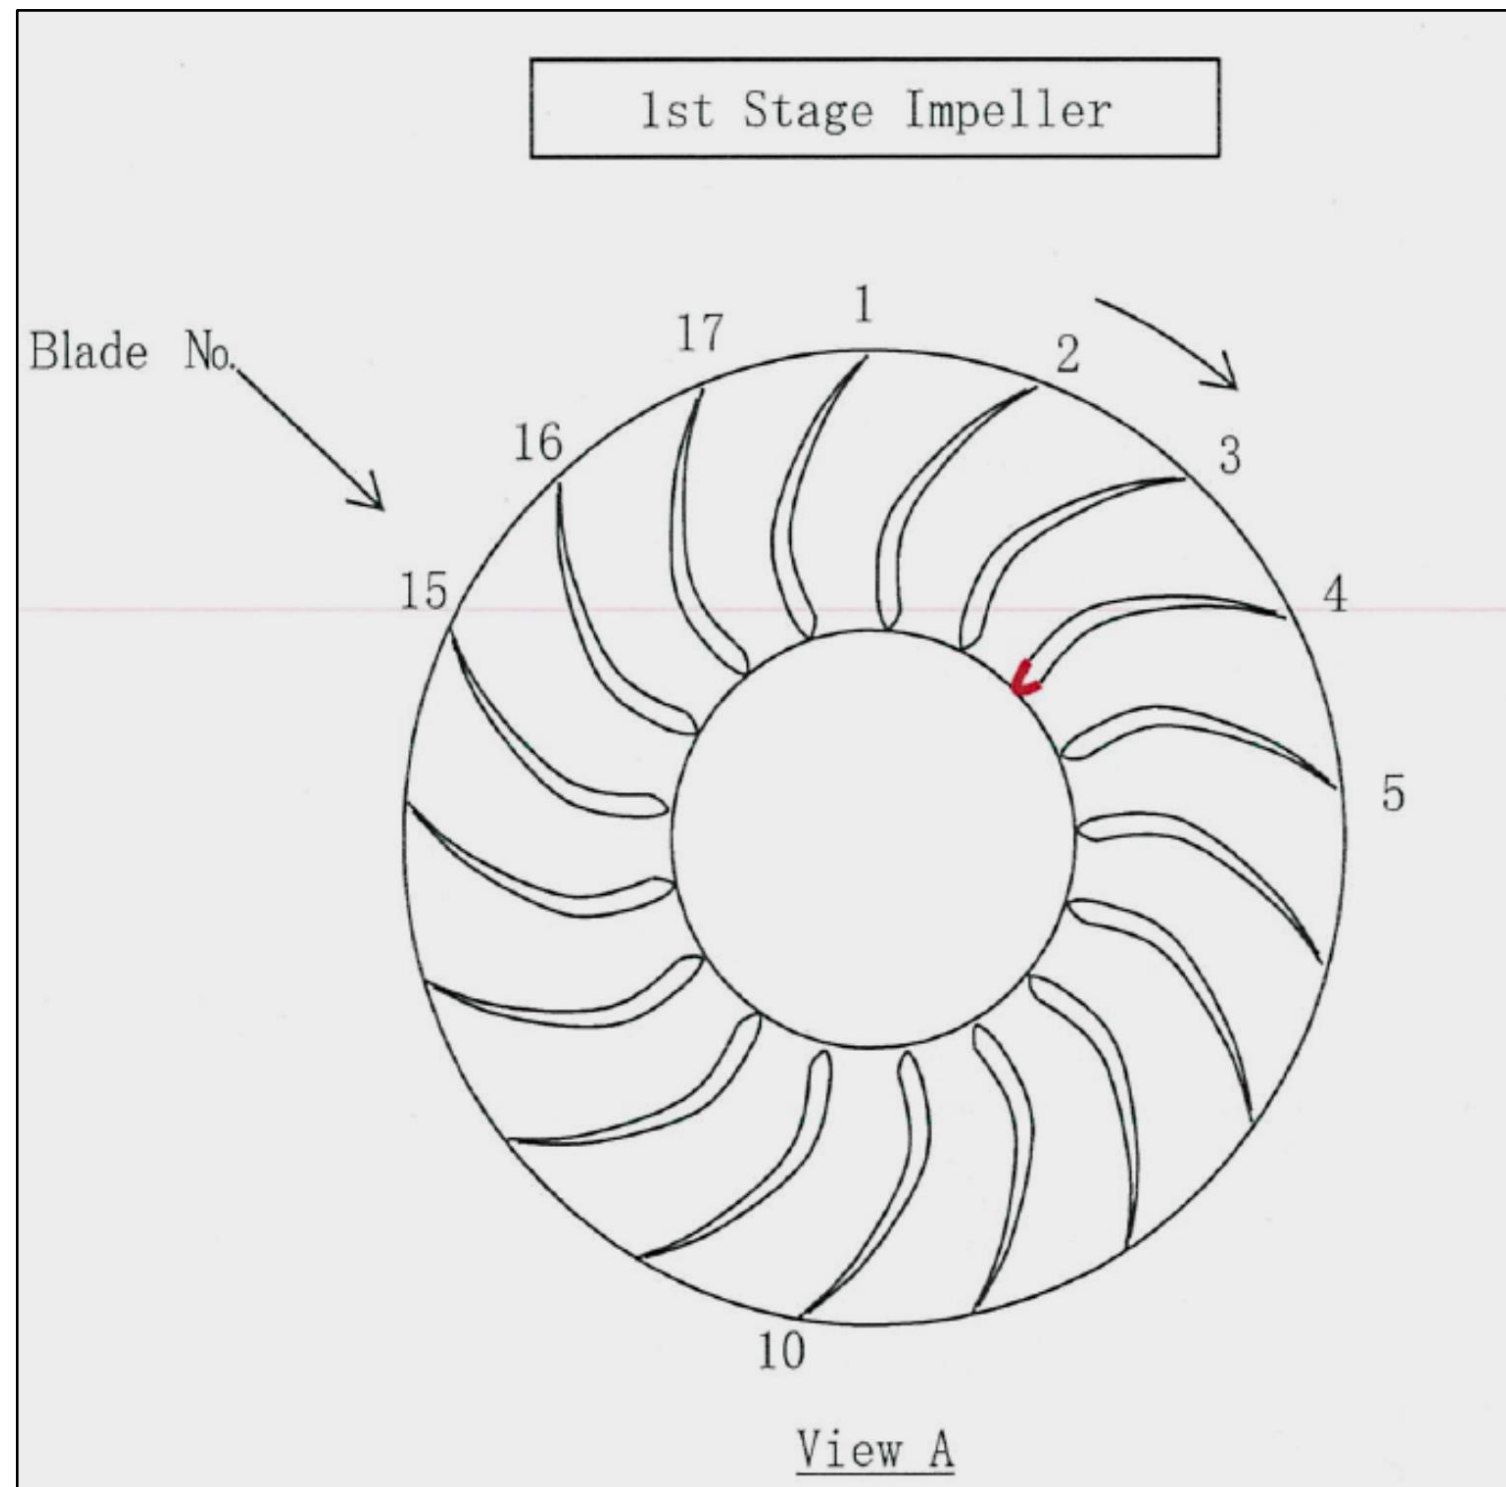
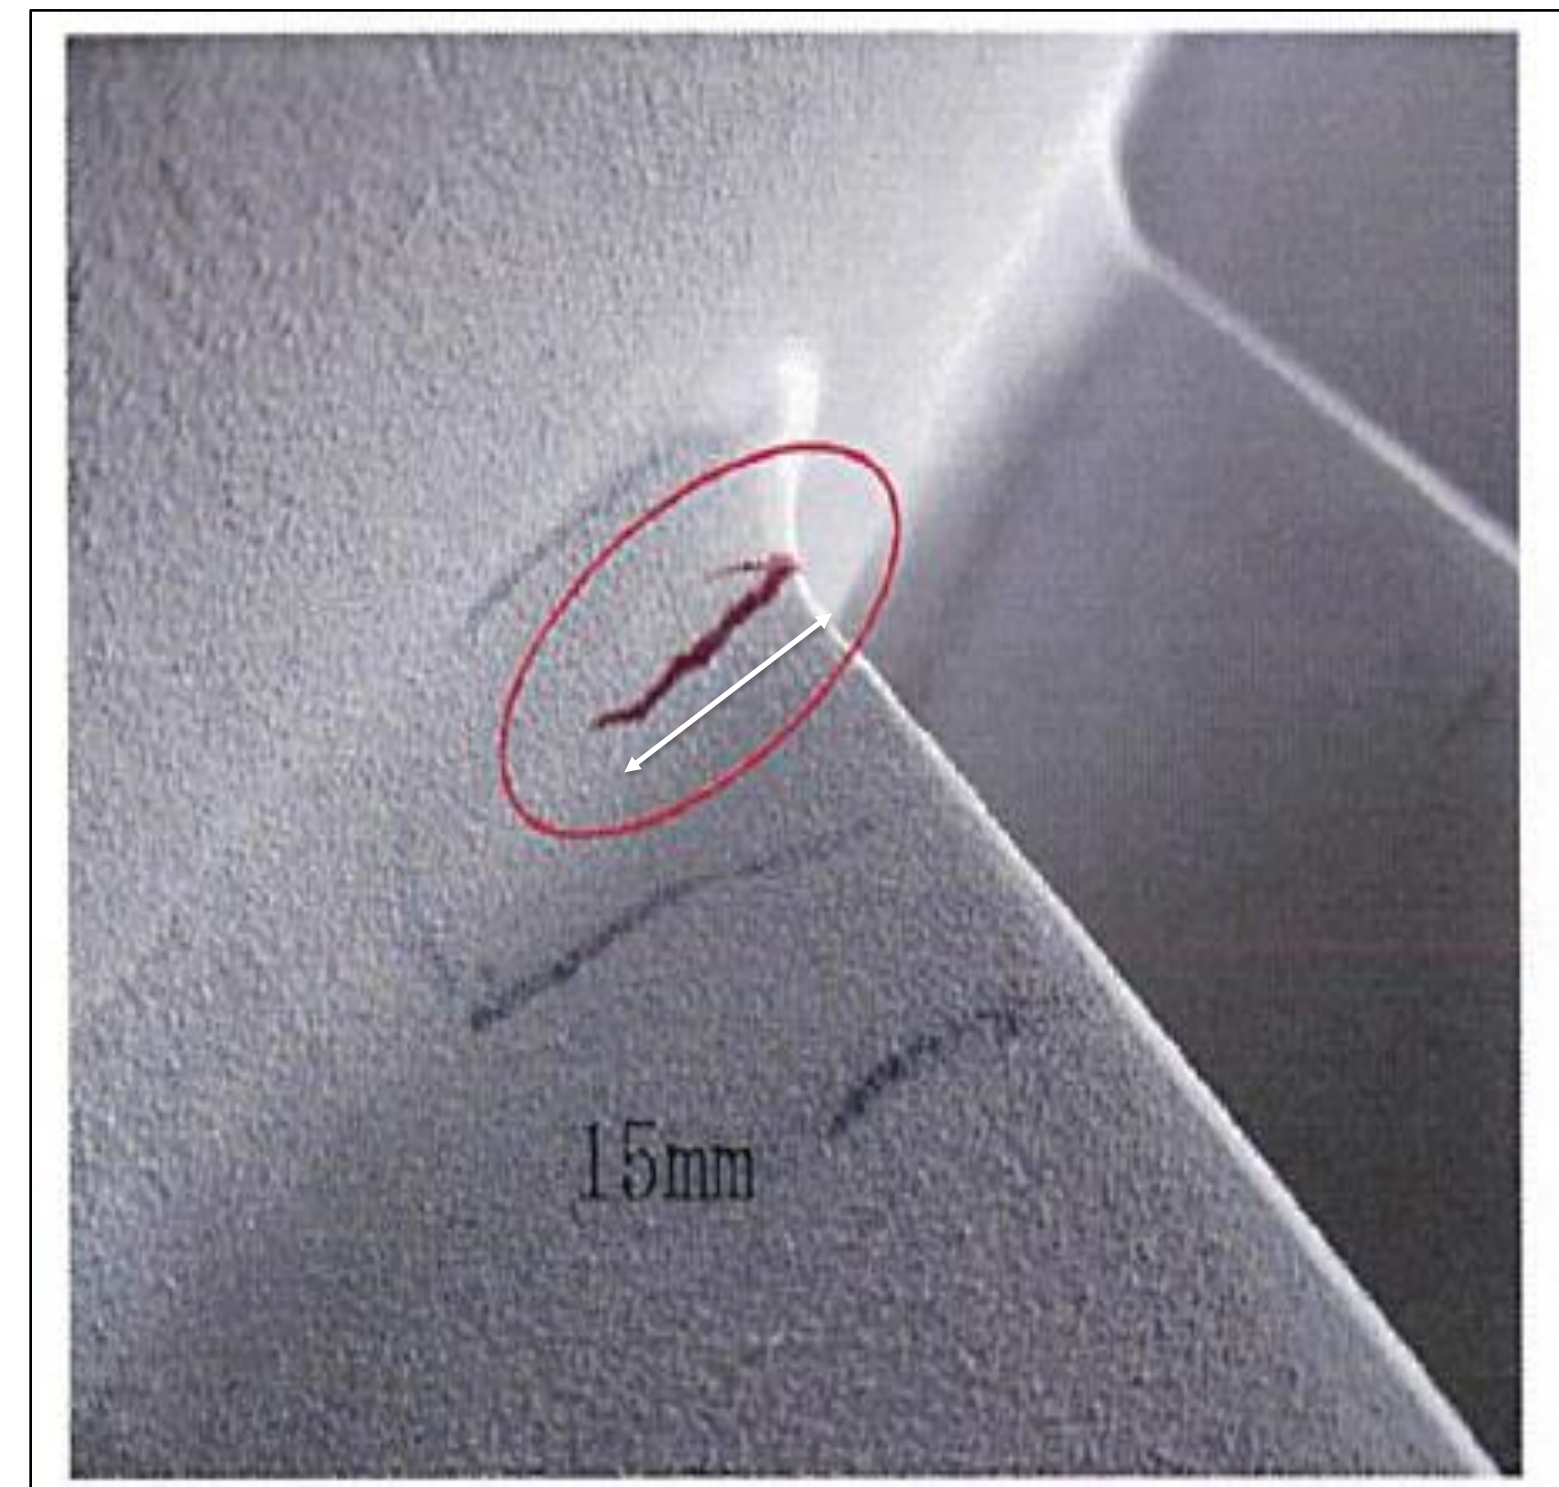
Crack in vane # 4 of 1st stage impeller as of 2020 TA

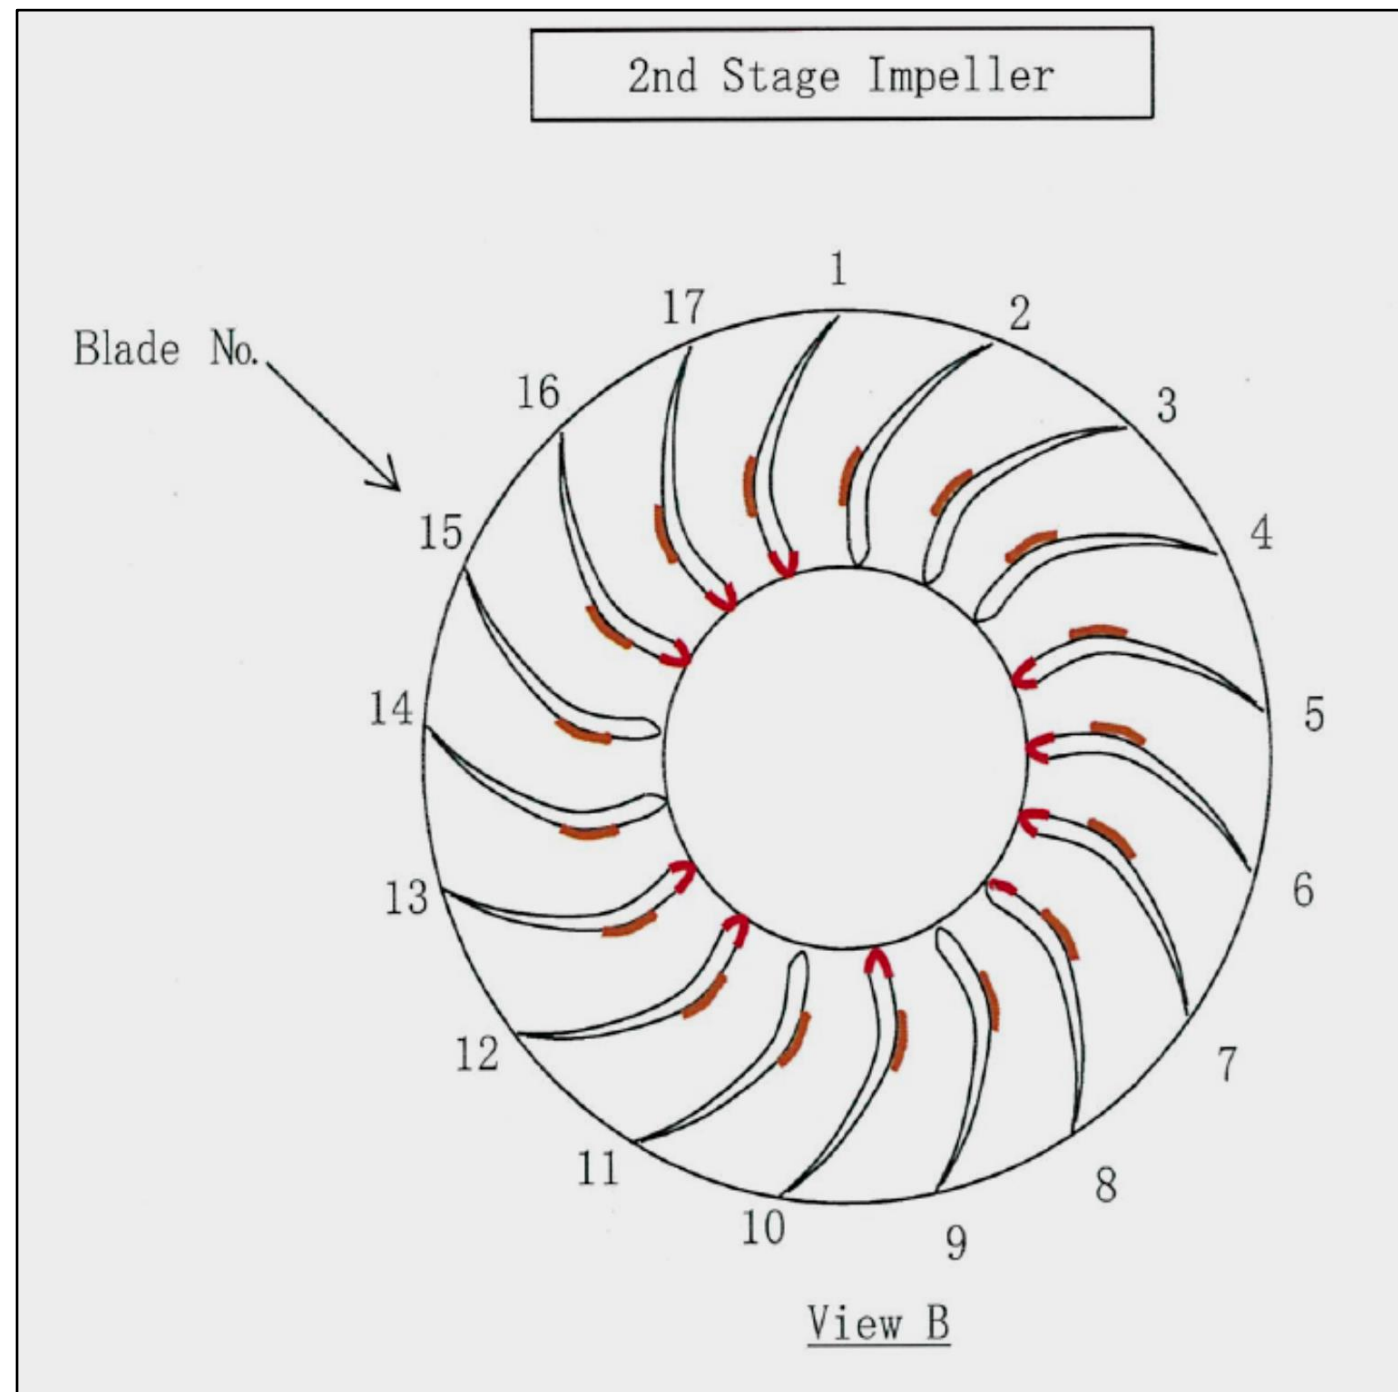
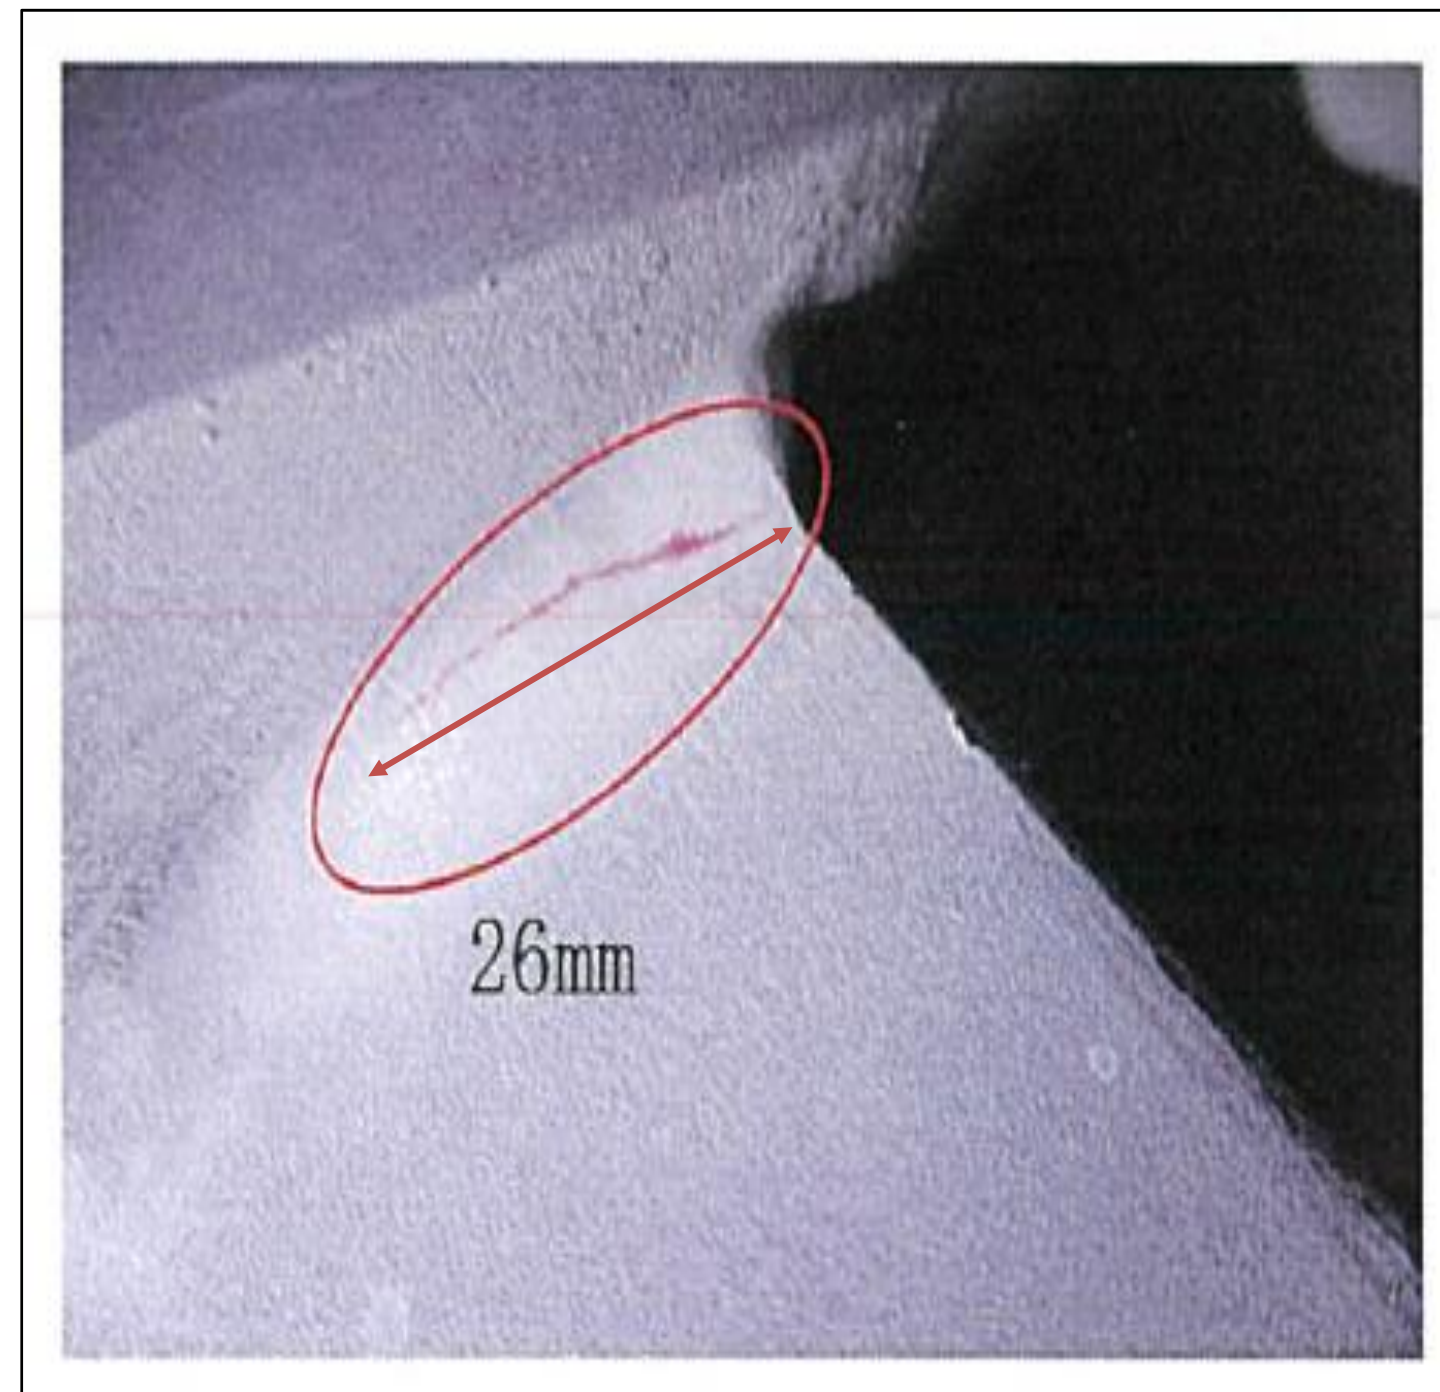
Crack in vane # 7 of 2nd stage impeller as of 2020 TA

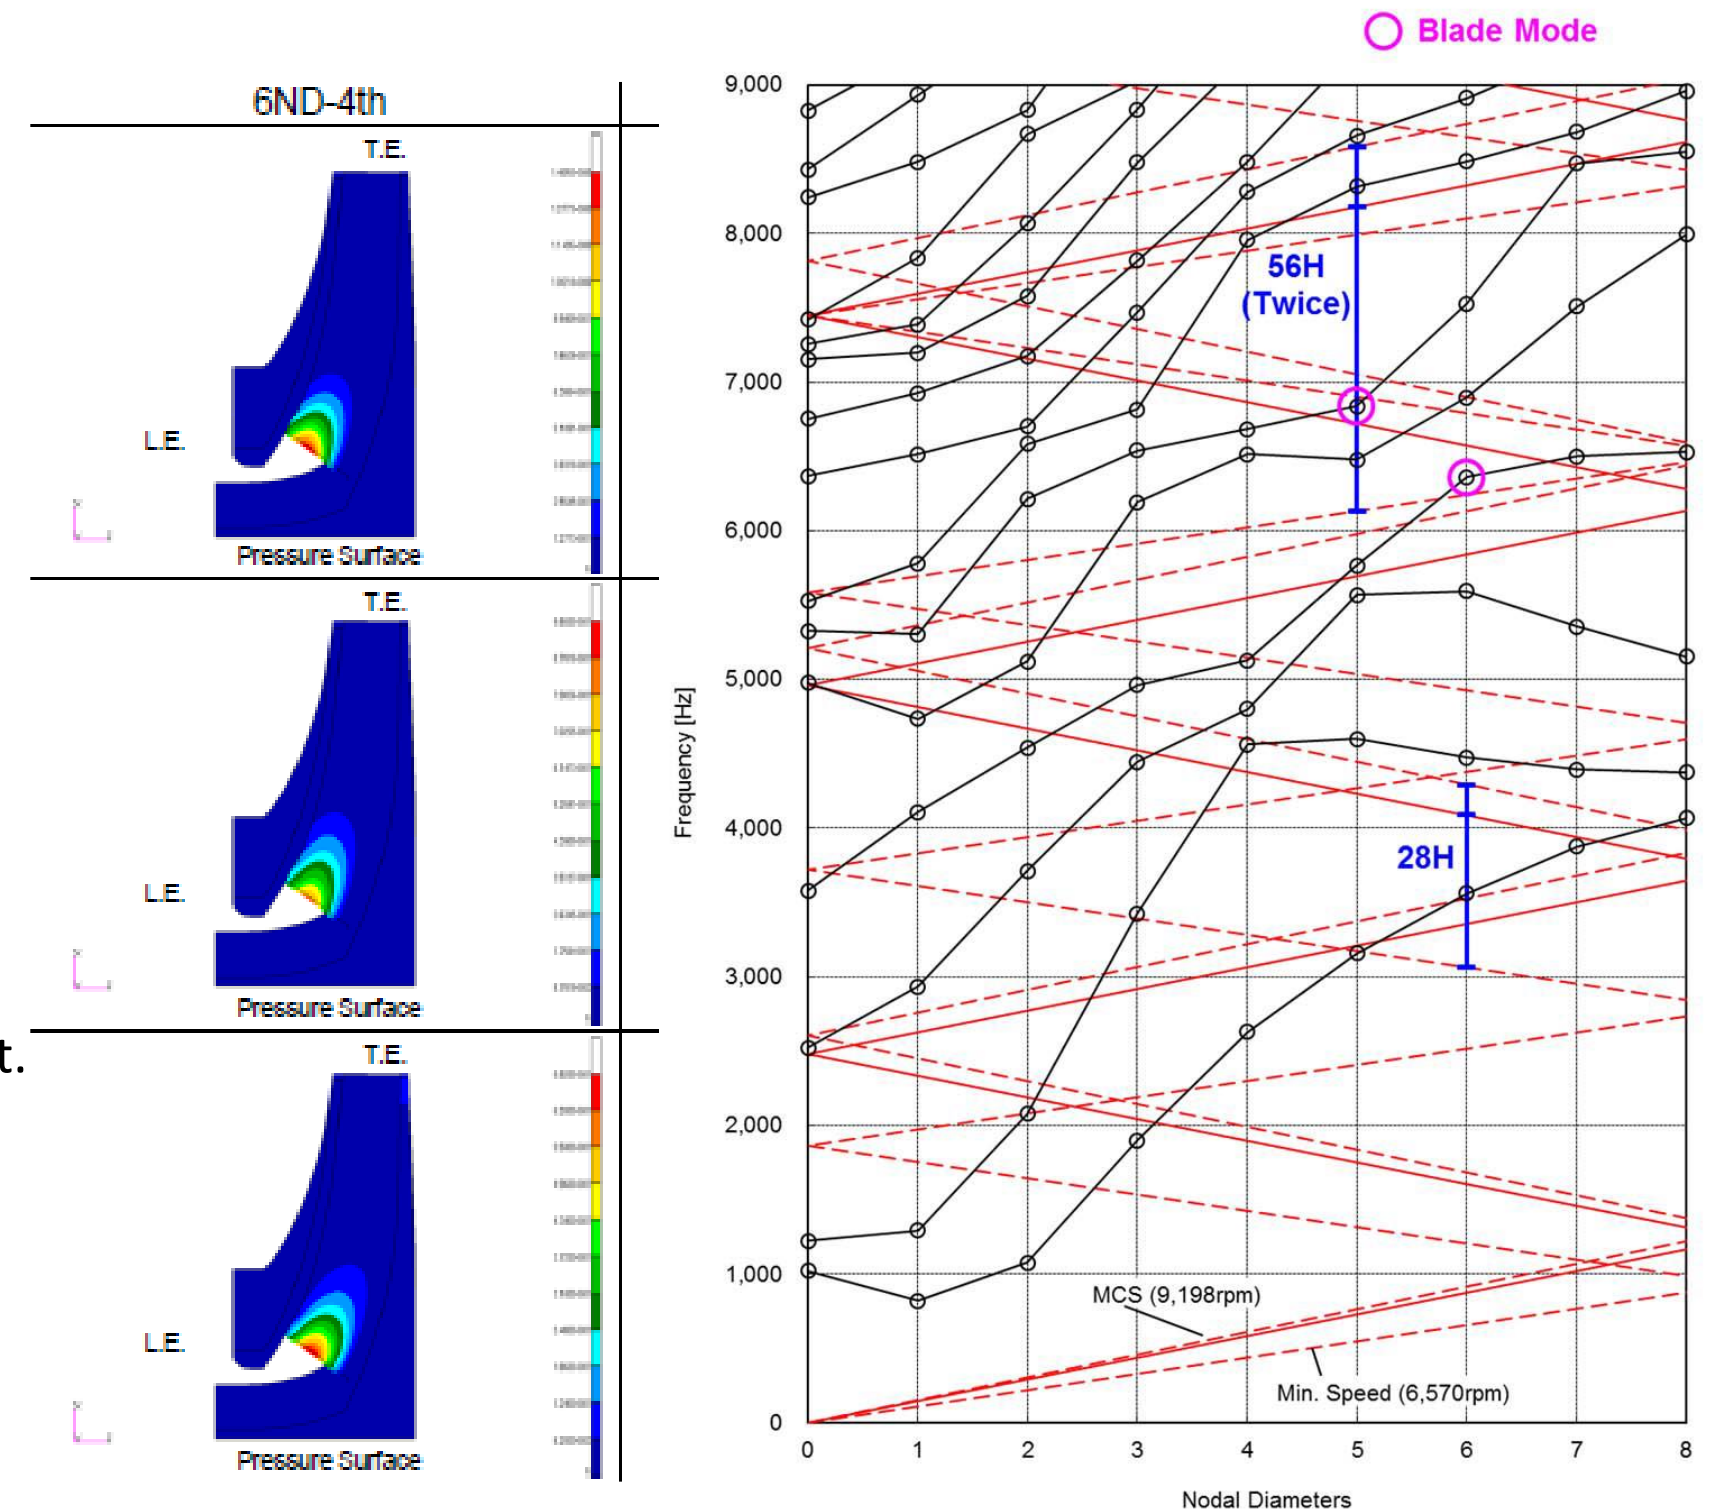
- Engineering study was done for 2nd impeller on Syn. Gas Compressor LP, especially focused on the influence of resonance.
- Impeller natural frequency and vibratory mode was evaluated by FE analysis.
- Concerned vibratory mode (blade mode) is 6ND-4th, and its separation margin is 48.2%. It was confirmed that 6ND-4th is surely avoided.
- Wake flow (28H and 56H) harmonics was evaluated by dynamic flow analysis at design point.
- Suspected resonance conditions have enough large safety factor for fatigue limit.

Therefore, it is unlikely that the impeller was damaged just only by the influence of blade-row interference.

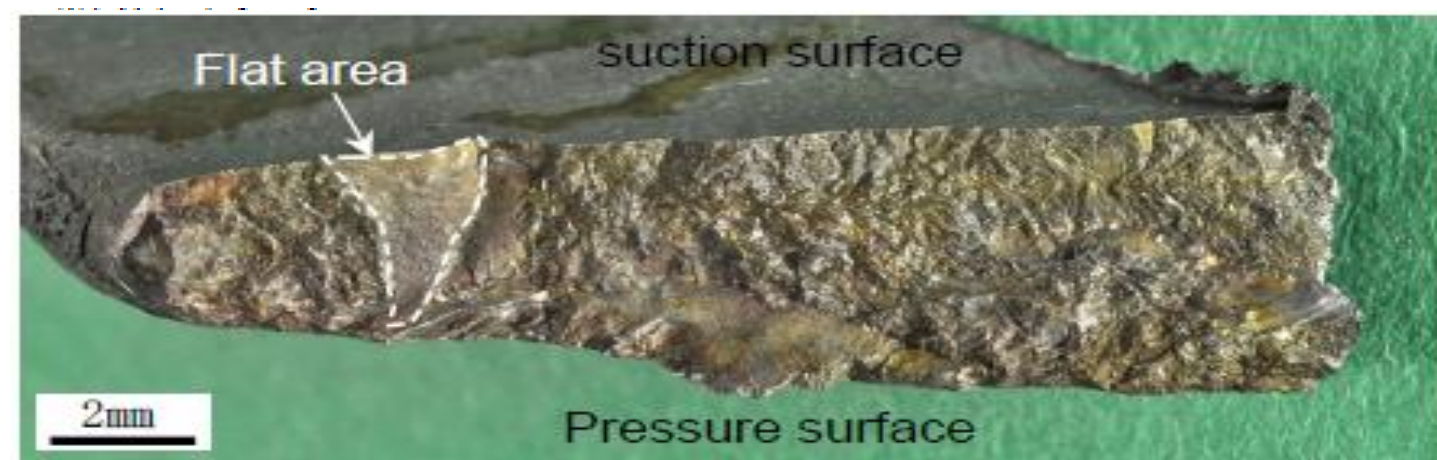
- O, Fe, C are the major observed components in fracture area.
- Na, Mg, Al, Cl, Ca, Ti, Cd observed as minor and are not included in Rotor materials. Its added from process gas impurities.

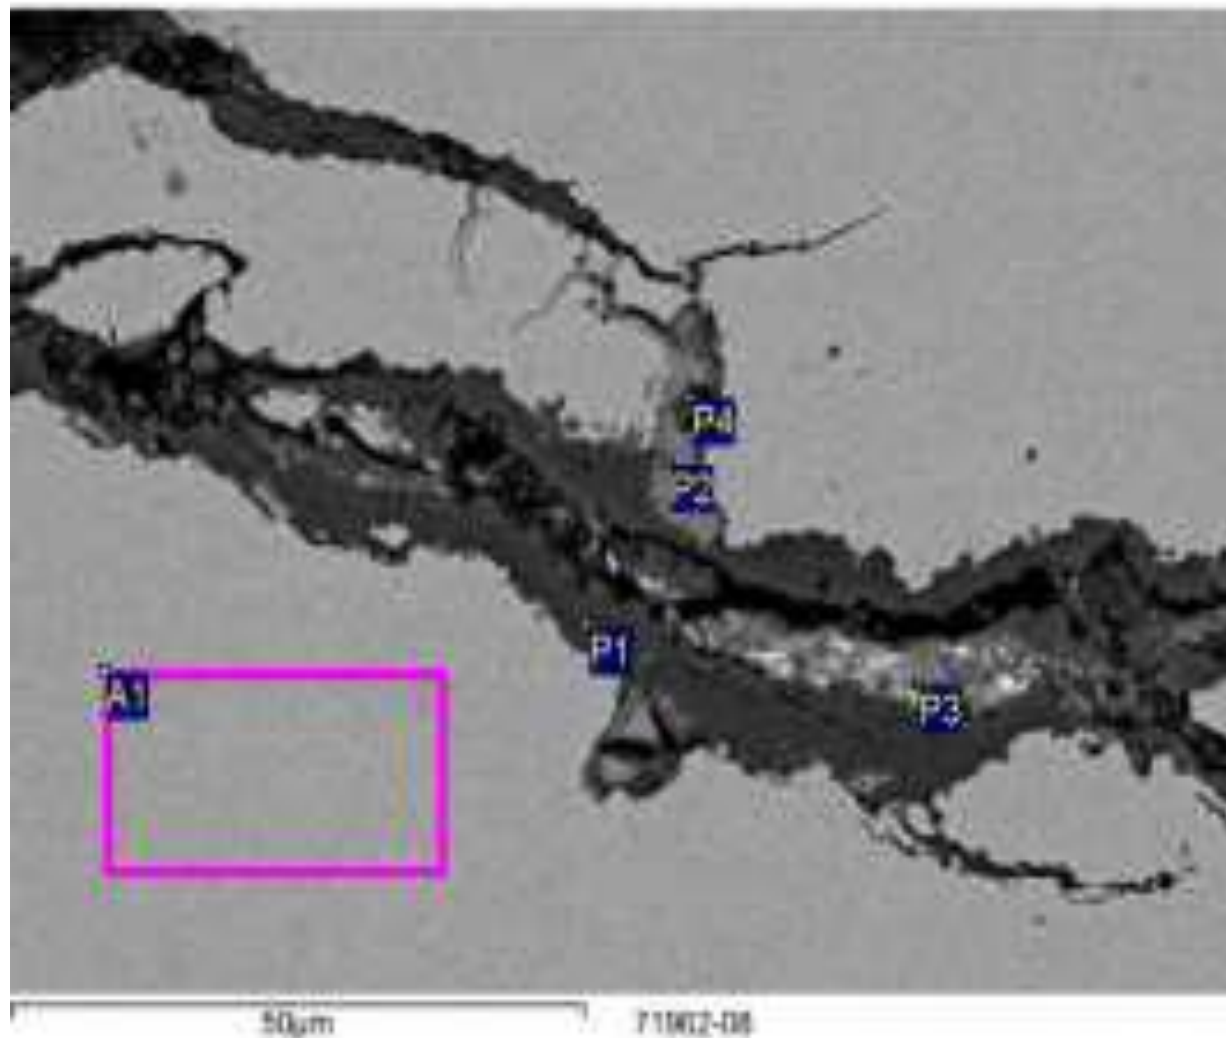
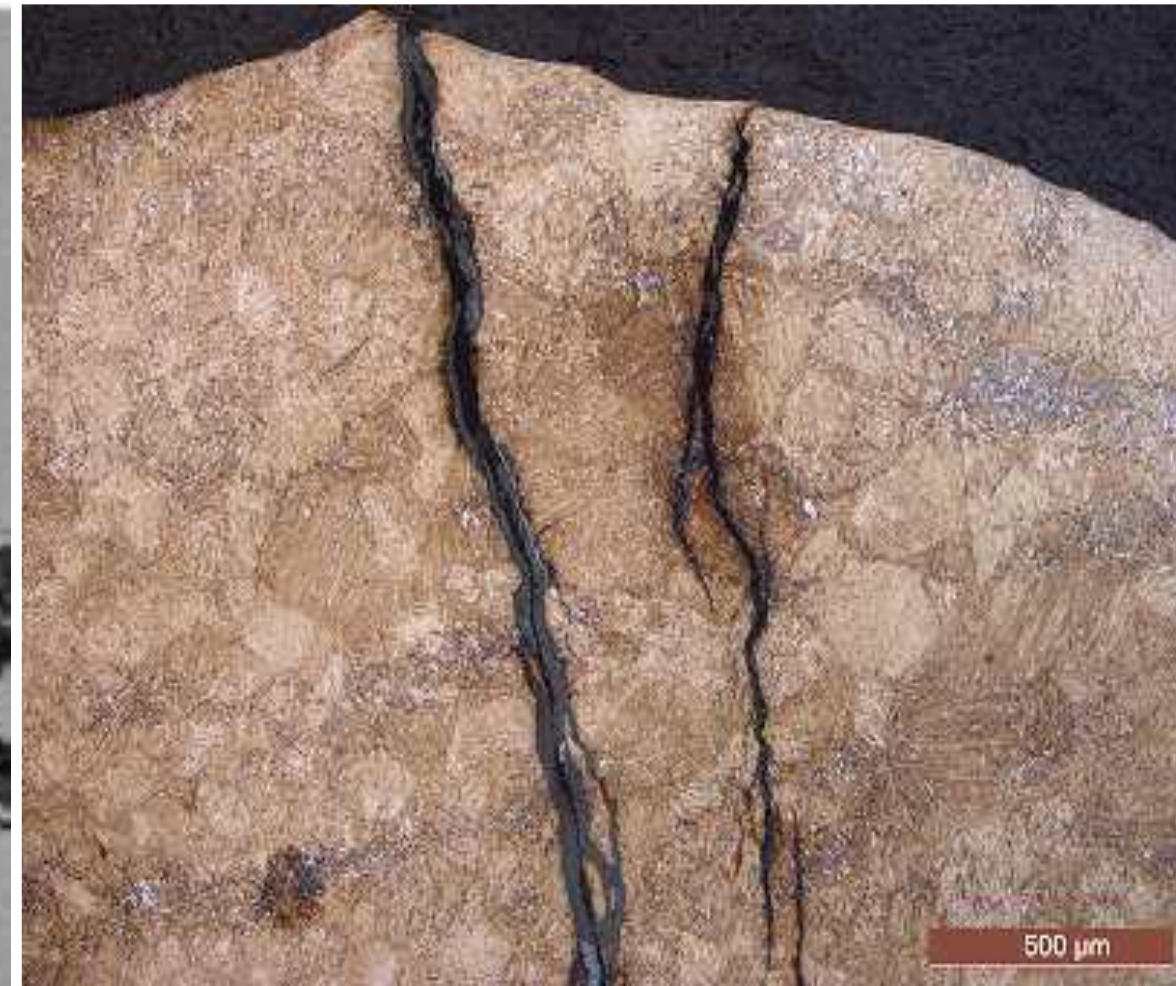
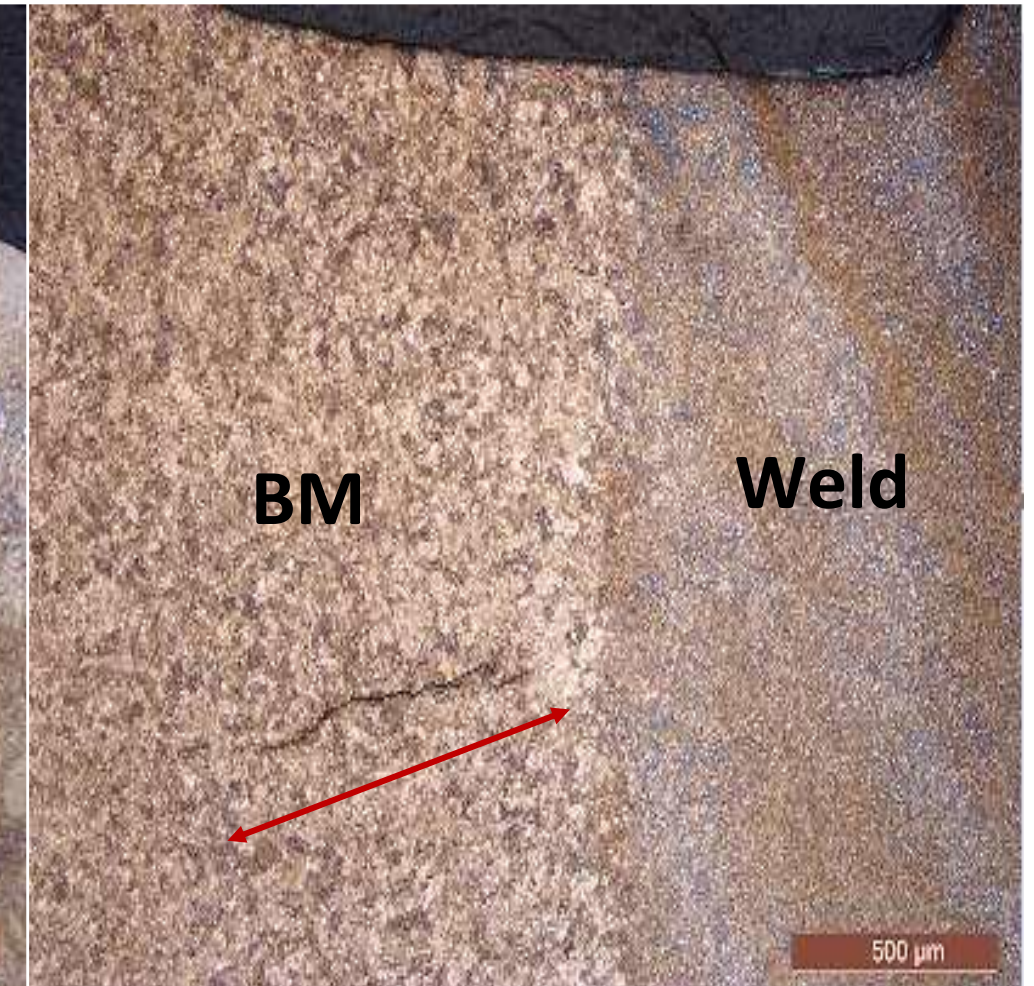
2019 SABIC Analysis Report

Significant amounts of S were detected inside cracks indicating that the failure mechanism is sulphide stress cracking (SSC), cracking is trans-granular crossing the grains.

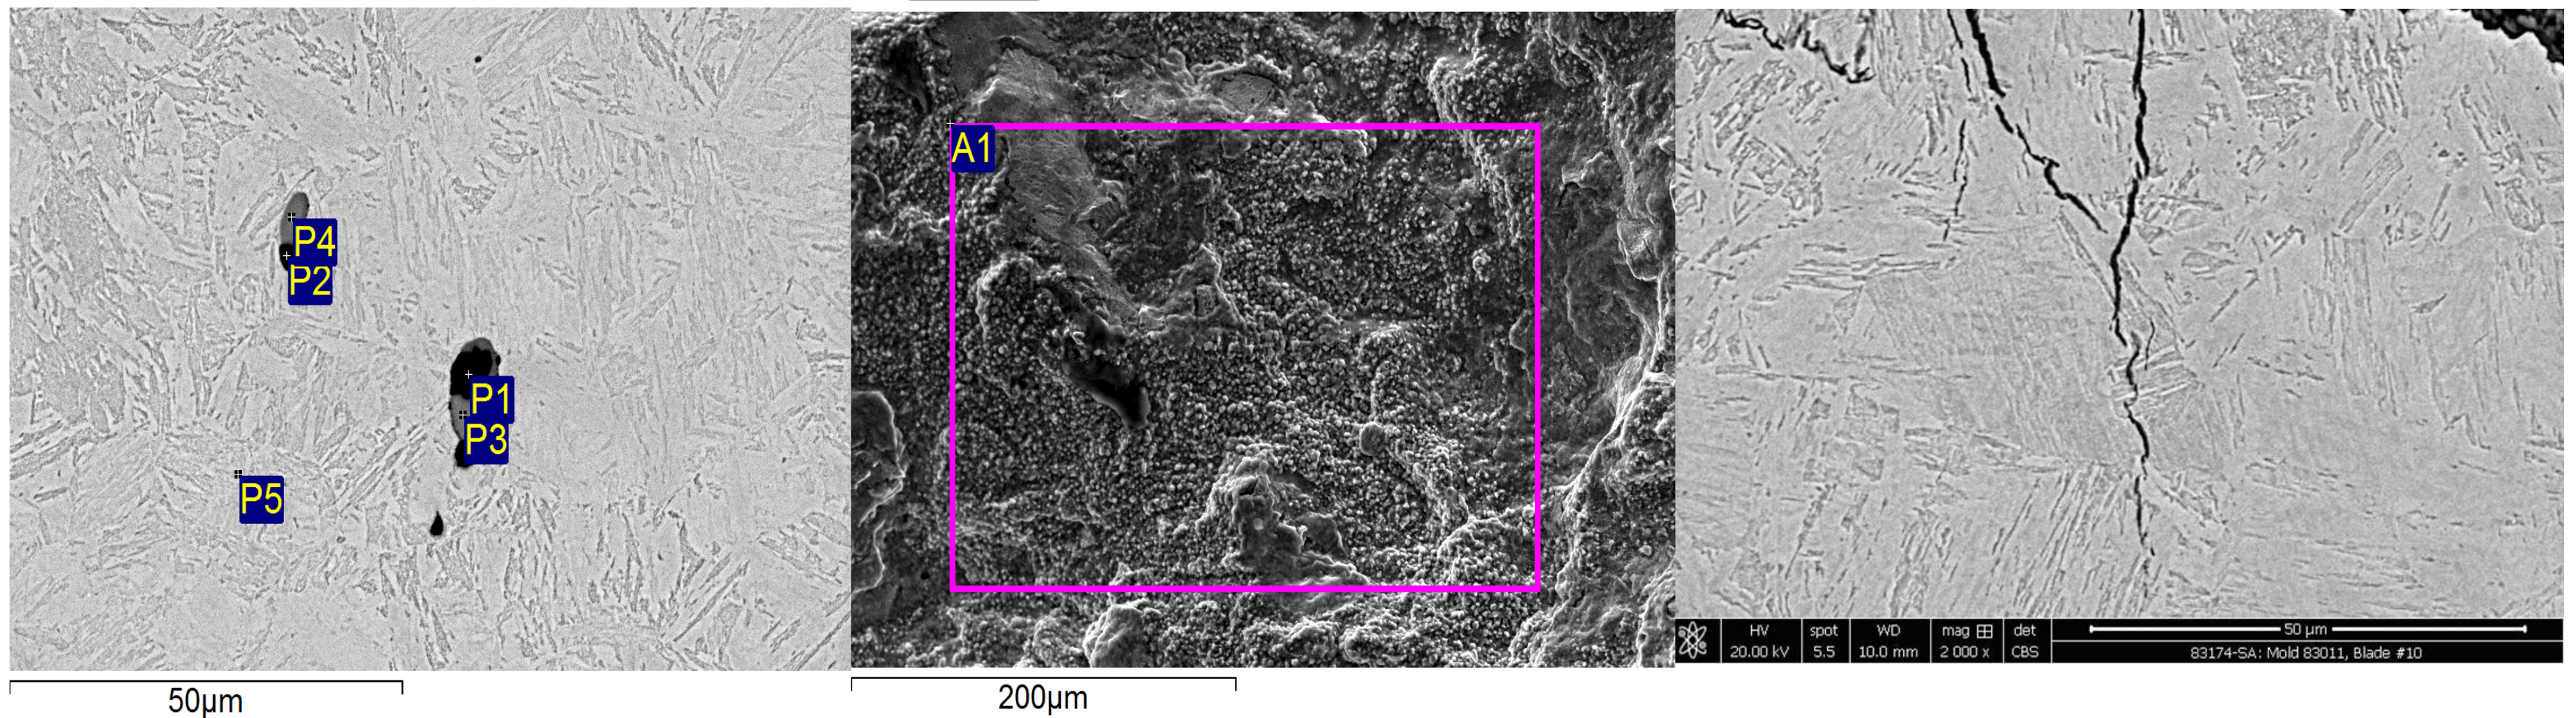
2021 SABIC Analysis Report

Significant amounts of S were detected on the fracture surface and cracking is trans-granular with limited branching indicating that the failure mechanism is sulphide stress cracking.
