# JUBCOR

CARBAMATE CORROSION OF STAINLESS-STEEL UREA  
GRADE WELDS DUE TO IMPROPER WELDING

# LEAK OF UREA HPCC-A

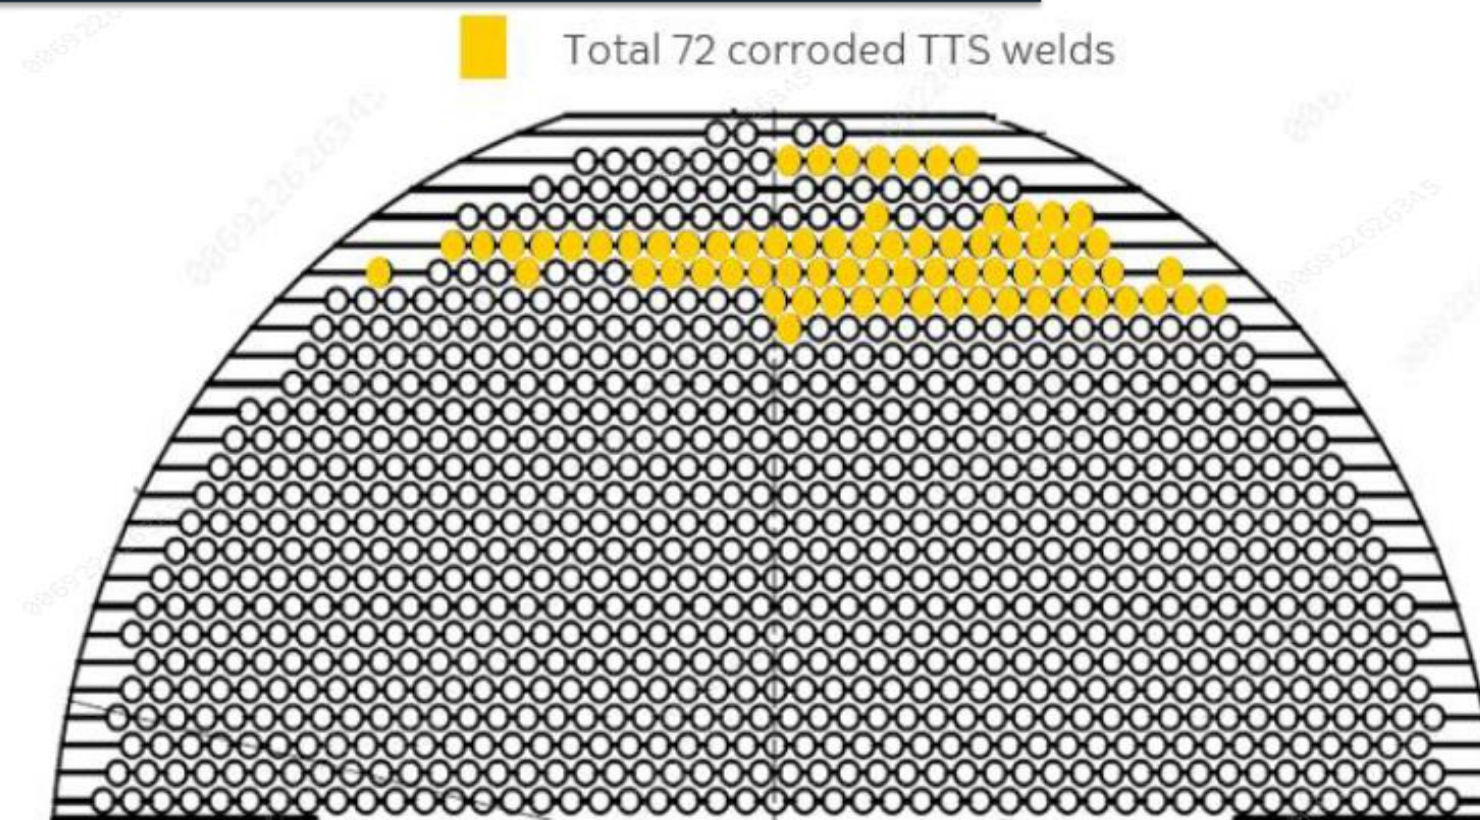
During initial inspection, the exchanger was tested by pneumatic test at 4.9kg/cm<sup>2</sup> to identify the leak locations. Nine tubes were found leaking from TTS weld. Row number and tube number of each tube found leaking during the test is shown in Table.1. The condition of the TTS weld of the leaking tubes showed signs of corrosion as shown in the photos below Fig. 1 and 2. 72 TTS welds found corroded in upper part of the tube sheet. The location of the corroded TTS is shown in marked tube sheet layout.

corroded TTS in the upper part of inlet tube sheet

Corroded TTS welds were repaired by fusing the existing weld without filler wire and apply two weld passes on the existing weld and ensuring the interpass temperature does not exceed 100°C and using 1.6mm filler wire diameter. Welding was done using 25.22.2 filler wire of 1.6mm diameter. Filler wire material was verified by PMI prior to welding. The weld repair was tested by DPT and found accepted. Ferrite was measured and found to be less than 0.3.

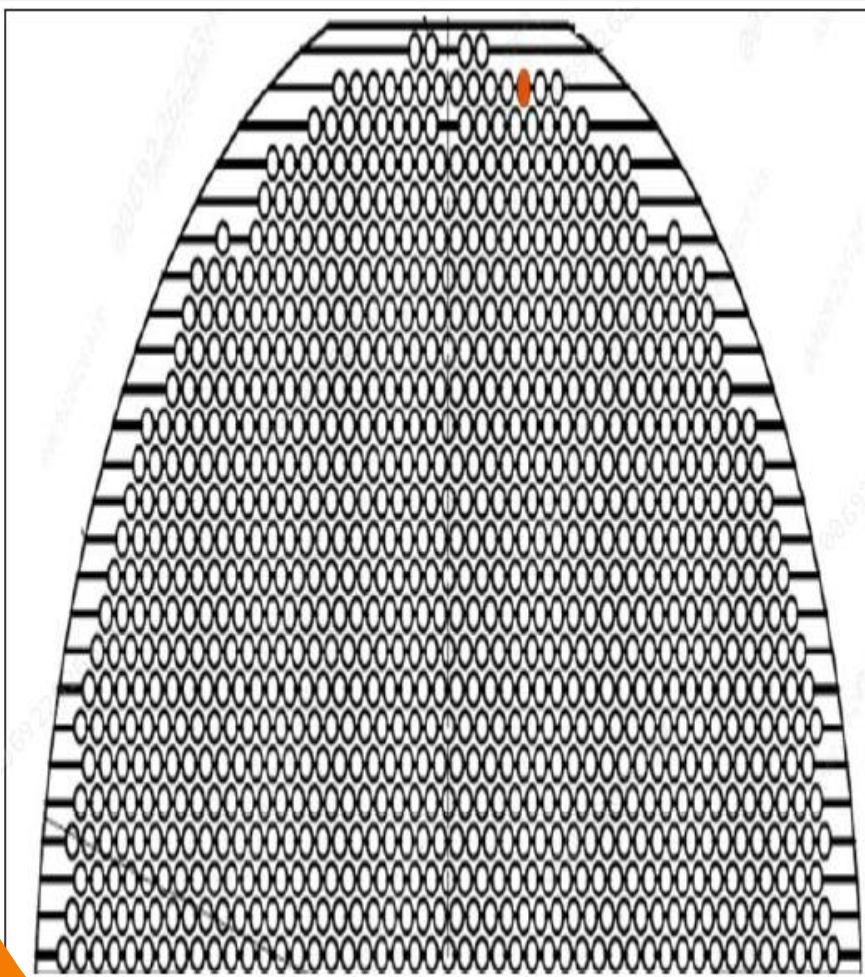
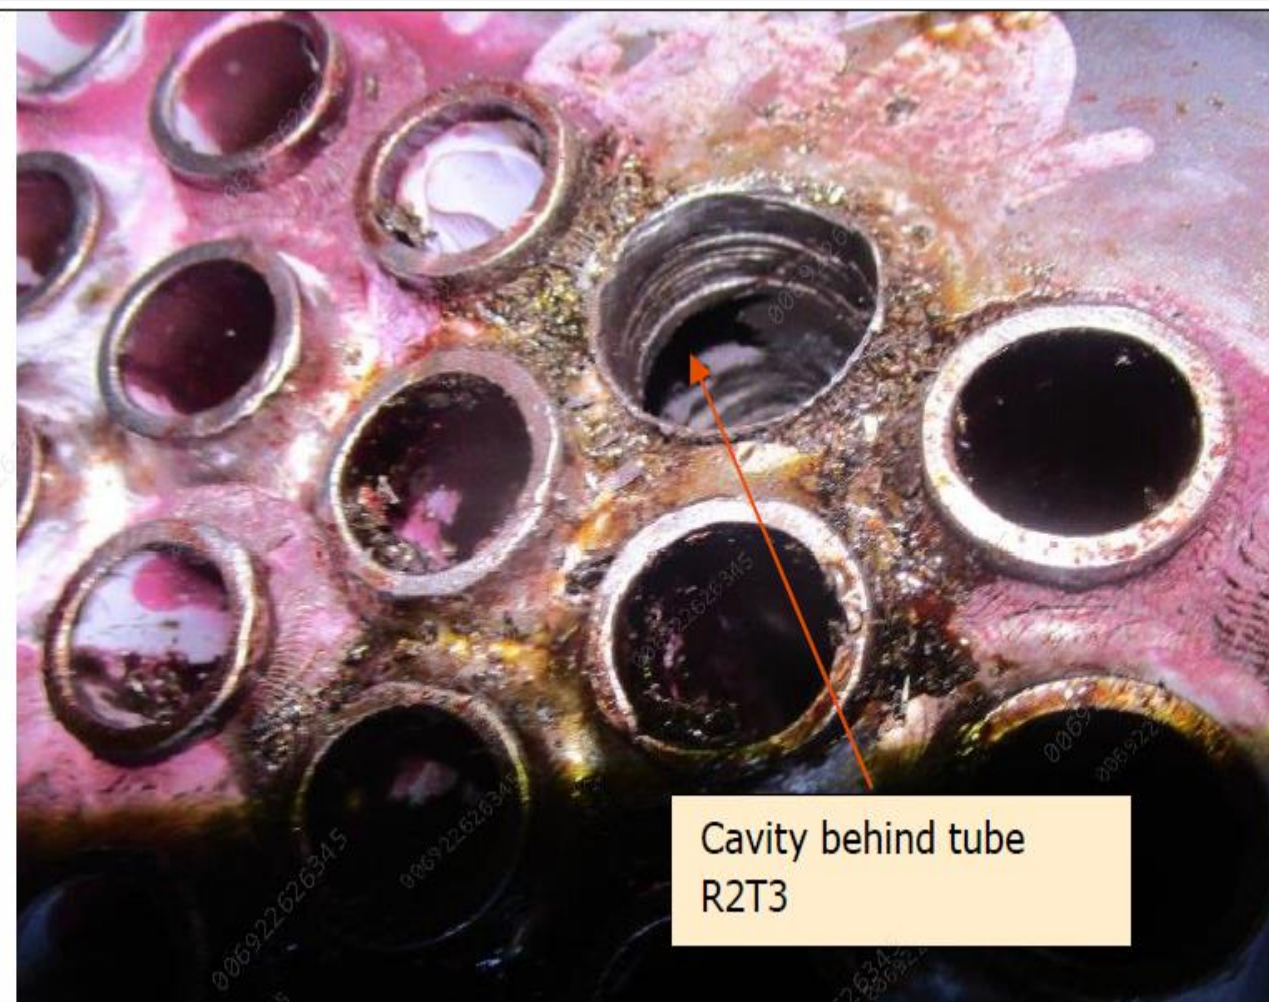
Drilling was done for tubes found leaking. No corrosion in the CS tube sheet observed behind the liner. Full removal of the tube up to 40mm from the tube sheet was measured by inserting a plug of 19.08 OD and 40mm length. Corrosion in the CS portion was observed behind Tube T3 in Row 2 after removing the tube from within the tube sheet, therefore the surrounded tubes were also drilled and the liner removed to check the extent of corrosion behind the liner.

corrosion observed in CS portion behind Tube T3 in Row 2 after removing the tube

The repair procedure was developed based on the findings and the size of corrosion cavity. After taking the measurement of the cavity, five solid bars of 22mm diameter and 3mm length was installed inside the cavity. Two plates above Row#2 were placed to fill the gap. Material of the plug, and plates is 25.22.2 as confirmed by PMI. The edges of the tube sheet overlay were smoothed and bevel prepared in order to be welded with a plate of 25.22.2 material that was placed on top of the cavity. The weld was tested by DPT and found accepted. Ferrite was also measured and found to be less than 0.3. PMI of the was done on the final weld pass and the plate. Material was matching to 25.22.2.

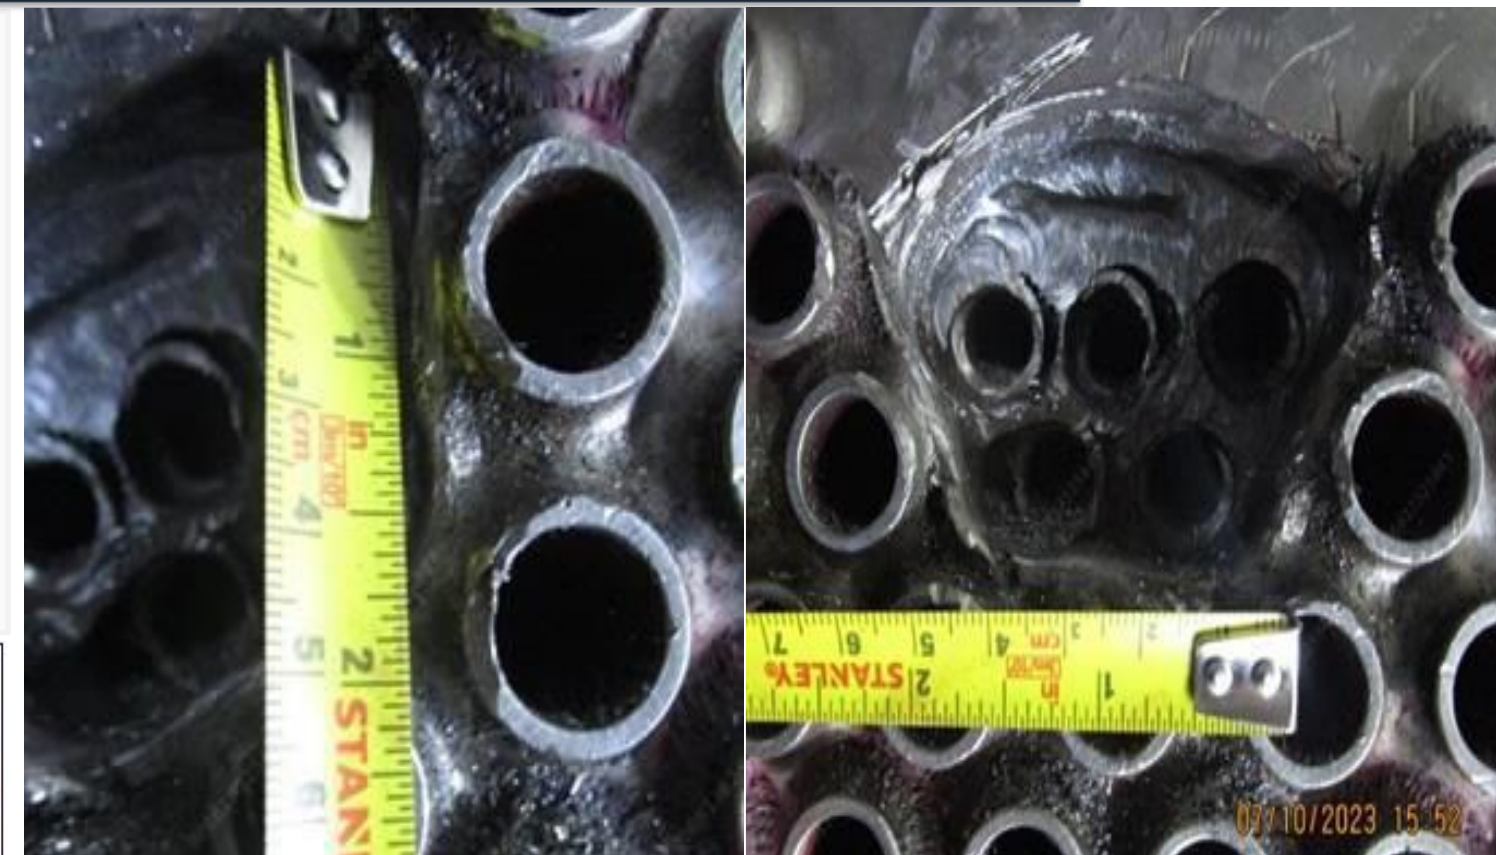
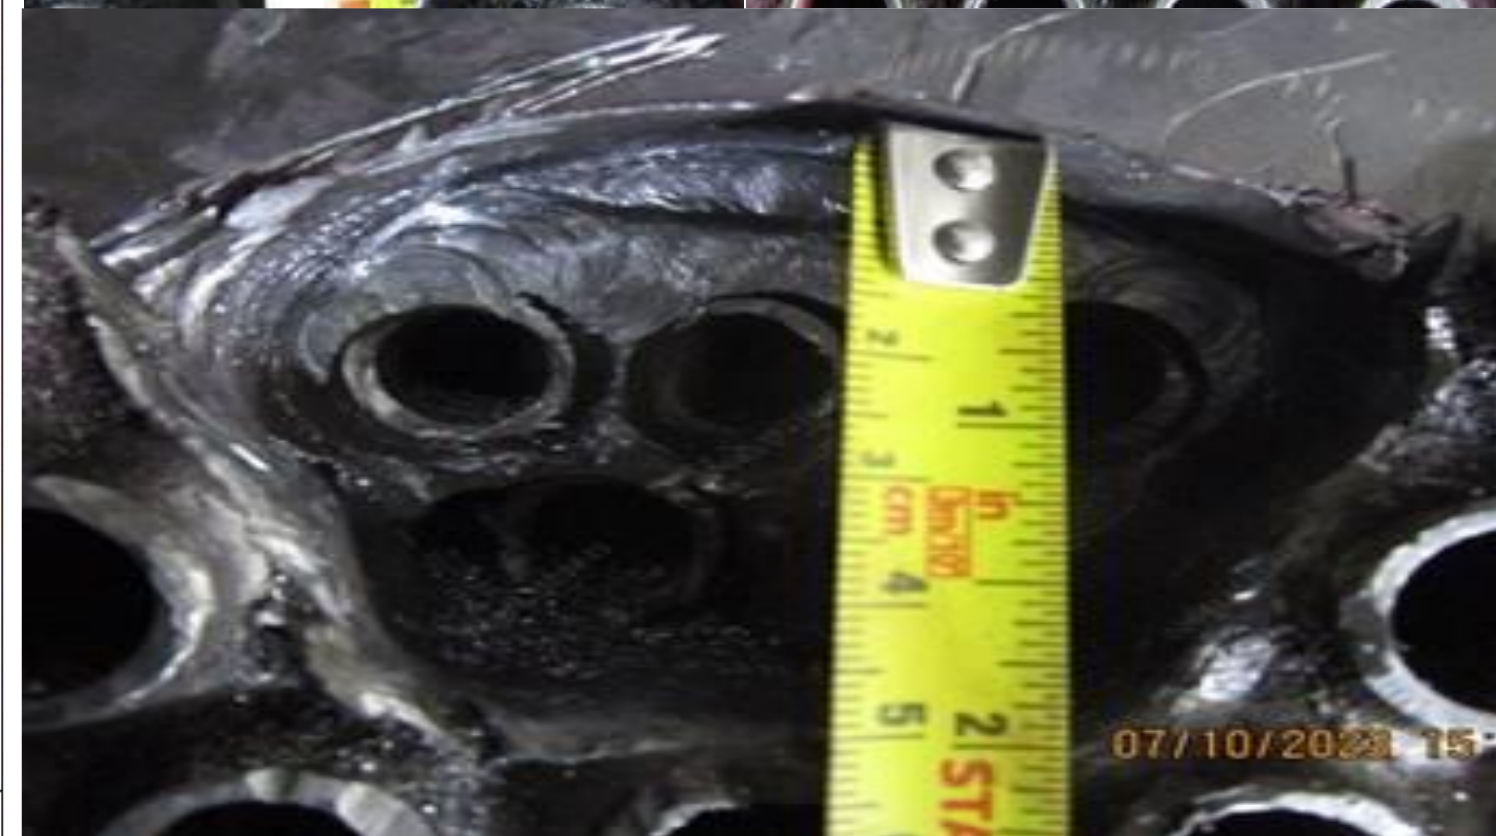
corrosion cavity

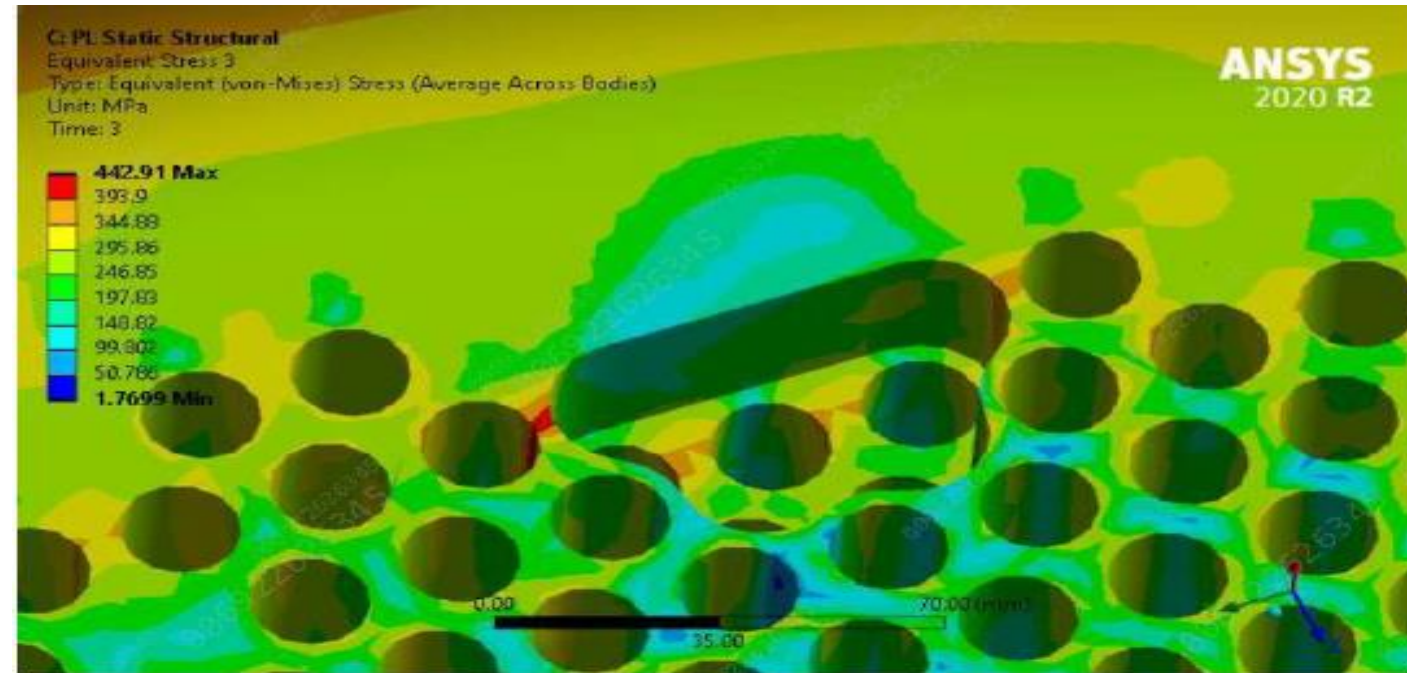
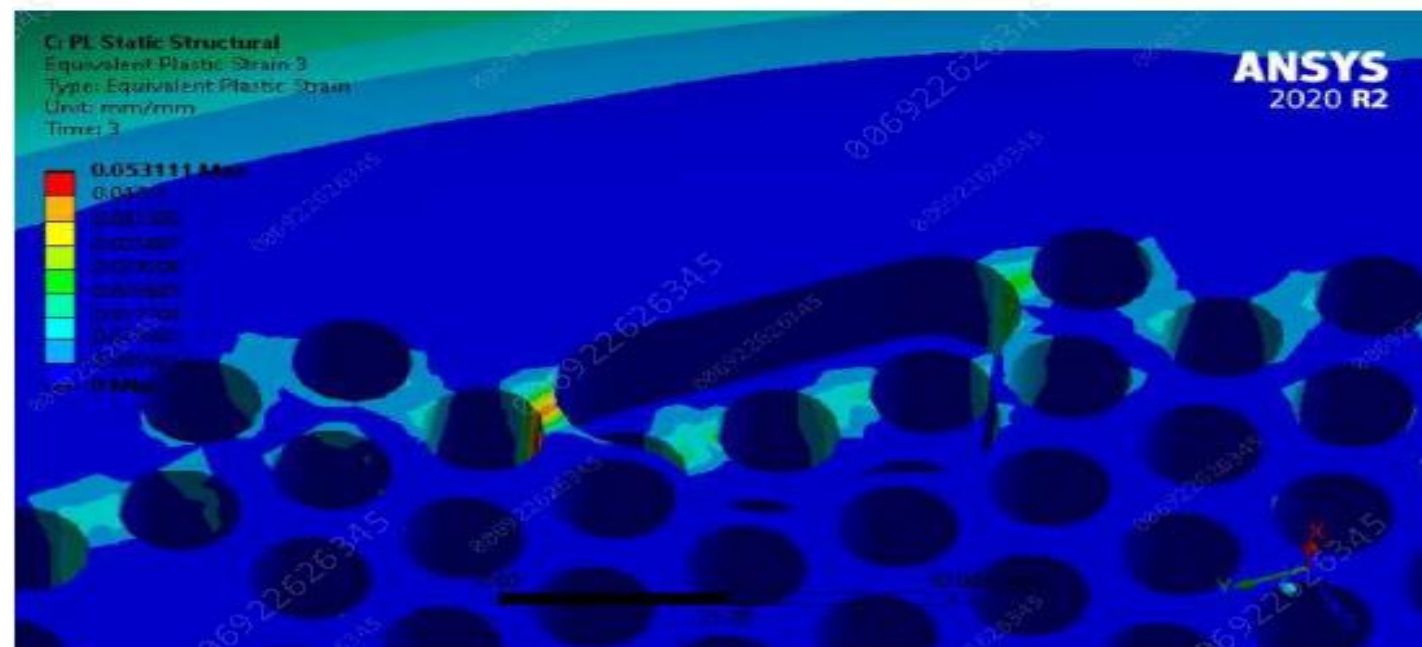
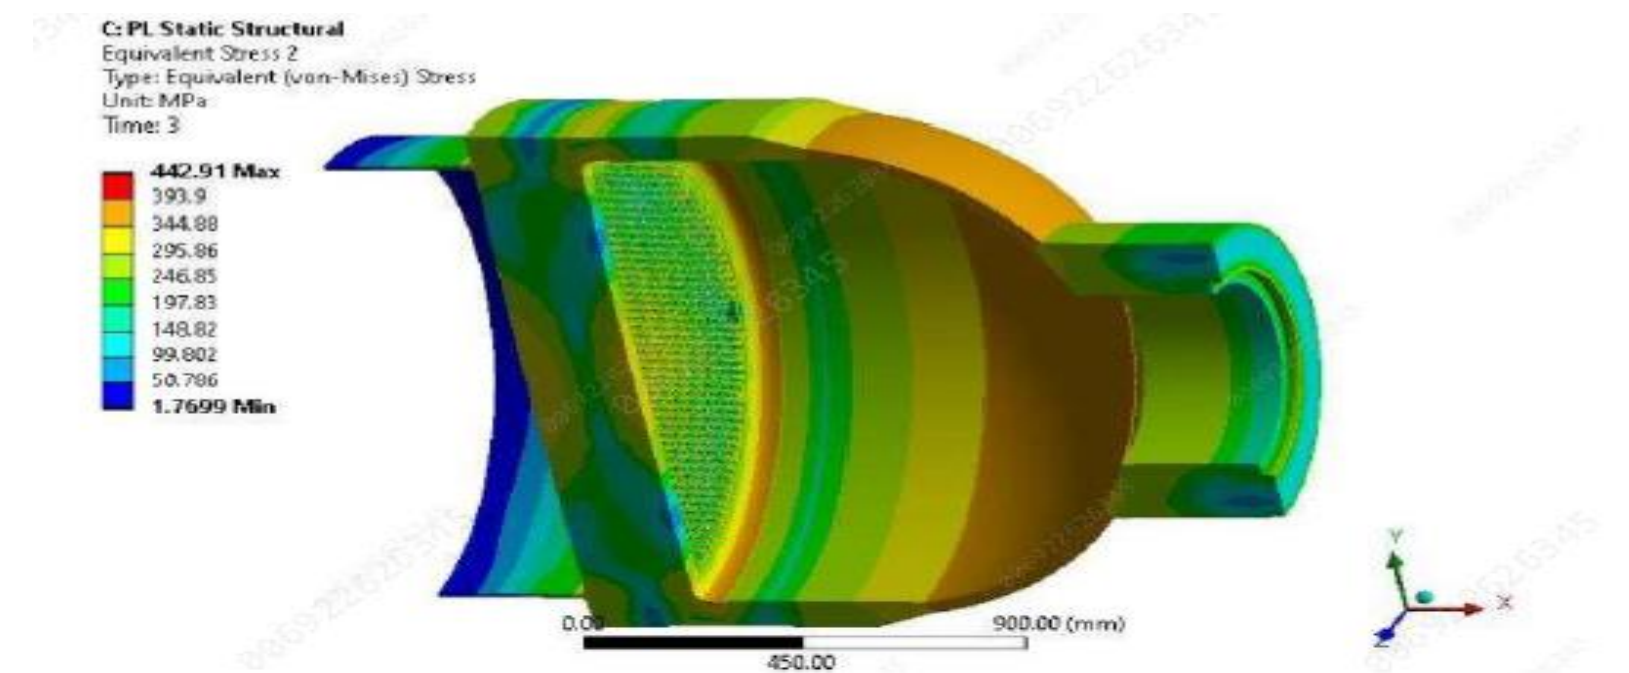
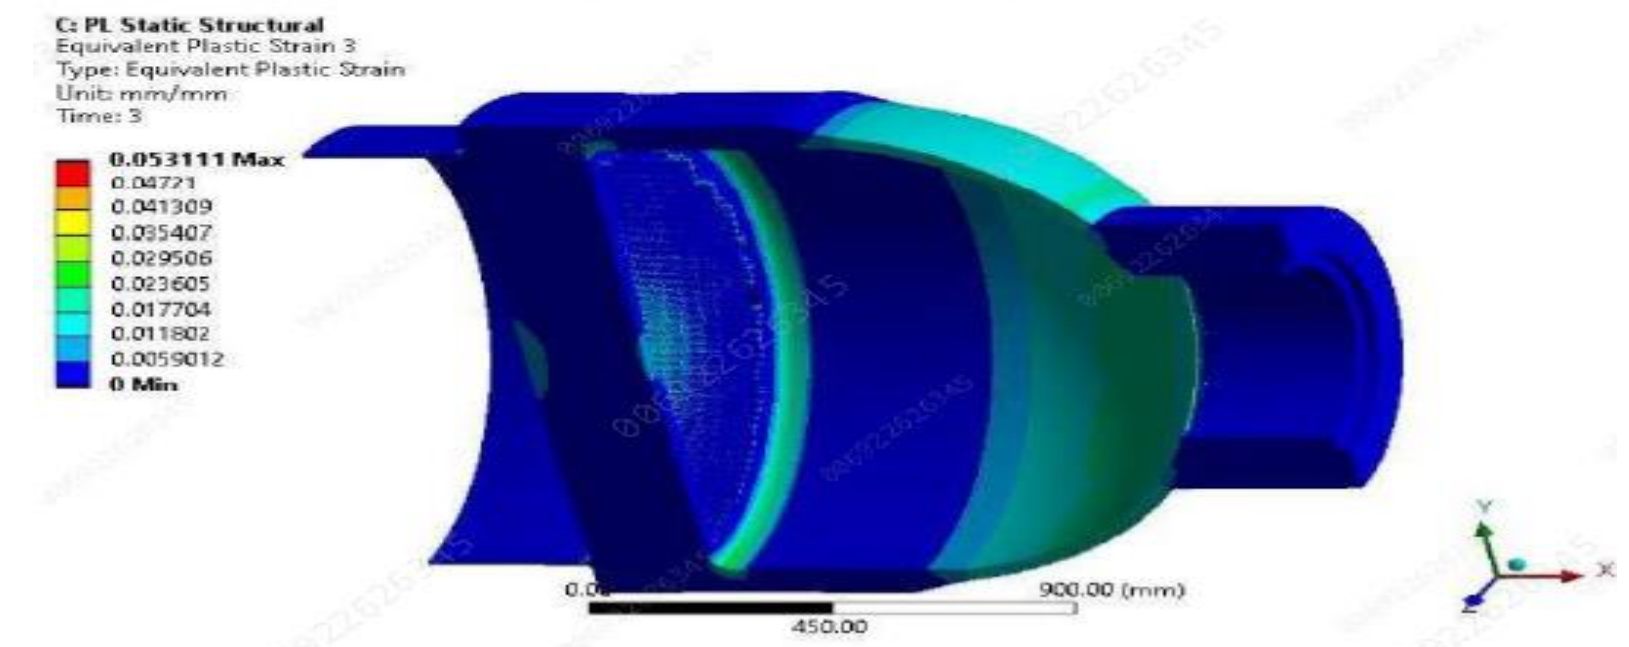
FEA proved that the components are in compliance with the criteria according to ASME sec. VIII Div.2.

LC1-Von Mises Equivalent stress contours [MPa]

LC1- Equivalent plastic strain contours [mm/mm]

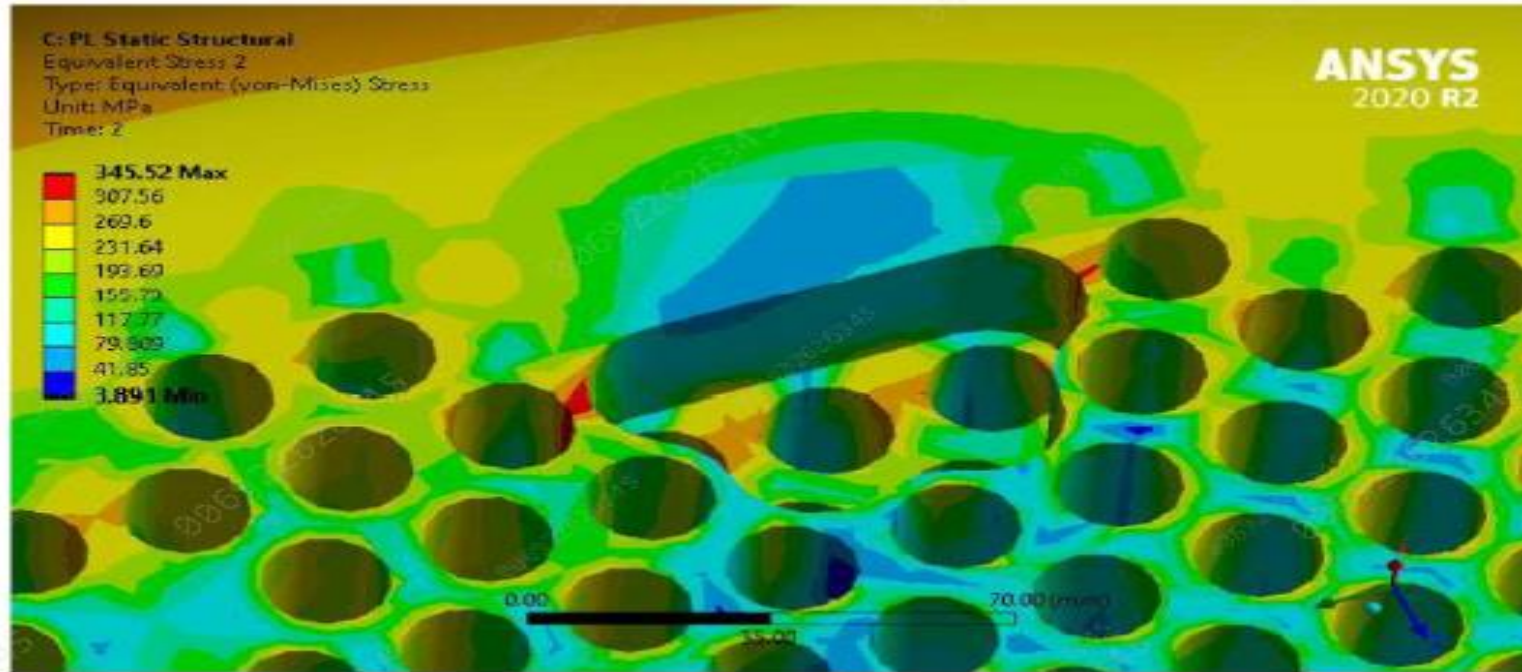
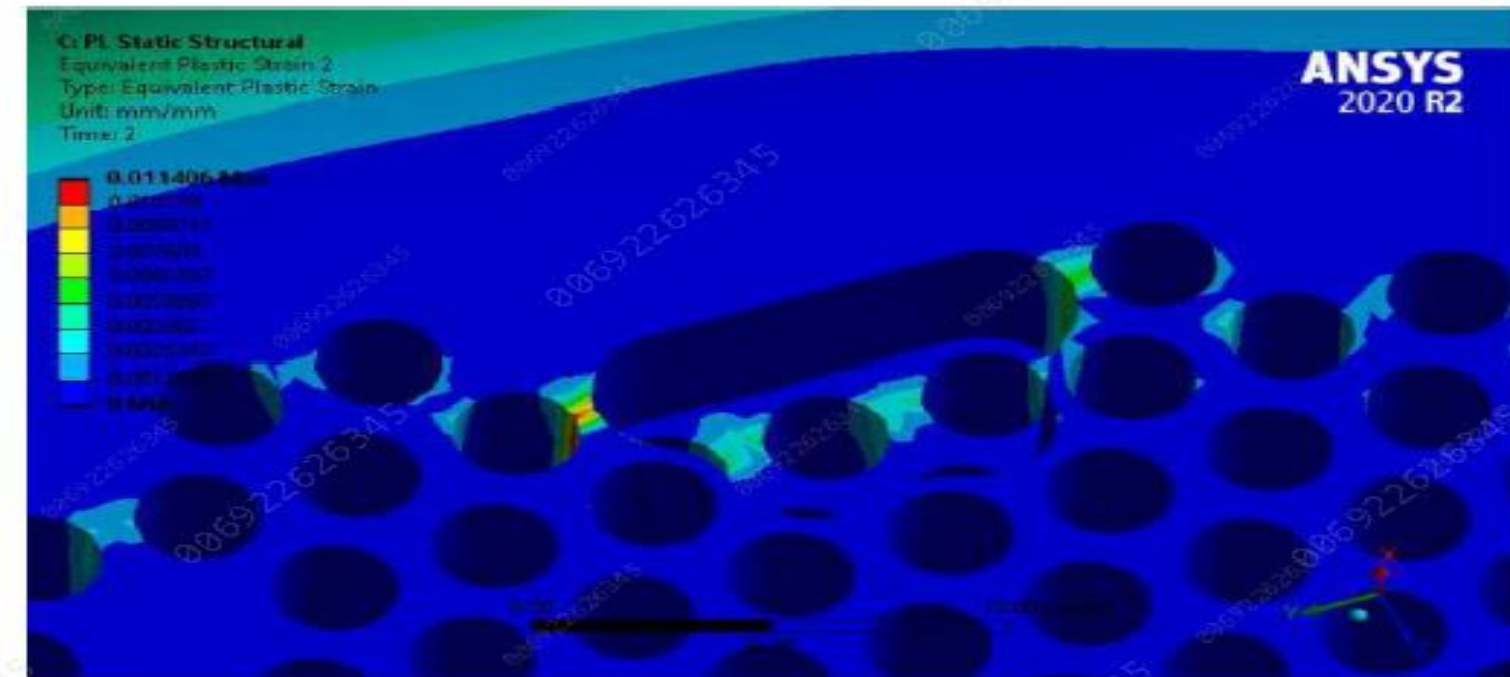
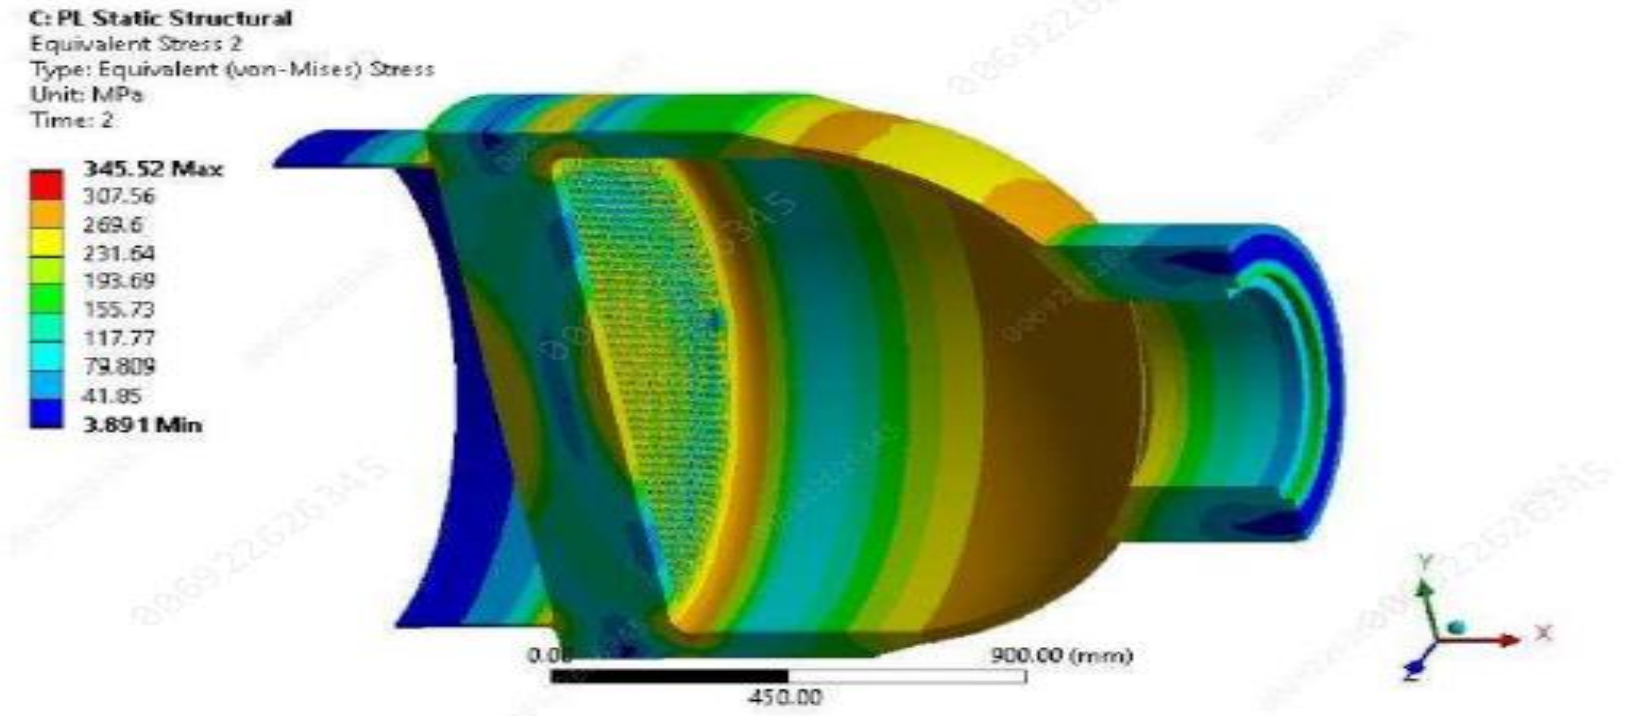
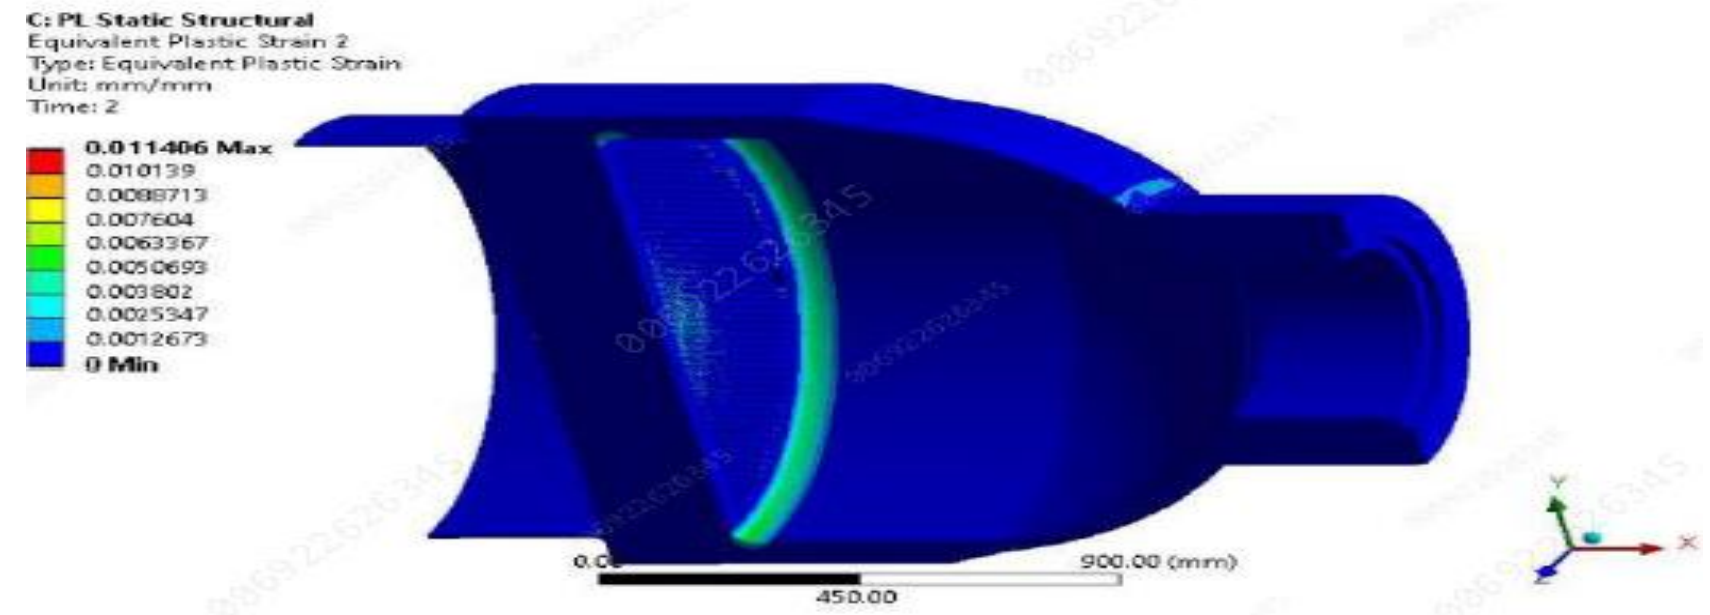
LC2-Von Mises Equivalent stress contours [MPa]

LC2- Equivalent plastic strain contours [mm/mm]

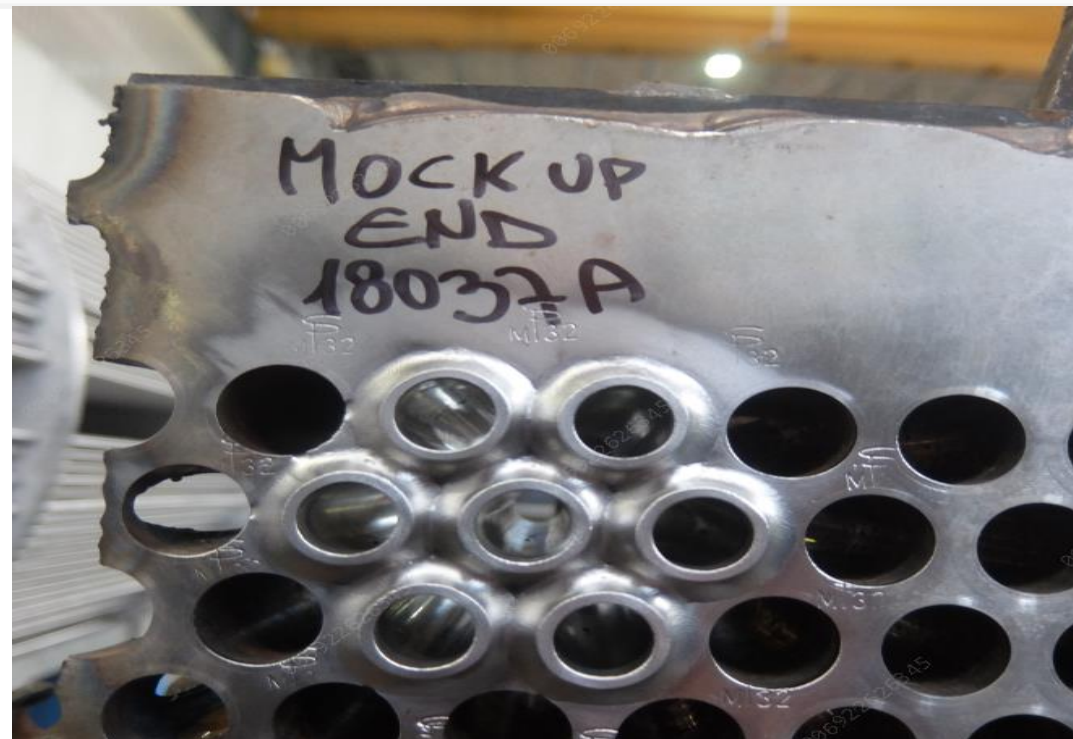
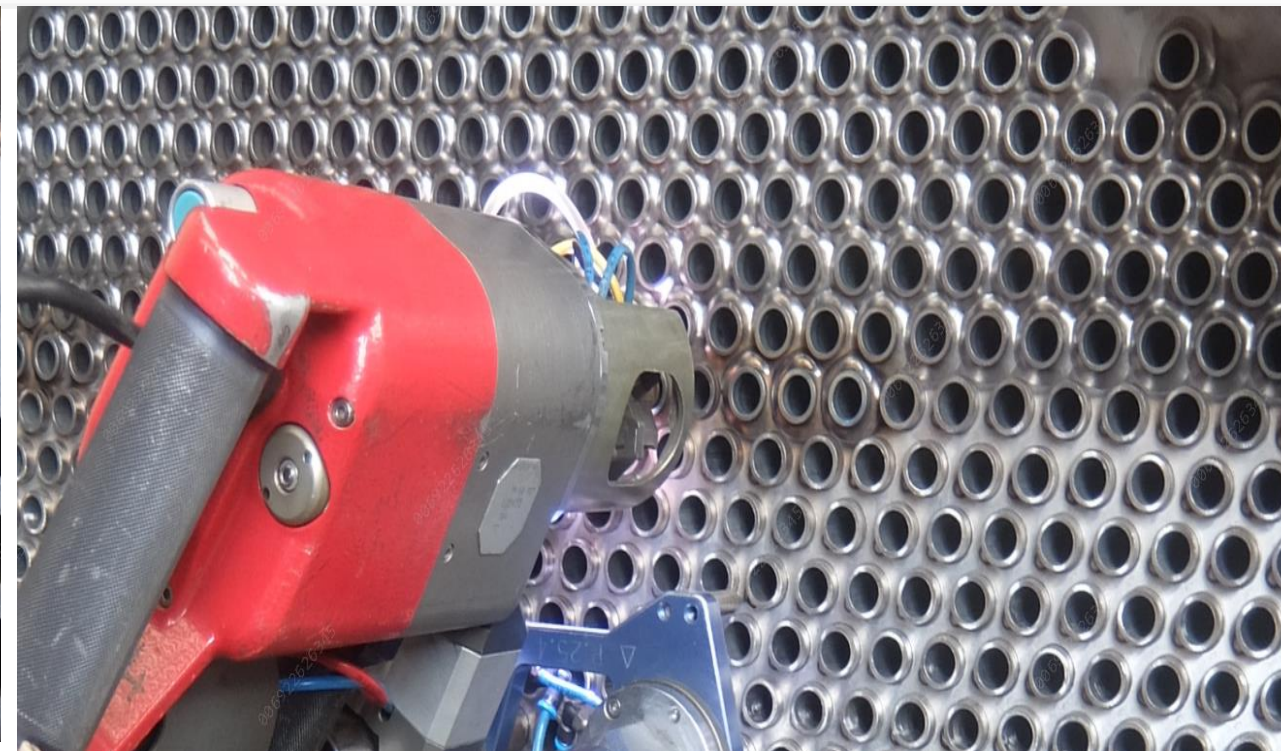
- OEM confirming the wavy surface due to pulsed current were used while WPS 8037A-45 Showing No pulsed current, and beads is string not weave.
- The auto welding is an approved welding technique but there no recorded pictures nor witnessed party to check the welding steps.
- Mock up was not witnessed.
- The wavy surface is a result from uncontrolled pulsed current which was done to lower the heat input and not to burn through the tubes but it should have being set to the minimum to have a smooth surface. It is very important to have as smooth as possible surface ( excellent surface roughness) for stainless steel material to have a very good corrosion resistant.

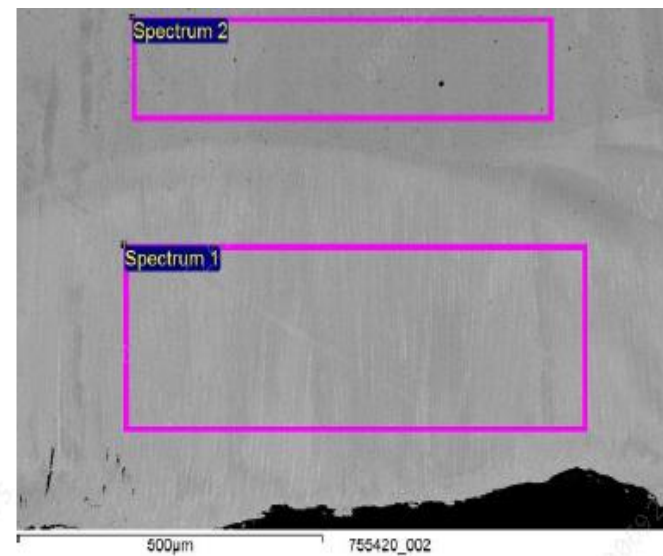
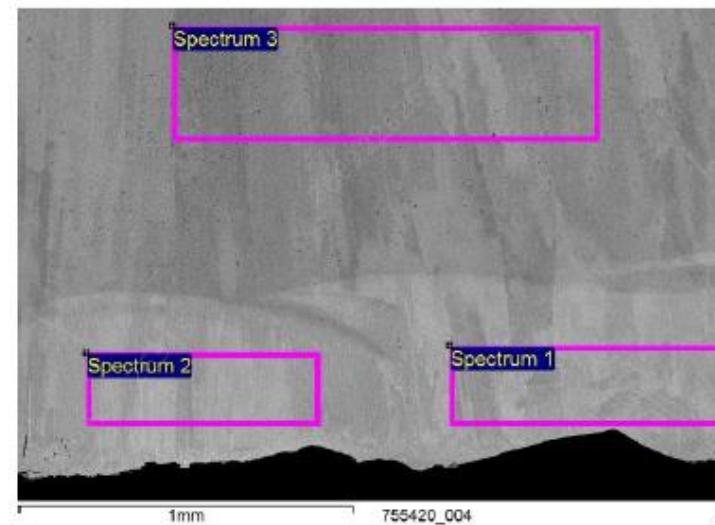
- The chemical composition result of the TTS weld material does not match the specification of the design filler wire material ASTM A312 grade S31050.
- Signs of corrosion were observed on a selected area which is at the top of the inlet urea process side suggesting that there was a mixing of filler wires used during the fabrication.
- The analysis of the weld at the front side of the tube sheet showed high nickel, moly, and less other elements.
- the result of the weld at the tube sheet is different from the subsequence welds.
- **Based on the above analysis, it was concluded that the root cause was due to using improper filler wire during fabrication**

Spectrum	C	Si	Cr	Mn	Fe	Ni	Mo
Spectrum 1	8.26	0.30	22.65	1.28	17.53	44.71	5.27
Spectrum 2	7.68	0.62	23.73	3.34	42.34	20.21	2.08
Mean	7.97	0.46	23.19	2.31	29.94	32.46	3.67
