JUBCOR

Premature Failure of Radiant Shield Boiler Tubes in a Reformer Convection Section

A Failure Analysis Case Study

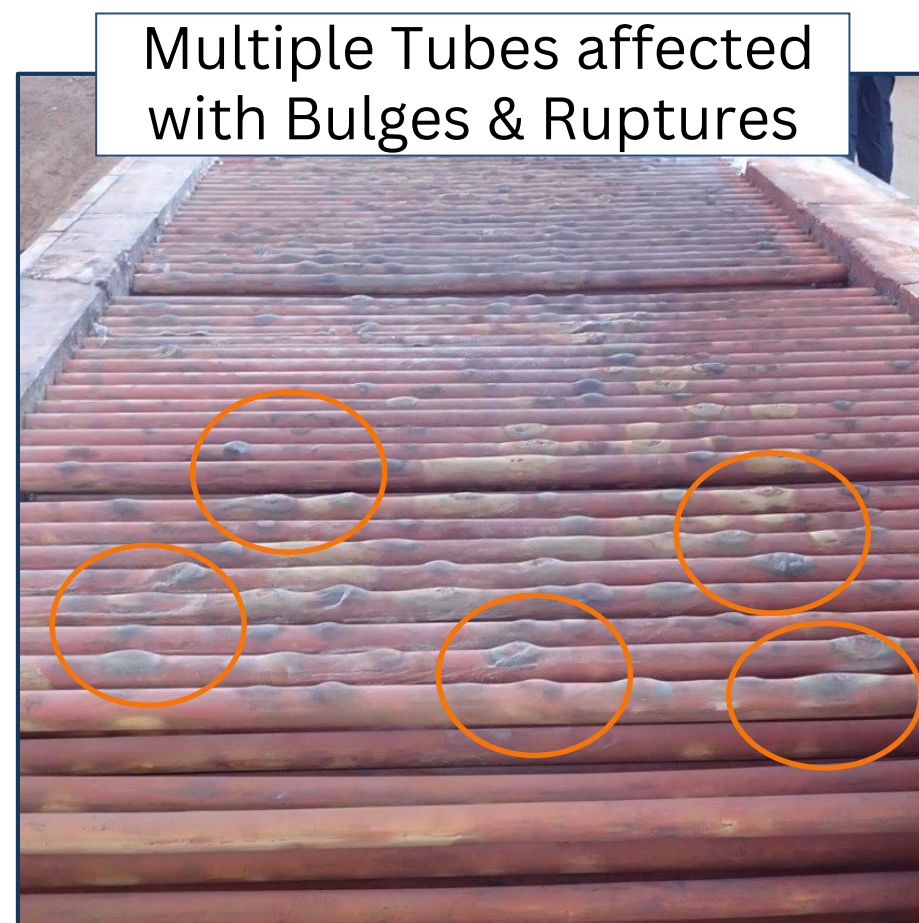
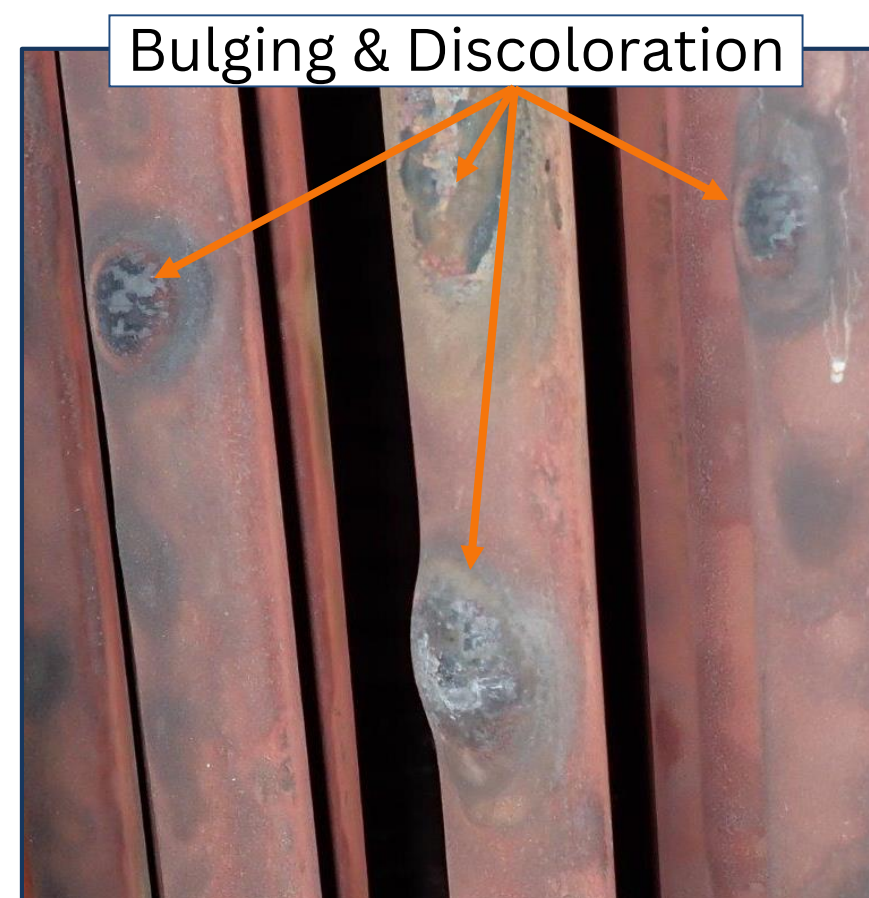
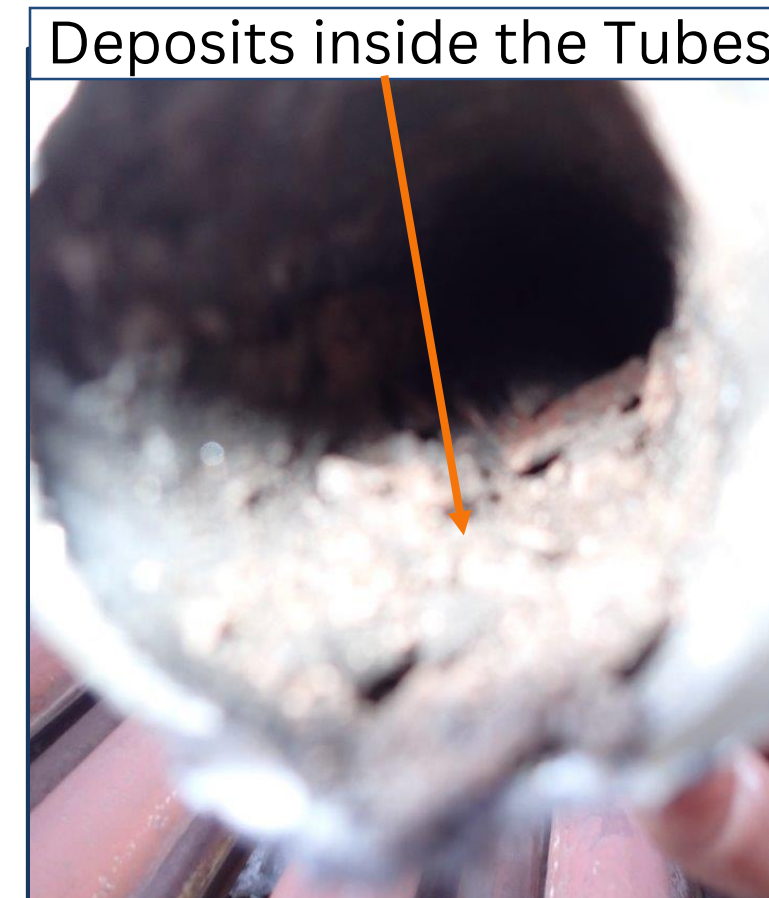
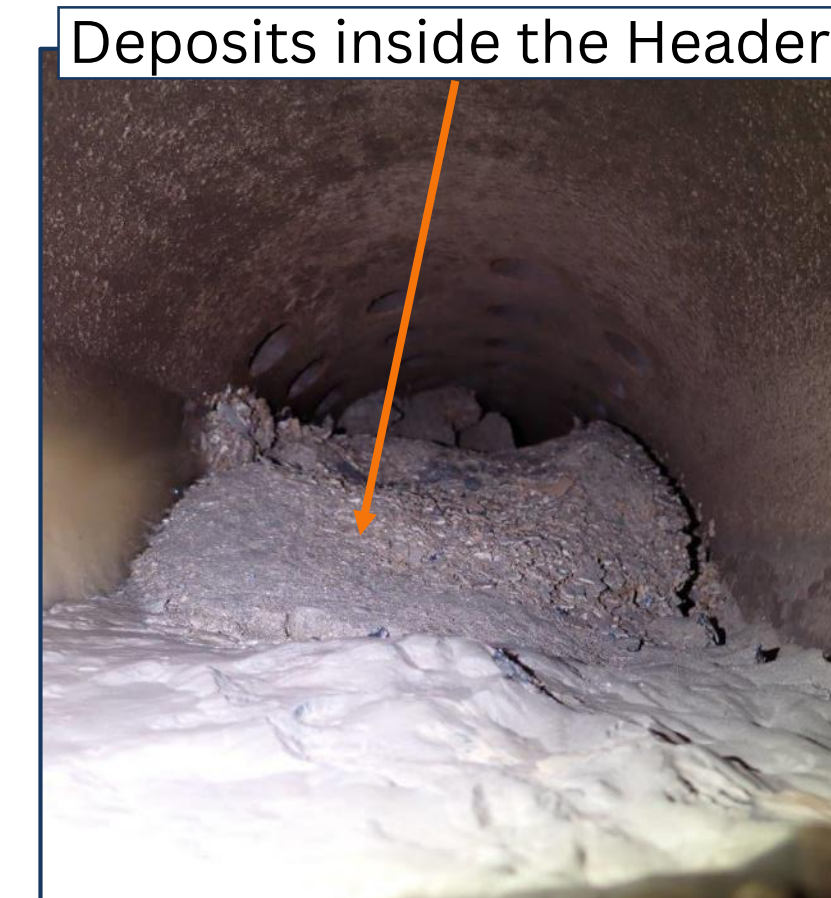
- Longitudinal cracking and bulging in multiple discolored areas along Row 1 tubes were observed
- The bulging and discoloration is typical of overheating damage
- Deposits inside the headers and tubes were observed
- Heavy deposits can block tubes leading to overheating

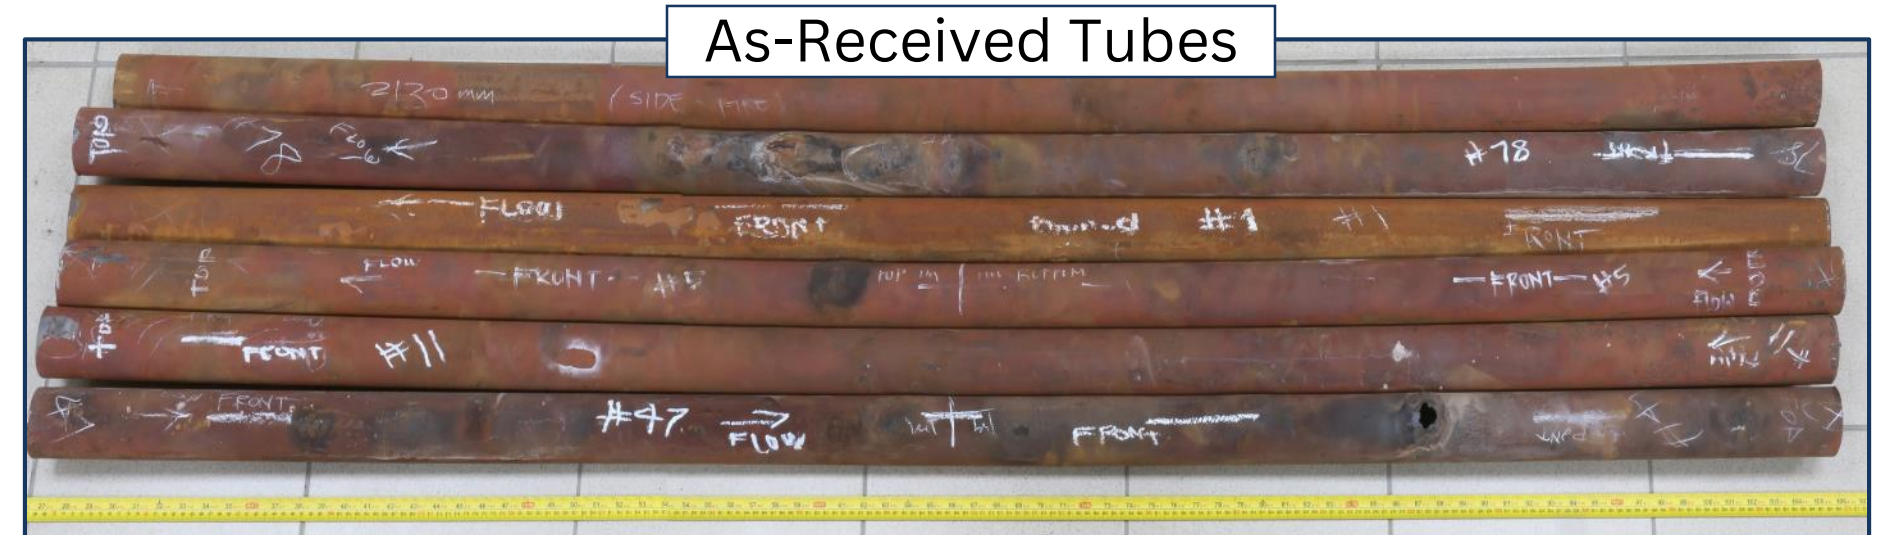
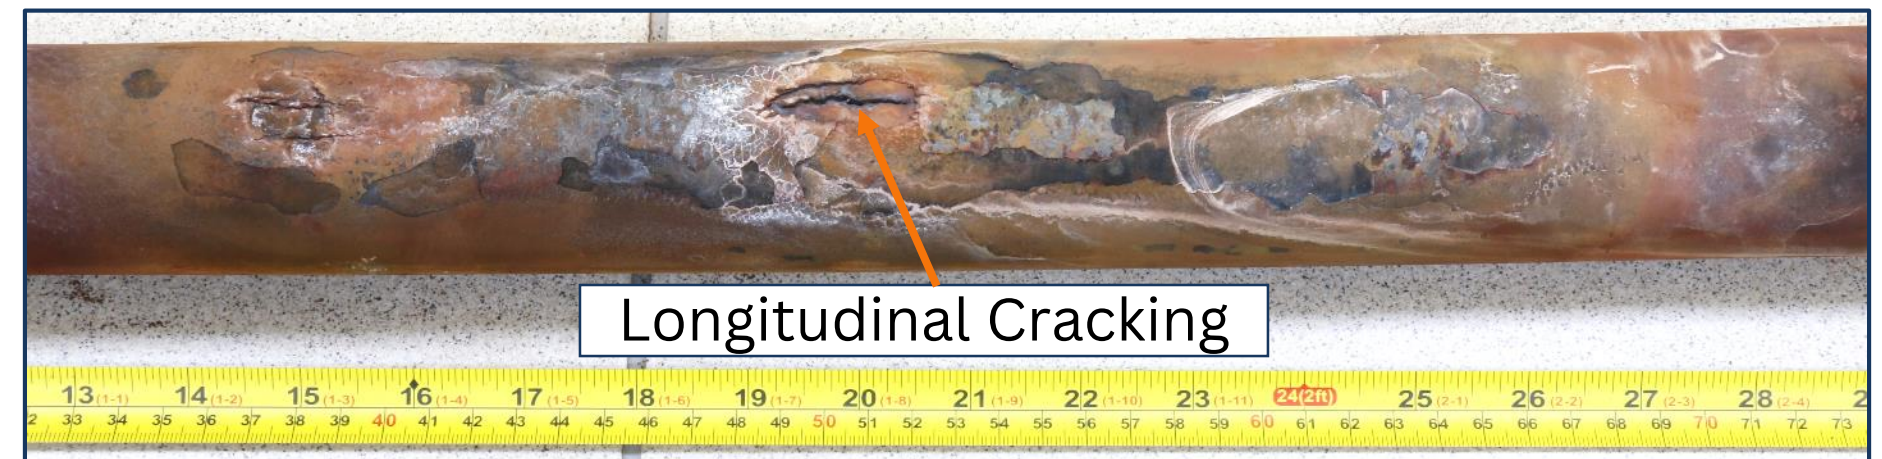
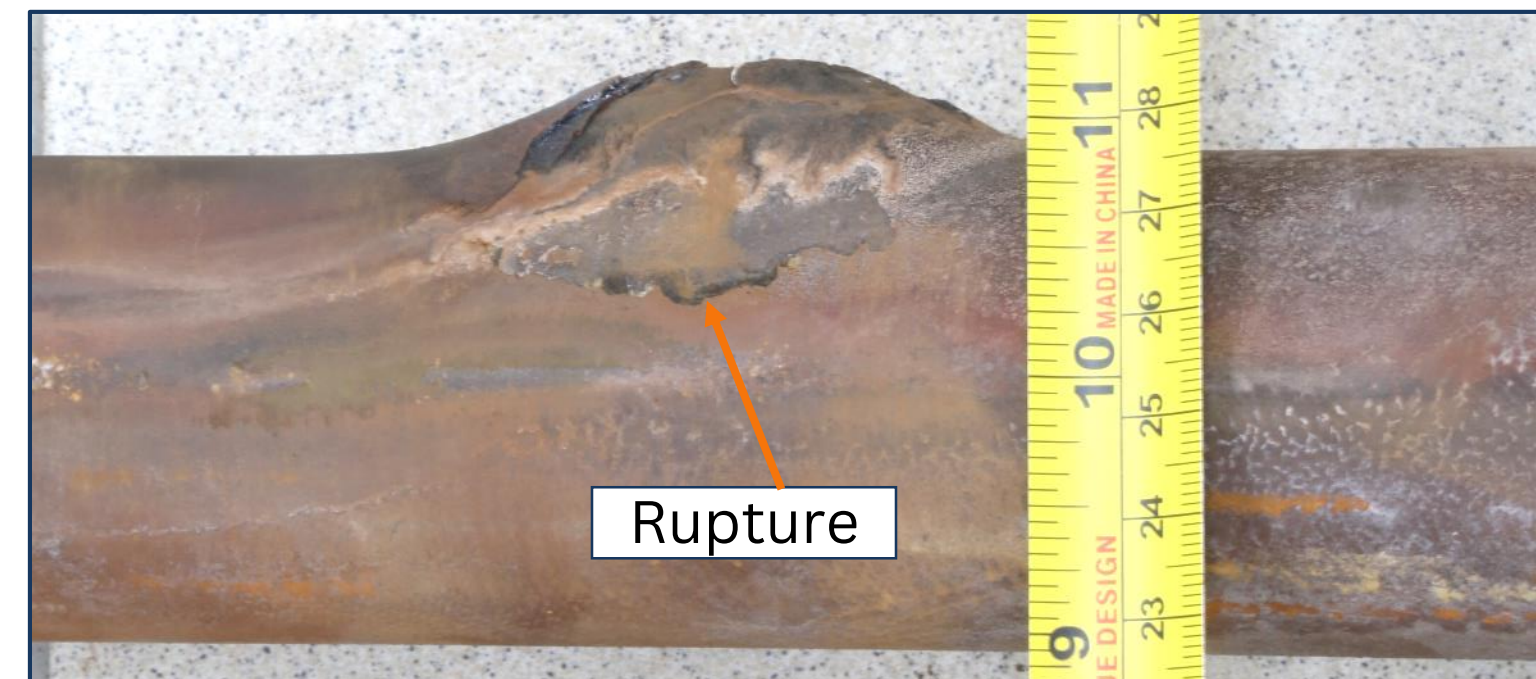
- 6 tubes were selected for analysis:
 - Row 1 – 5 tubes (tubes# 1, 5, 11, 47 & 78) with varying degrees of damage (opening, cracking, bulging, no apparent damage)
 - Row 4 – 1 tube with no apparent damage was selected for reference purposes
- The damage is on the upstream side (US) of the tubes (side facing the oncoming flue gas)
- Cracking is longitudinal and multiple
- Crack direction indicates that cracking is driven by stresses due to internal pressure (hoop stresses)
- Scaling and discoloration coinciding with the bulged and cracked areas is a sign of overheating

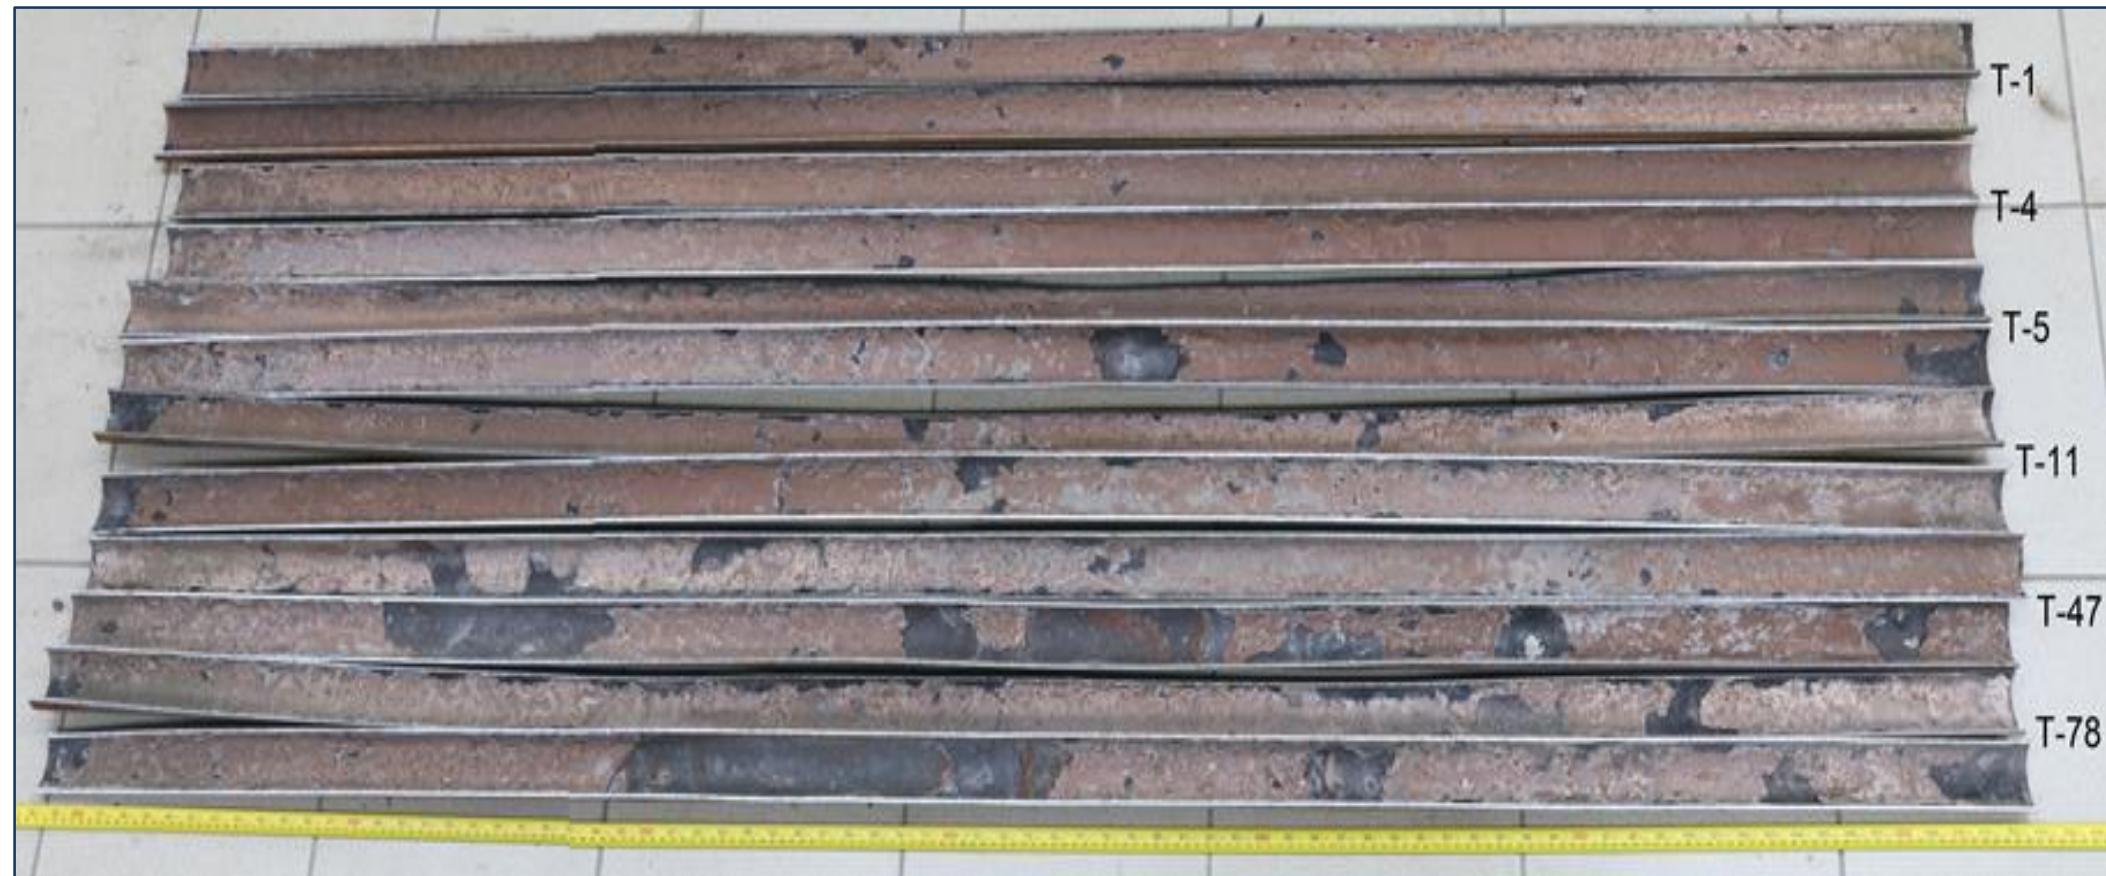
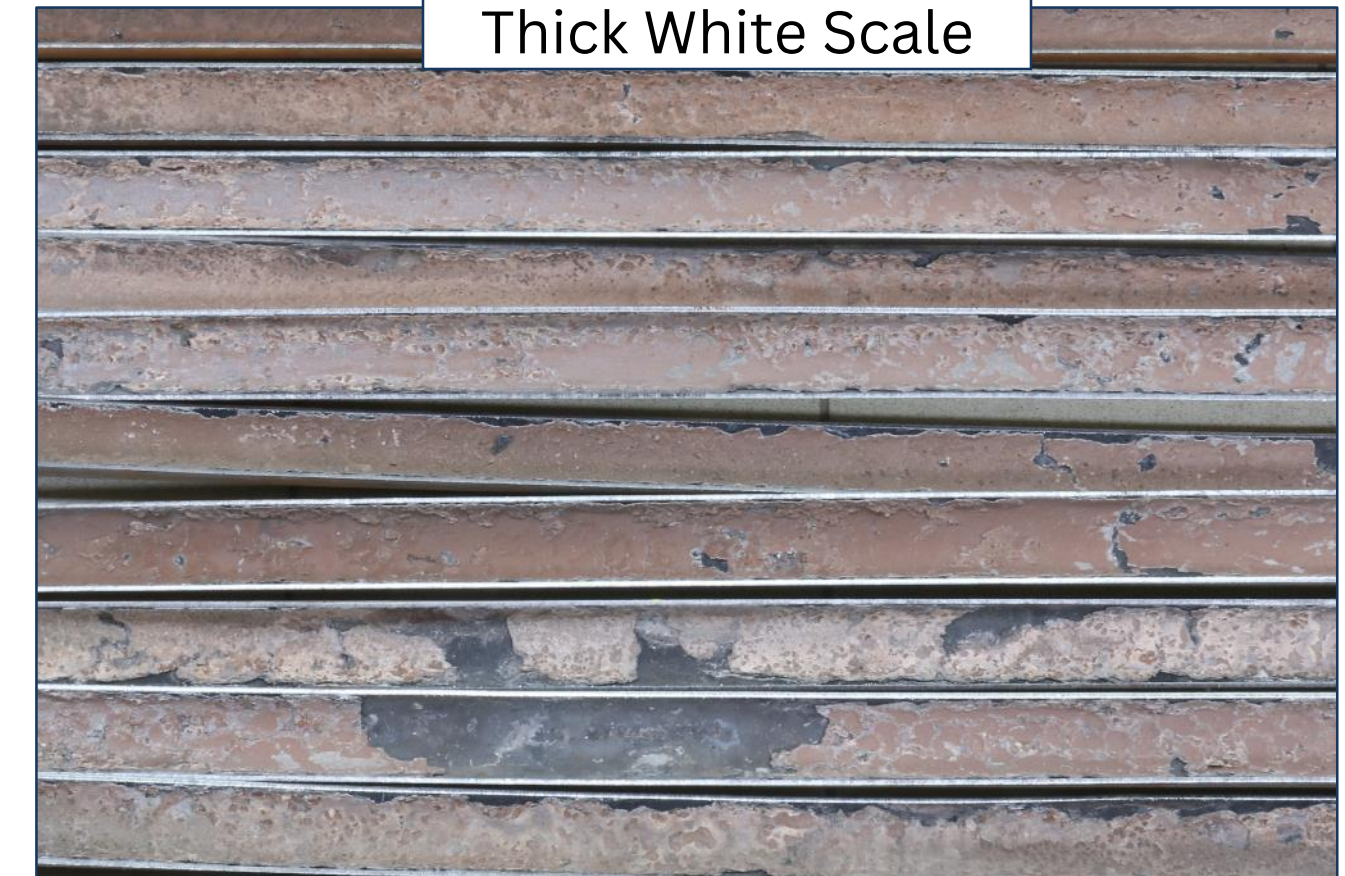
- The internal surfaces of the tubes were covered with loose whitish scale
- Internal scales can insulate the tube from the cooling effect of the water resulting in increased tube wall temperatures.
- One of the cracks was sectioned in the middle and cross sectional views revealed a thick walled fish mouth type of rupture which is typical of creep failures.

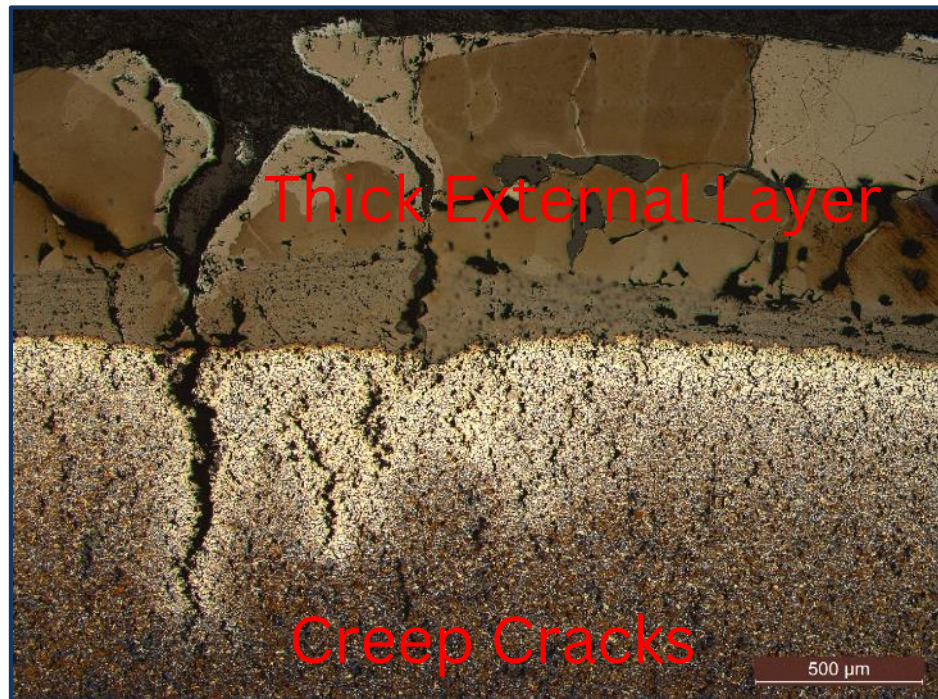
Row 1 ,Tube 47 – Trans. - Crack

Thick External Layer

Creep Cracks

- The creep threshold temperature for carbon steel is 371°C.
- Oxidation of carbon steel becomes significant above 450°C.
- All these temperatures are above the design temperature.

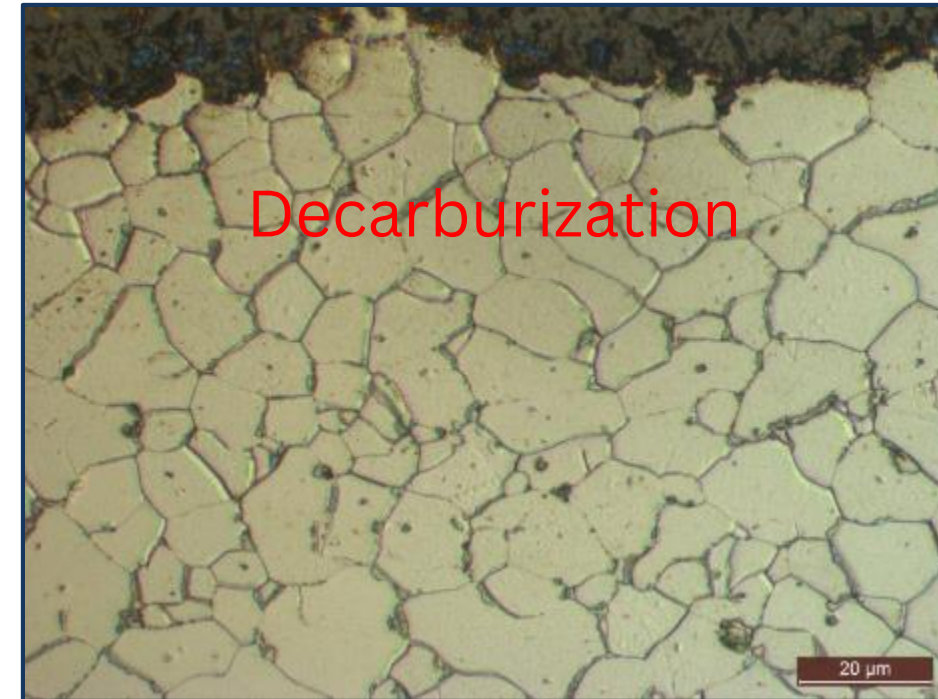
Row 1, Tube 47 – Trans. - Bulge

Decarburization

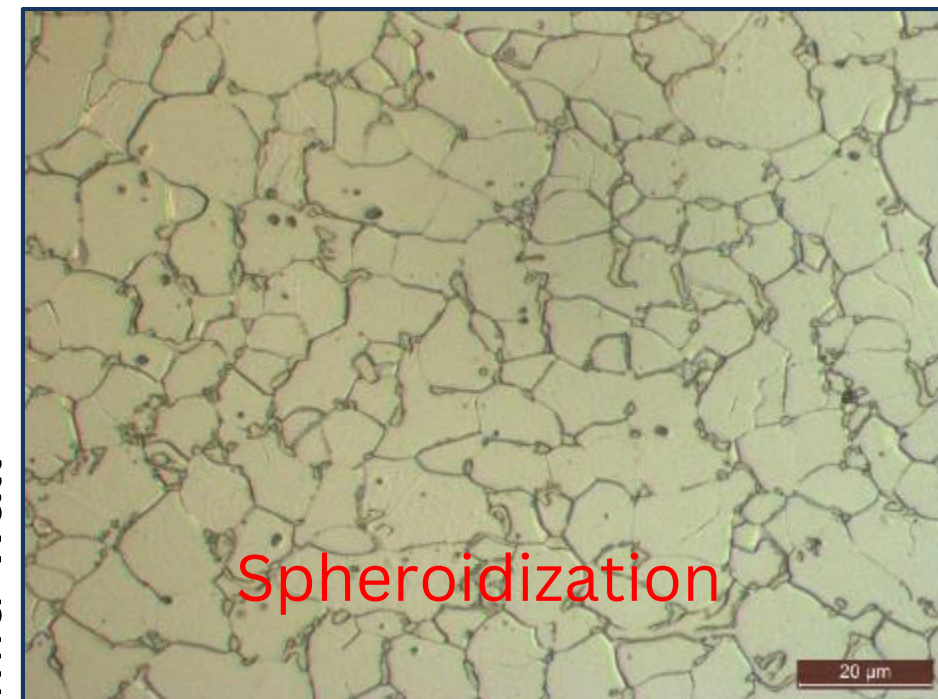
Spheroidization

- Spheroidization occurs between 440°C and 760°C. May occur within few hours at 550°C but may take several years to occur at 455°C (API 571).

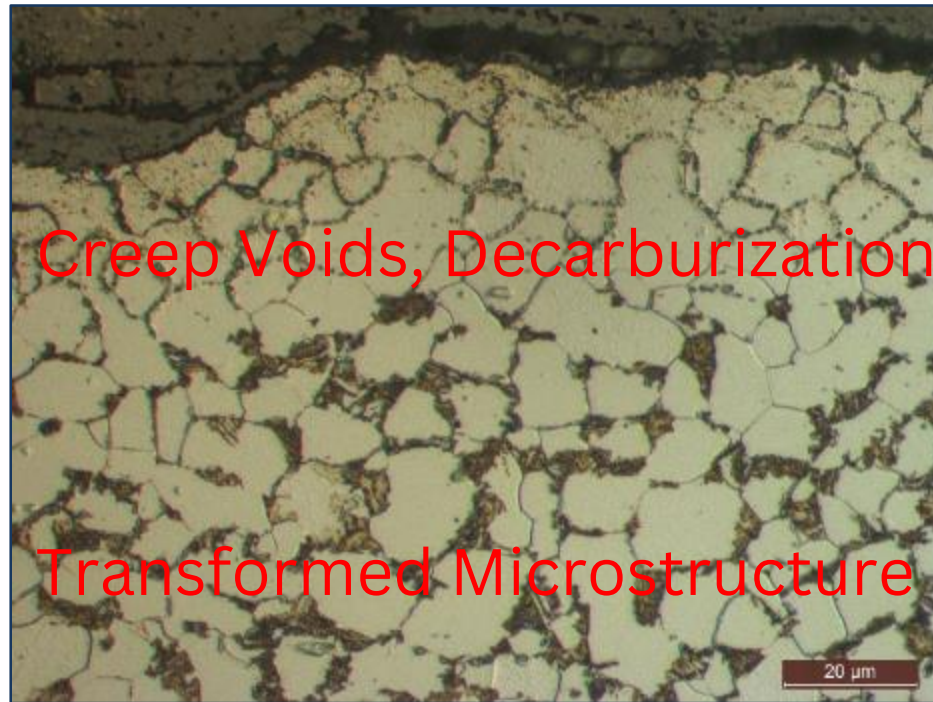
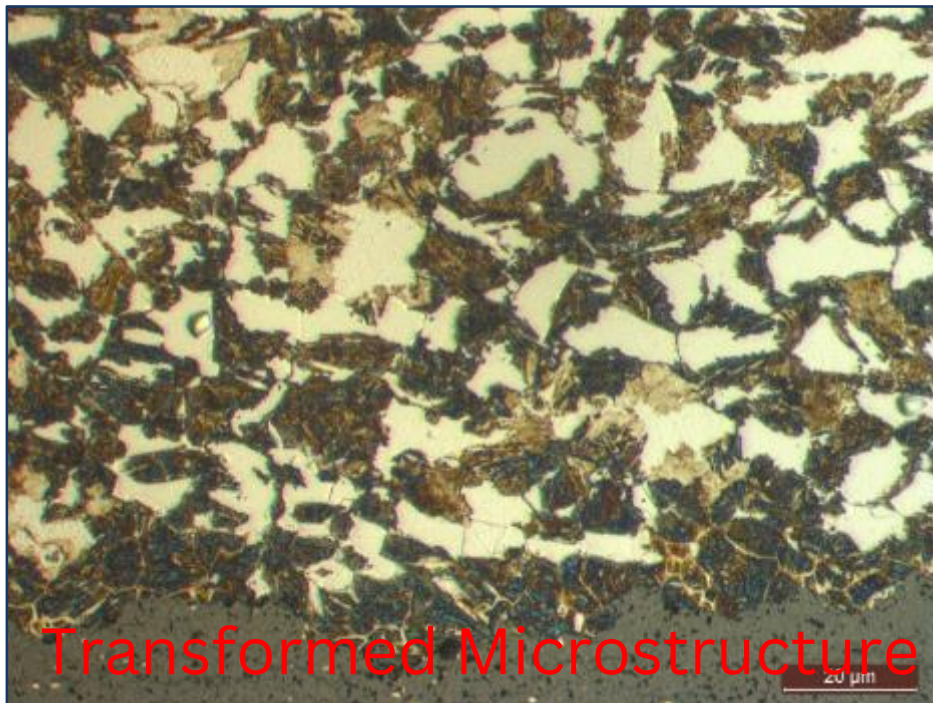
Row 1 ,Tube 47 – Long. - Crack

- Banded structure – Normal ; Equiaxed structure – recrystallization occurred
- Transformation – phase transformation occurred ; Transformation occurs above 720°C.
- The microstructure indicates overheating.

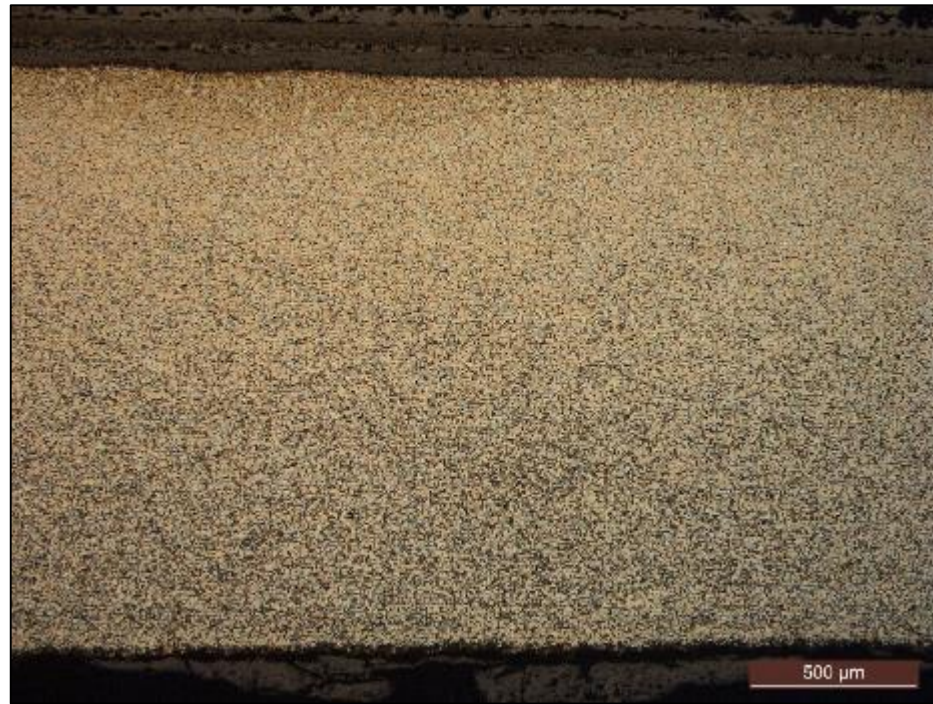
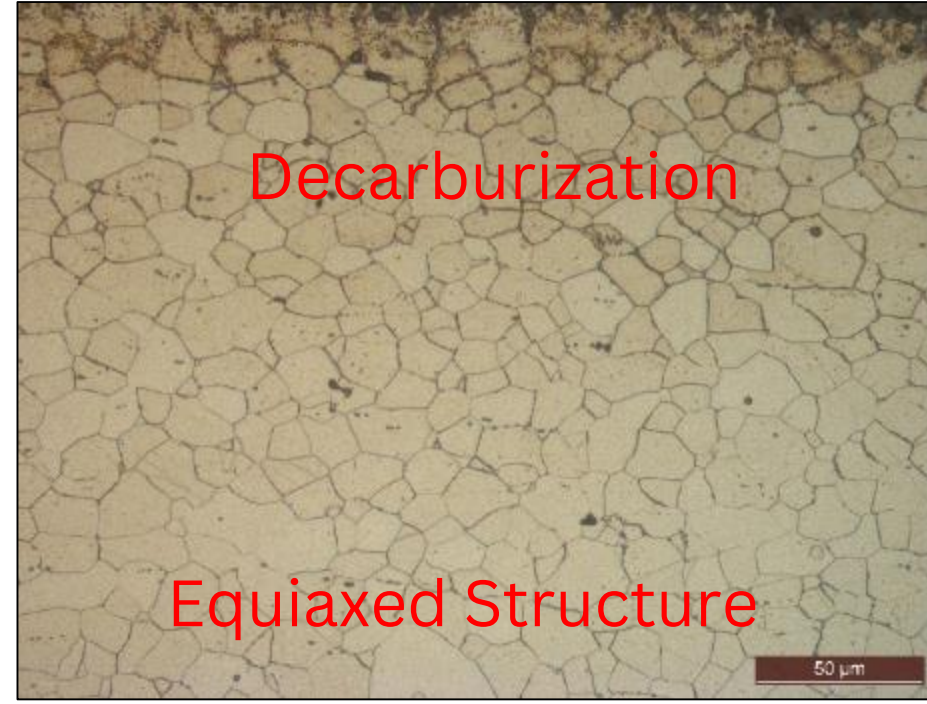
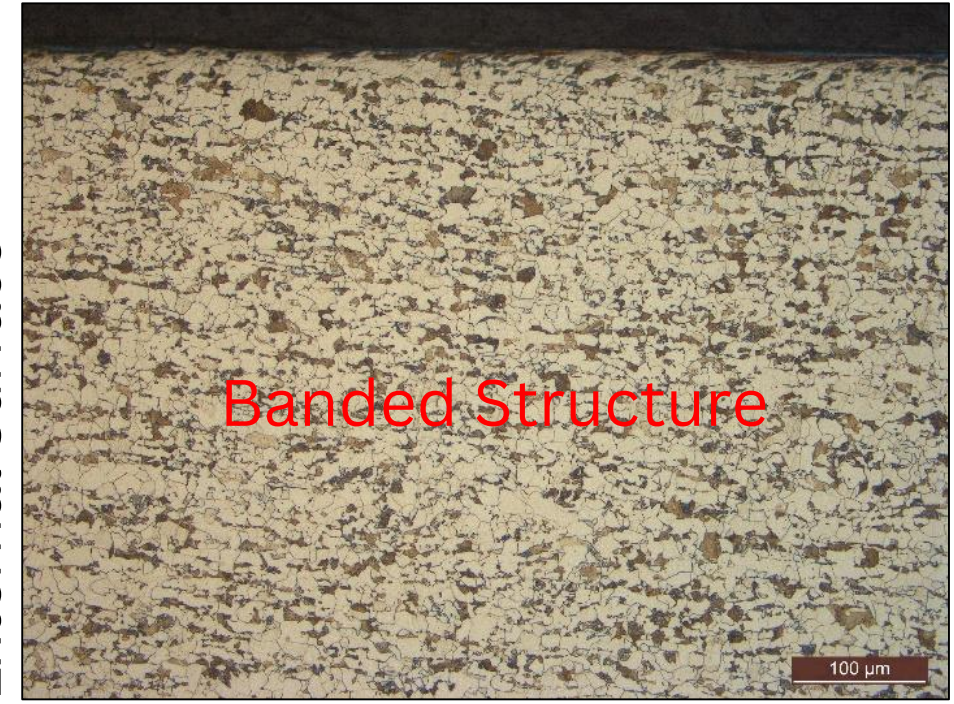
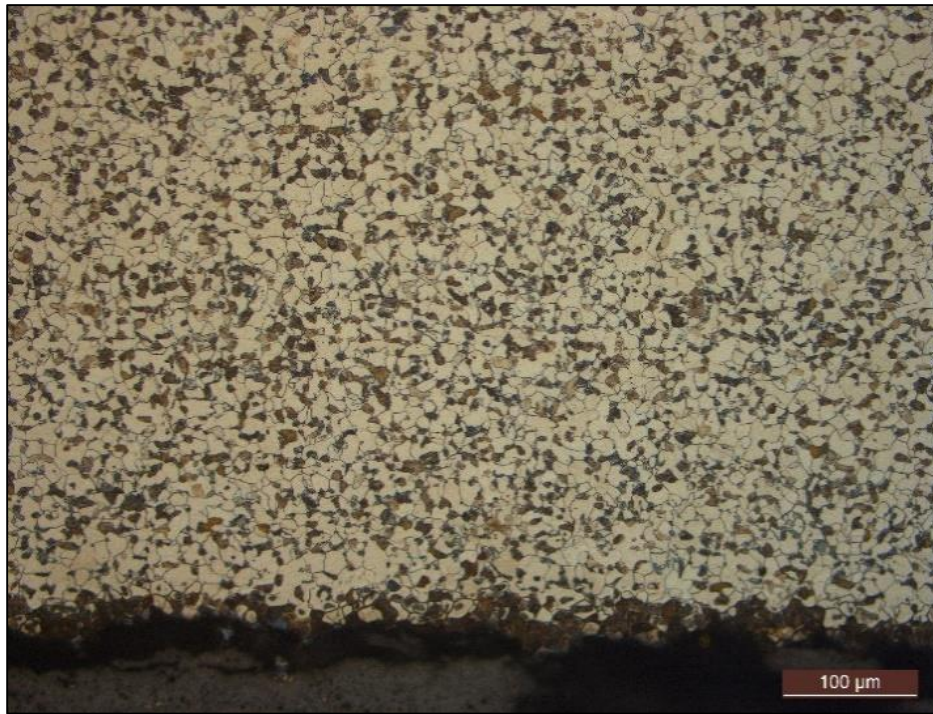
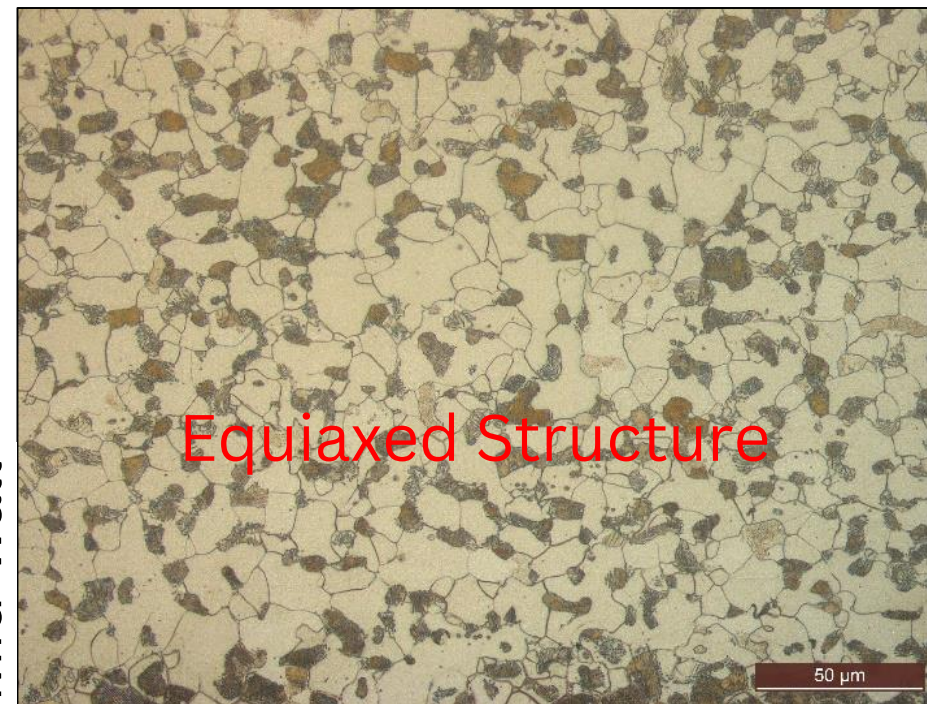
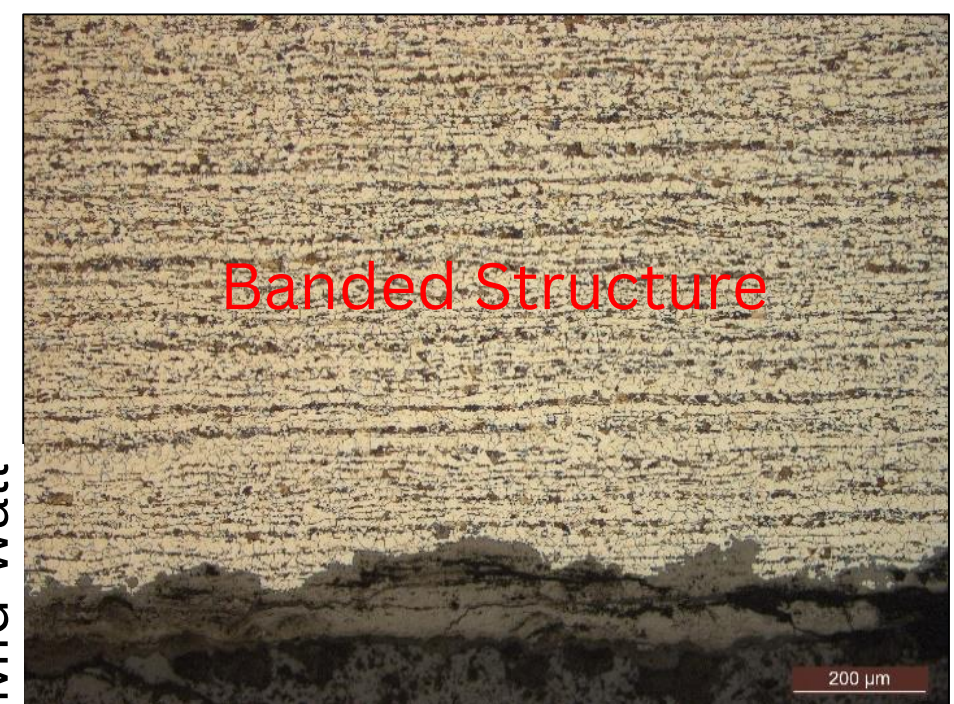
Row 1, Tube 5 – Long. – Bulge (US)

- Banded structure – Normal ; Equiaxed structure – recrystallization occurred
- The microstructure indicates overheating.

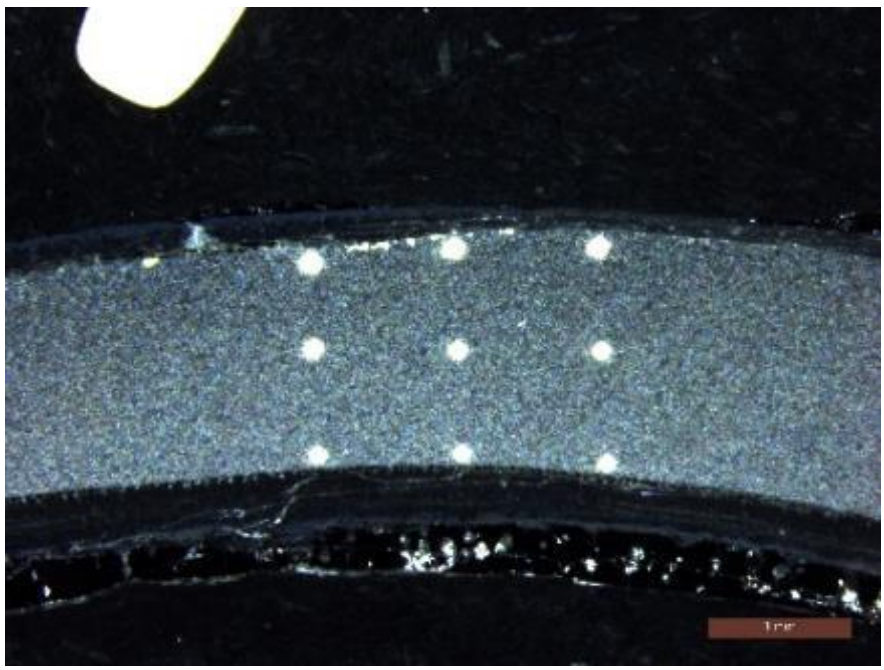
Row 1, Tube 47 – Bulge

- The specified maximum hardness for ASME SA 210 Gr C tubes is 179HB (179HV according to the conversion table in ASTM A370).
- The hardness of tube 78 sample is higher than the specified maximum. This can be attributed to the transformation that resulted in formation of harder phases upon cooling.
- The specified minimum tensile strength for ASME SA 210 Gr C tubes is 415MPa (that's an equivalent hardness of 123HV according to the conversion table in ASTM A370).
- The hardness of tube 47 OD is below the approximate minimum hardness. This can be attributed to softening due to spheroidization.
