# JUBCOR

## Flow-Accelerated Corrosion in Steam Generating Plants

WTIIRA, Sep 2024

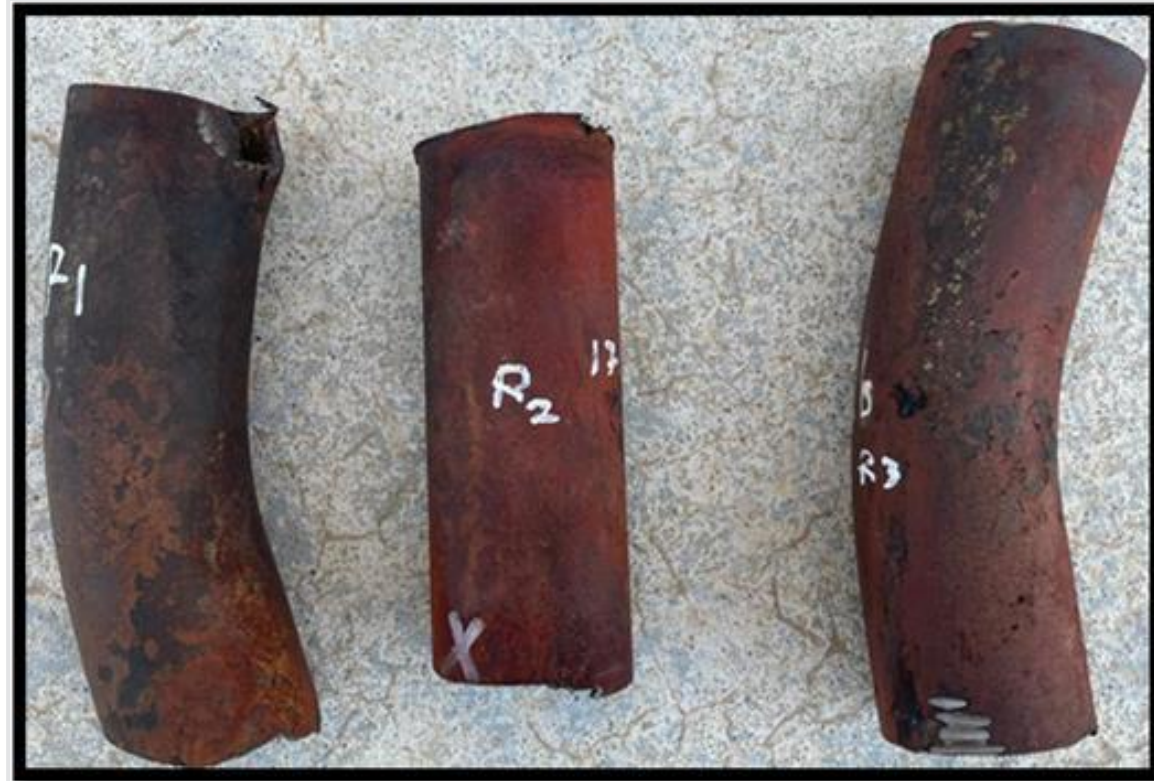
As received economizers tubes

Figure 1. Views of received tubes showing **scalloping pits**, typical of FAC morphology.

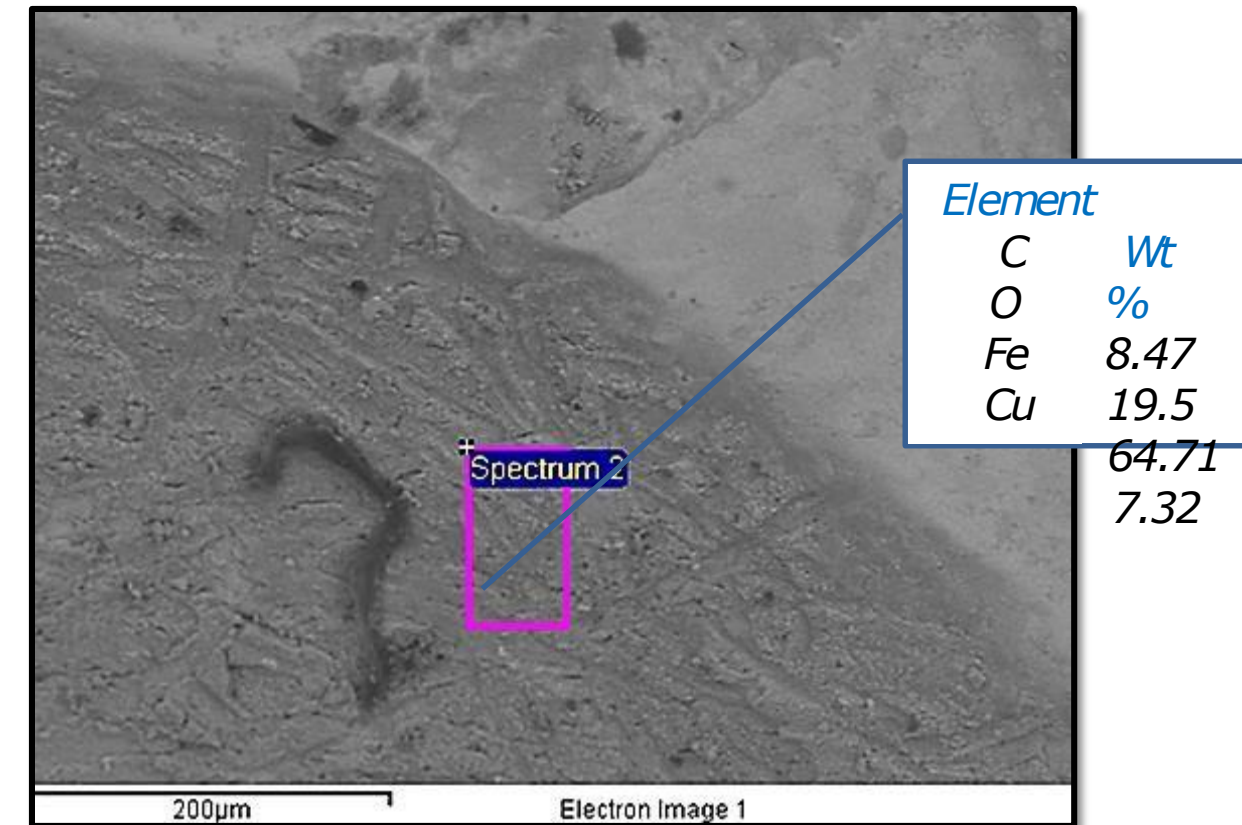
*A high content of copper (7.3 weight%) was identified on the internal surface of one of the tubes.  
This may enhance the corrosion rate due to the higher cathodic potential of cu than Fe.*

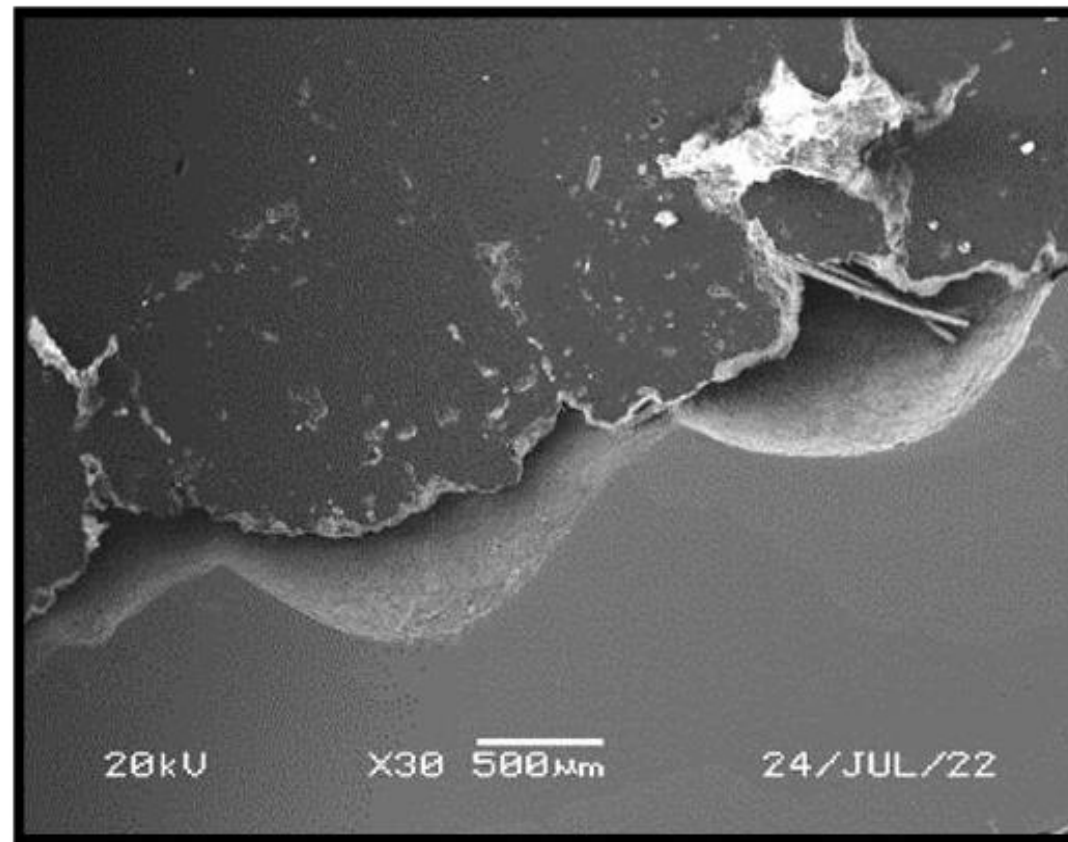
*The scalloping pattern of pit morphology was observed in different samples, Confirming FAC mechanism.*

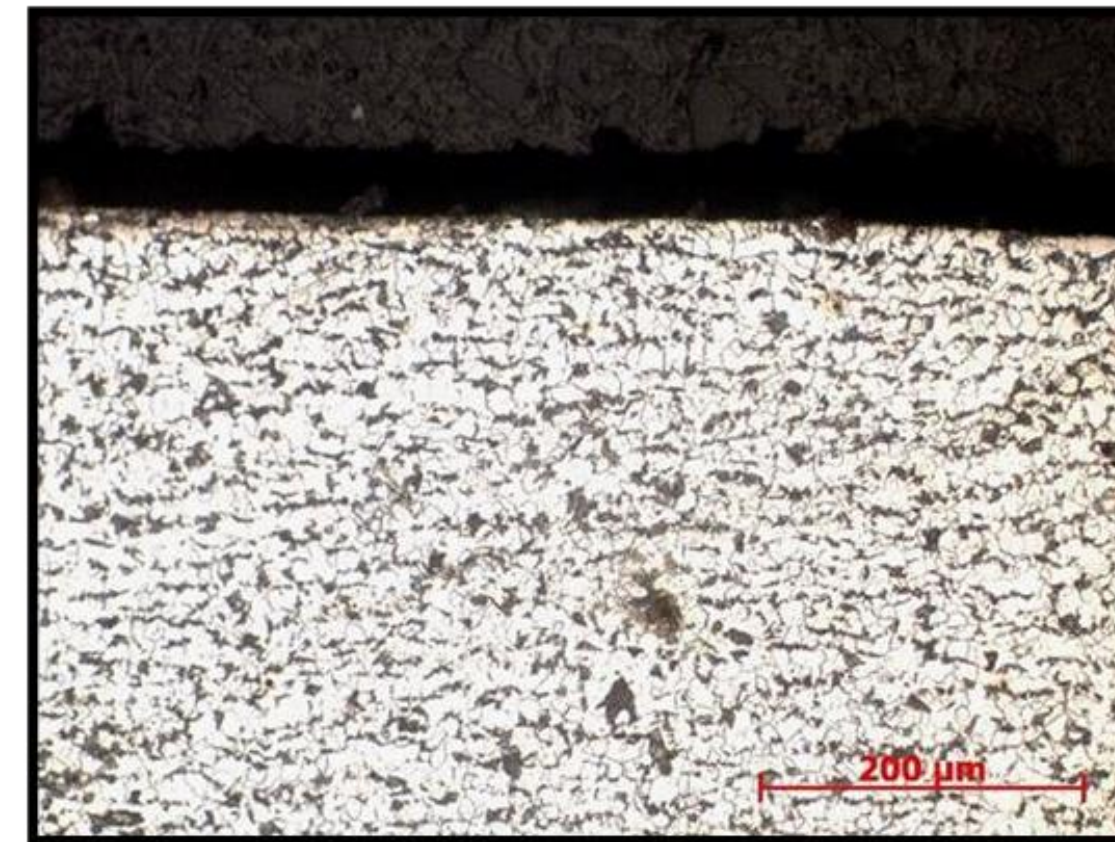
*Tube microstructure showed pearlite structures, ruling out possibilities of overheating of the tubes.*
