1ST NACE - JUBAIL INDUSTRIAL FORUM

"Impact of Deposit on Operation of Package Boiler "

Dr. AVTANDIL KHALIL BAIRAMOV

CASE I: FAILURE ANALYSIS OF PACKAGE BOILER FIRST SCREEN TUBE & ACID CLEANING

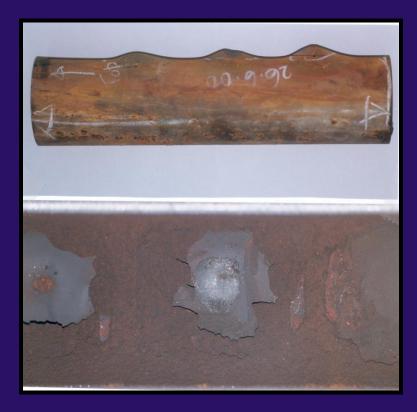
Figure 4

- FIGURE 4. Close up photographs of the sample with clearly visible multiple abrupt bulges. Note the presence of spalled layer of the deposit inside the longitudinally split tube.
- FIGURE 5. Presence of voids at and near the perforated edge (top of bulge, x400)

- Screen tube failed due to creep rupture as result of local overheating caused by presence of excessive dense deposit layer inside tubes.
- Calculated density of internal deposit was more than 200 mg/cm² at average thickness of 1.2 to 1.5 mm.
- Determined cleanliness of tubes is considered as "very dirty".

Acidic chemical cleaning was recommended and had been implemented.
Since then, the boiler operates normally more than 9 years.

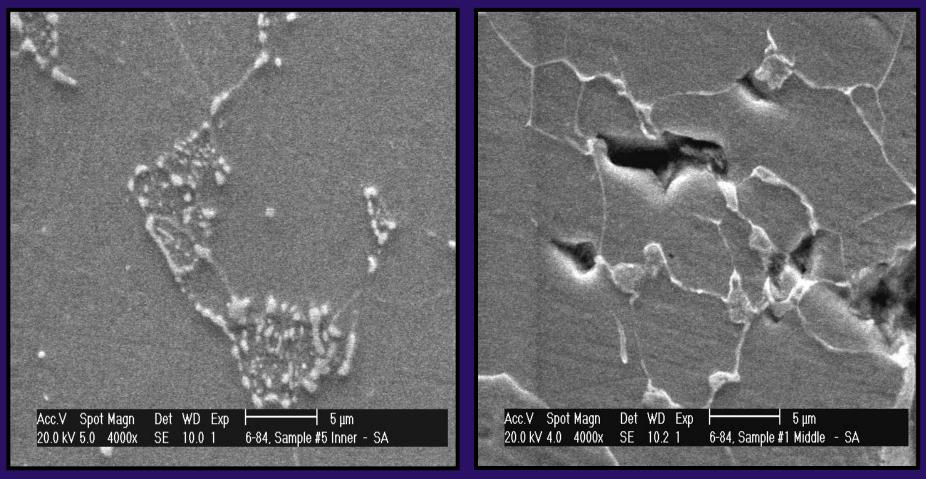
Figure 6 a

FIGURE 6. SEM micrographs showing speroidized morphology in pearlite colonis and the presence of voids (4000X)

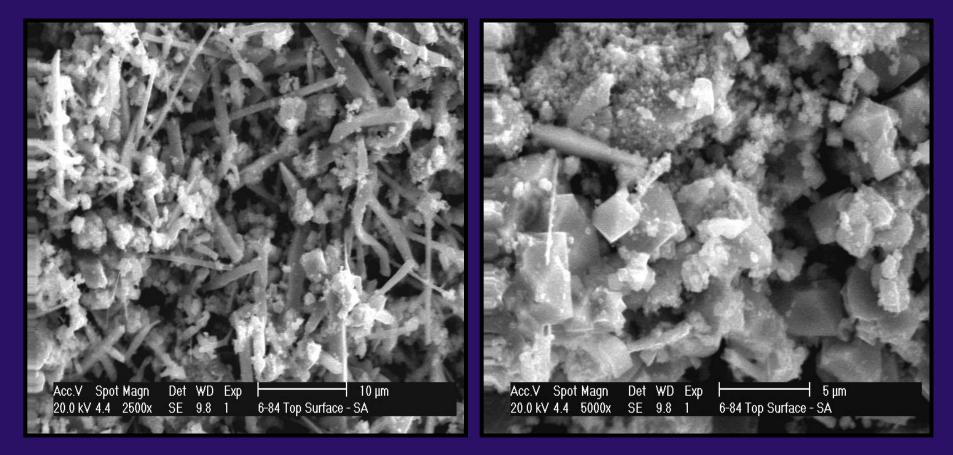
Figure 7 a

FIGURE 7. SEM micrographs of the flakes showing the presence of fine particles, fibers and short rods (a, 2500X) along with the typical crystaline particles (b, 5000X).
