# JUBCOR

**Challenges and Lessons Learned in  
Corrosion Management for Urea  
Solution Storage Tank Bottom Plate**

Presented By  
**Baher Elsheikh**

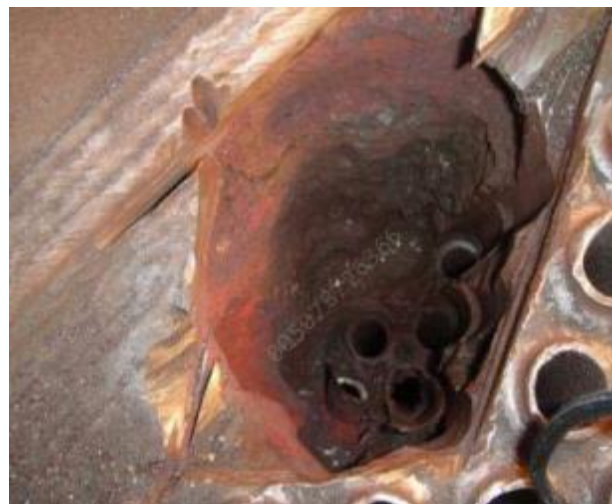
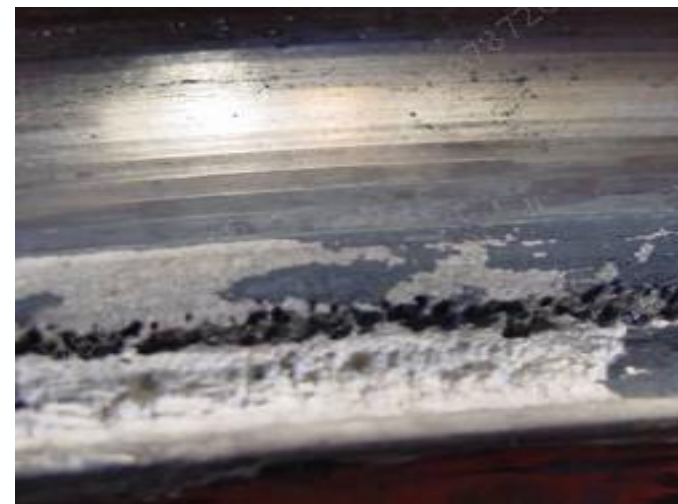
- Ammonium carbamate, which is present both in the reactor and the decomposition stages, is highly corrosive and active corrosion rate of 316L can be as high as 50 mm/year. Corrosivity of carbamate increases with temperature and is also affected by the ammonia/carbon dioxide ratio. Very few materials have adequate resistance to corrosion in such environment.
- Specific Austenitic stainless steel urea grades (SS 316L UG; 25Cr-22Ni-2Mo / 310LMo) and super duplex stainless steel (patented alloys) with restricted manufacturing quality control were developed in recent years. In addition to the use of Titanium and Zirconium in some of the urea stripper tubes.
- On other hand, Urea solution is mildly corrosive and requires handling in relative high temperature in austenitic stainless material (SS 304L / 316L)

Example of carbamate corrosion

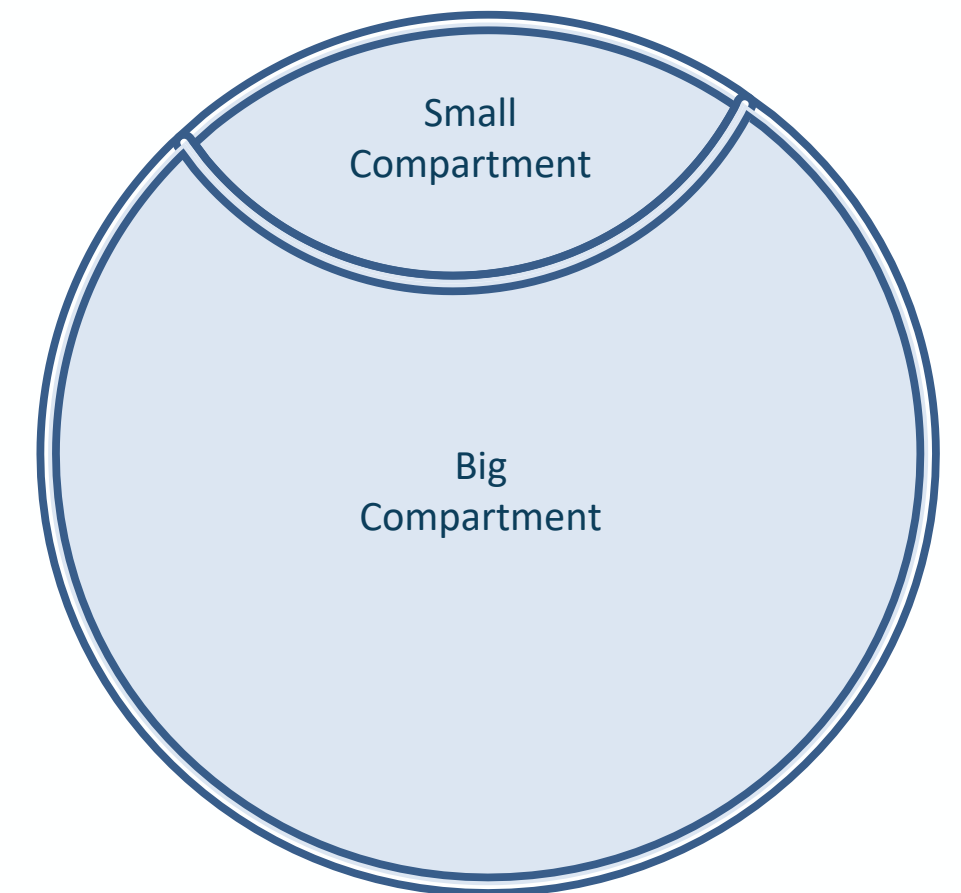
Tank Data	
Shell material	SS 304L
Bottom plate material	Duplex stainless steel UNS 31803, Thk. 7mm Original bottom plate was SS 304 and replaced after repeated cracks
Tank diameter/ height (m)	> 18 m / >5 m
Temperature (Design /operating)	> 150°C / >90°C
Service fluid	Urea solution
Construction code	API 650
Insulation	Yes
Construction year	2004

- Vertical insulated tank fabricated from austenitic stainless SS 304 L used for storage of Urea solution at temperature 93 °C
- The tank constructed from two different compartments (internal divider wall)

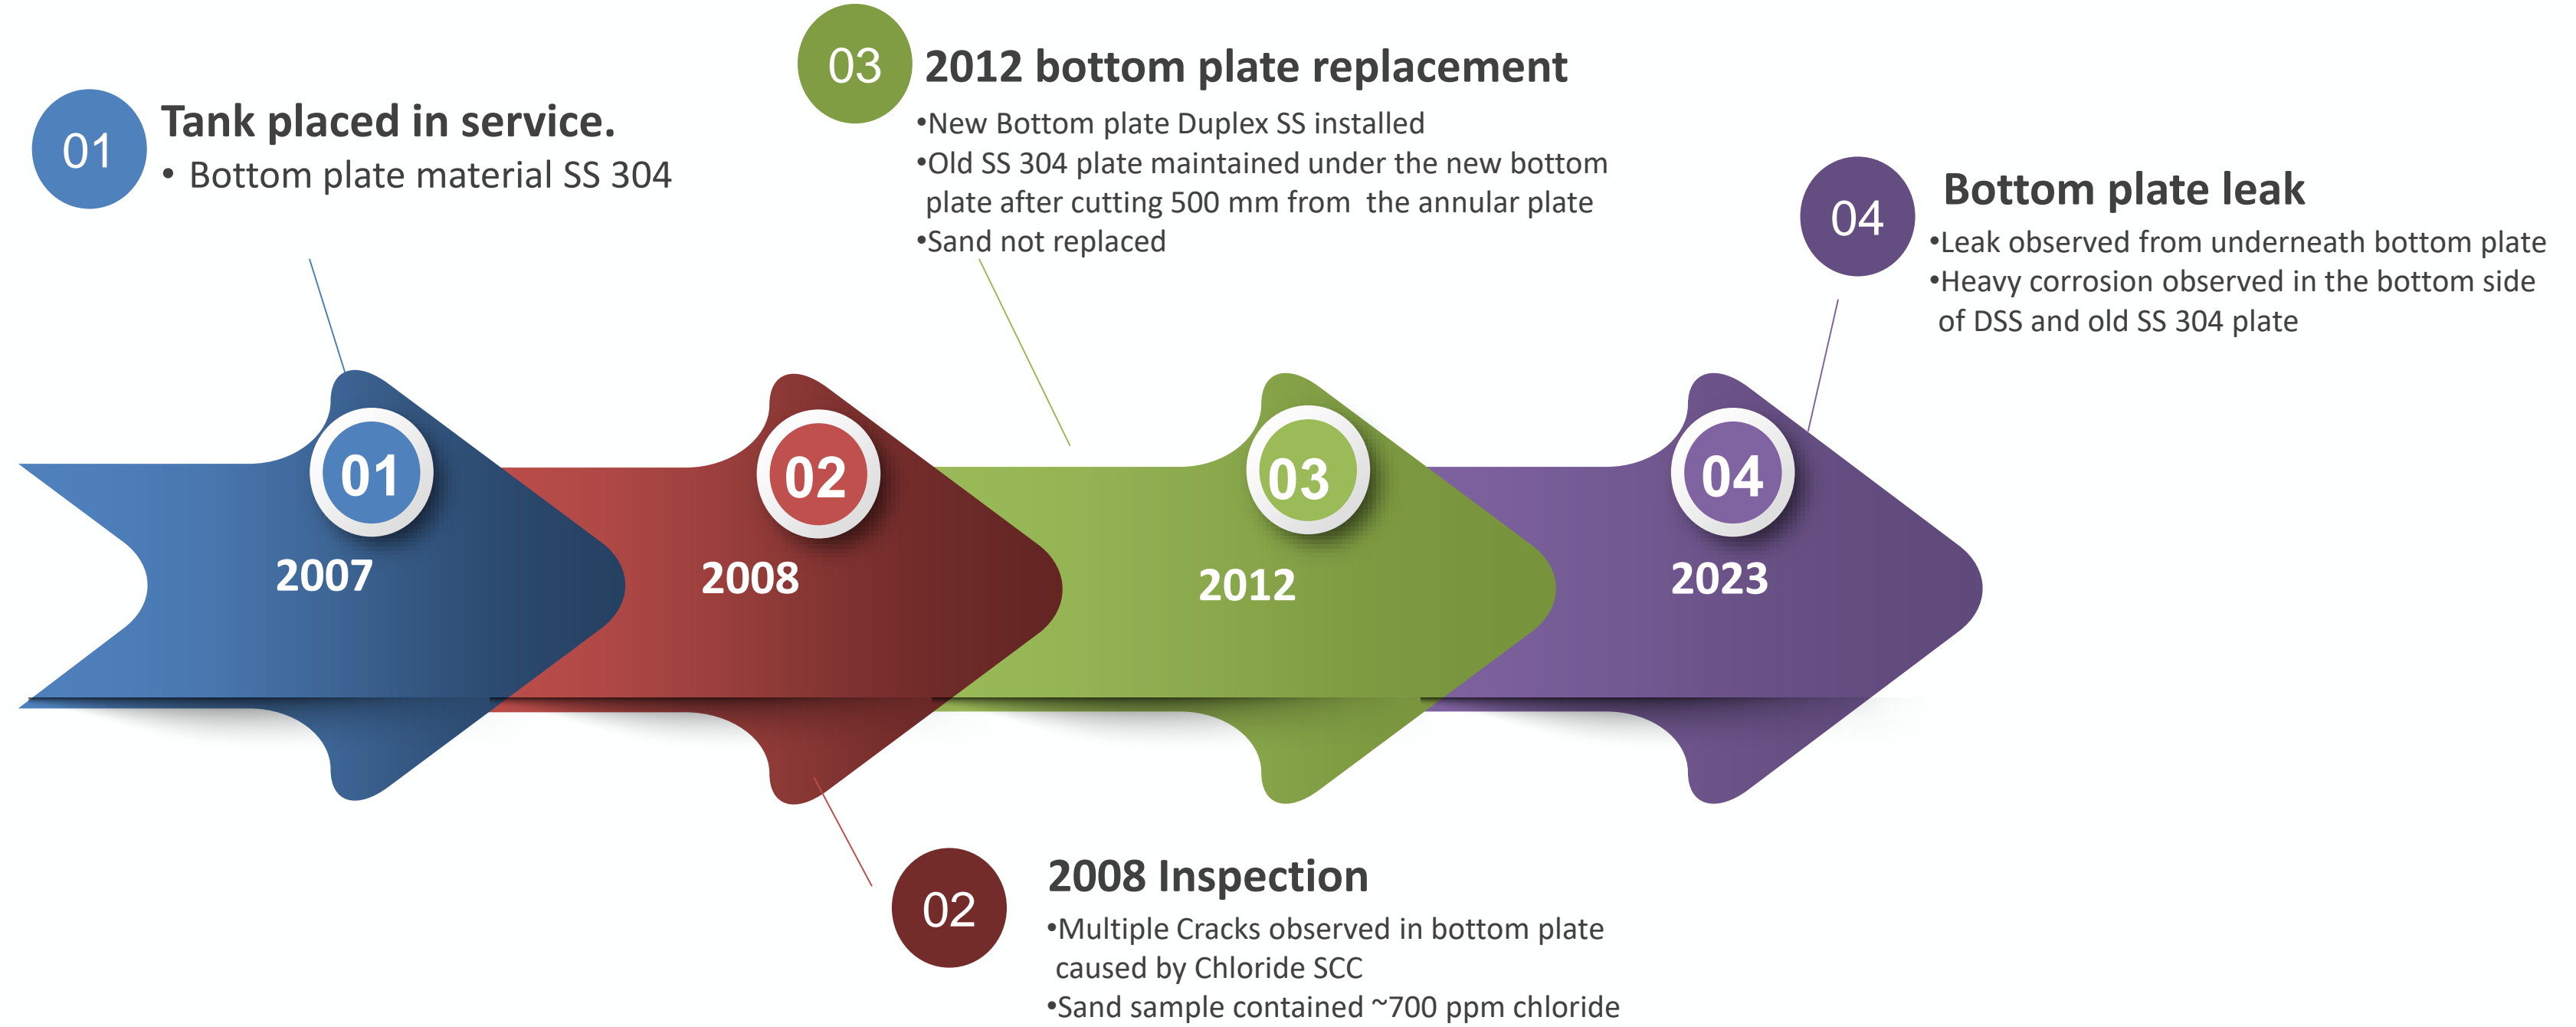
- Tank bottom plate was initially SS 304 then attacked by Chloride stress corrosion cracking from soil side after one year in service.
- Sand sample showed chloride content > 700 ppm.
- Bottom plate replaced by DSS, working satisfactory for 11 years, then leak again

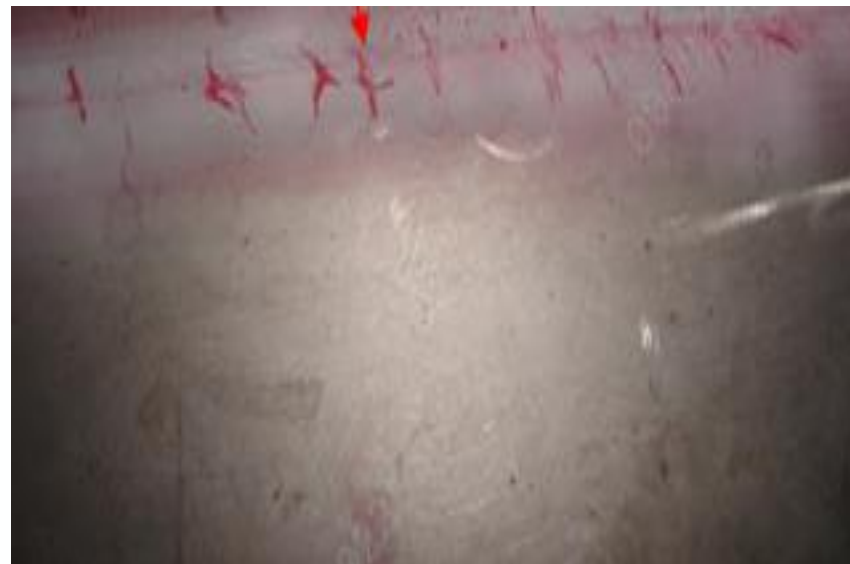
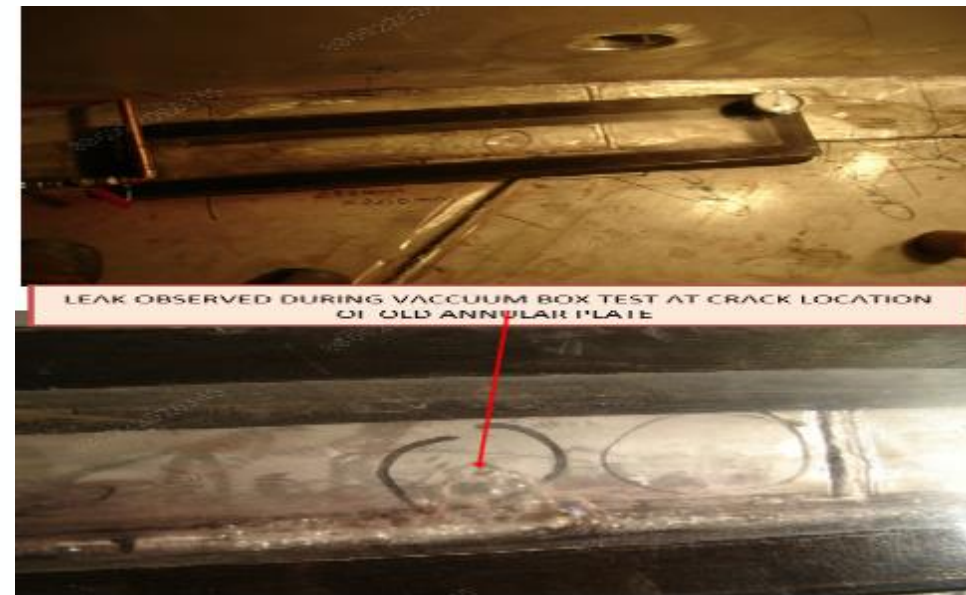
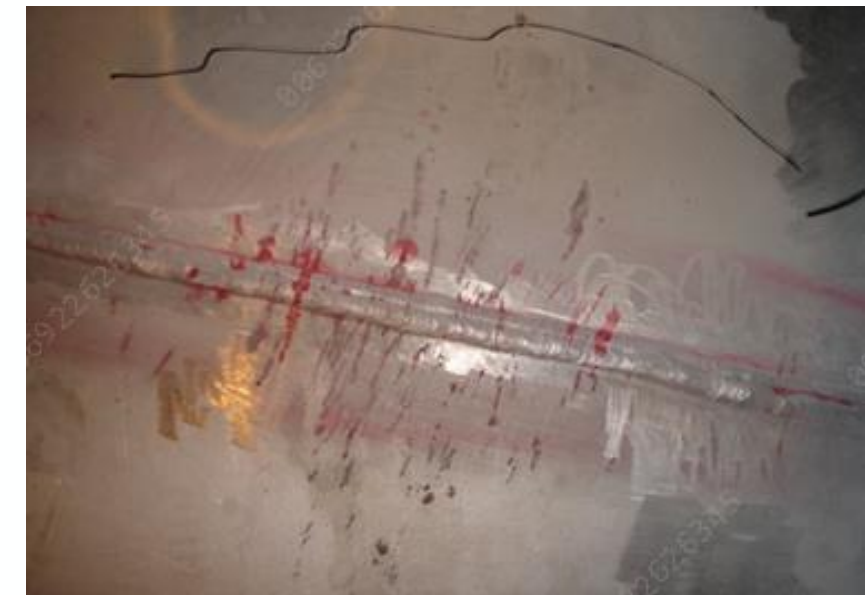
- Stress corrosion cracks (SCC) were seen in all the lap joint welds between annular plate and sketch plate. Many of these cracks were extending to the parent metal on either side. Also weld defect such as pin hole, porosity observed in the welds.
- The tank was inspected by vacuum box and confirmed leaking. The repair was done using patch plate covering the defected welds. The location of the patches provided is shown in the sketch below.
- Sample was collected from the crack location the Lab results confirmed that the cracks were caused by chloride stress corrosion cracking.
- Sand sample collected and showed chloride content of  $> 600$  ppm.
- It was recommended back then to replace the bottom plates with upgraded material (i.e. duplex stainless steel UNS 31803) the replacement was executed in 2012.

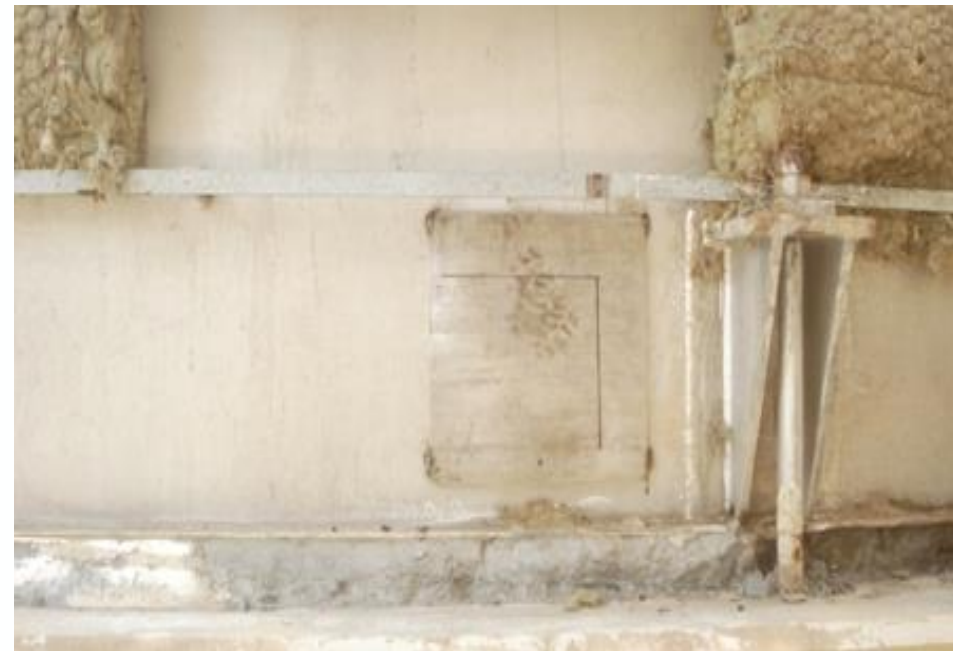
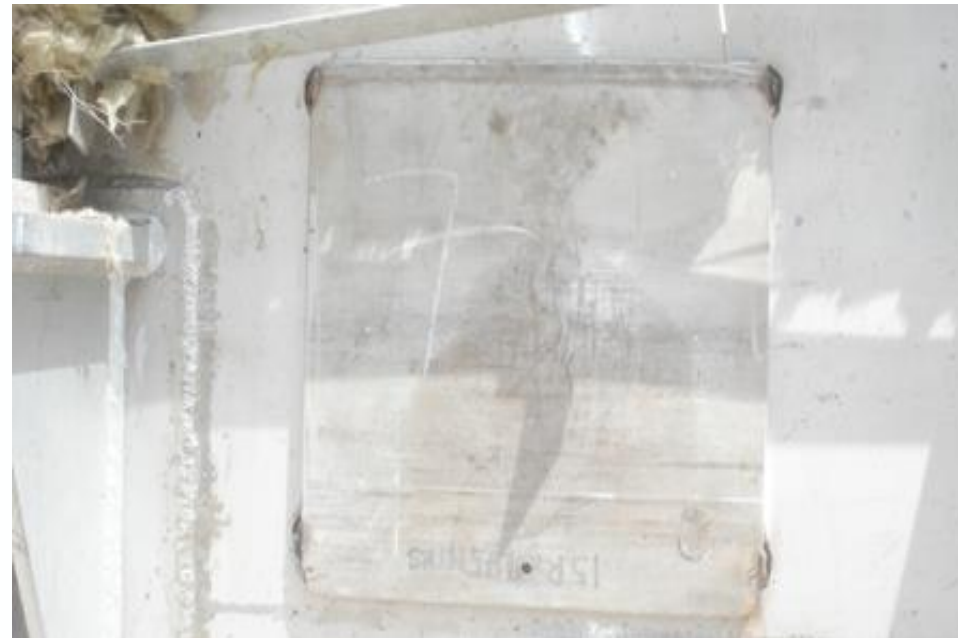
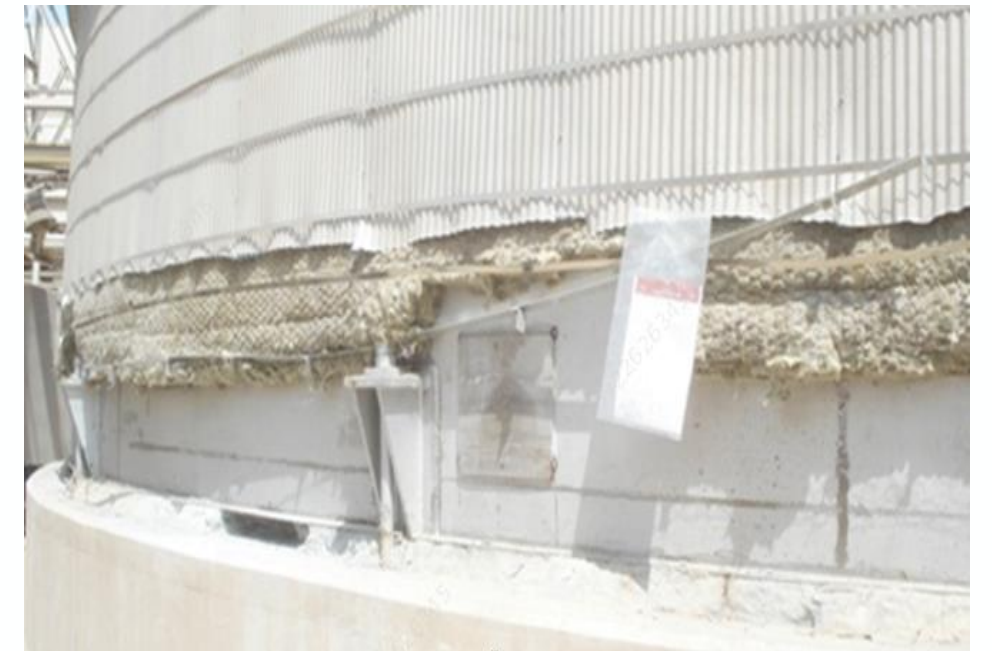
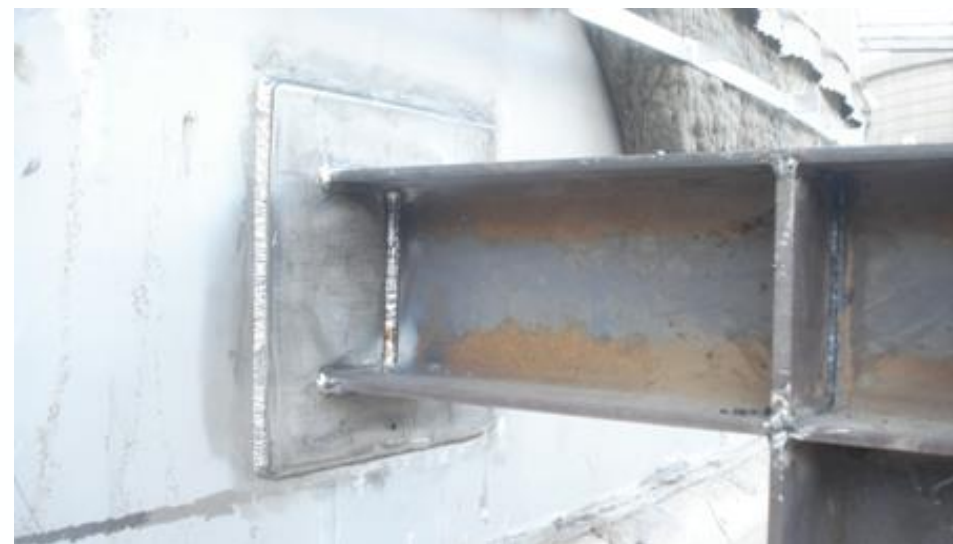
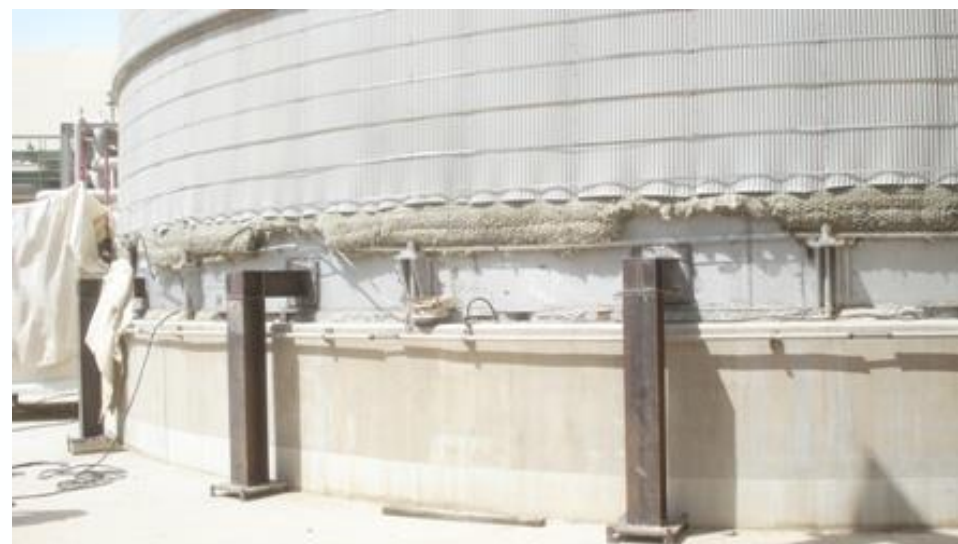
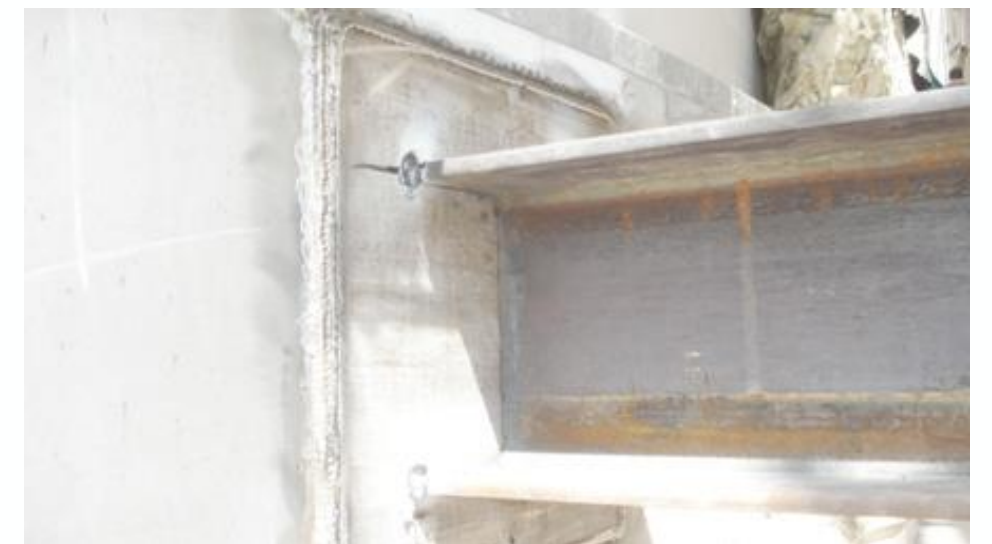
Bottom plate was replaced in 2012 with upgraded material (duplex stainless steel UNS 31803)

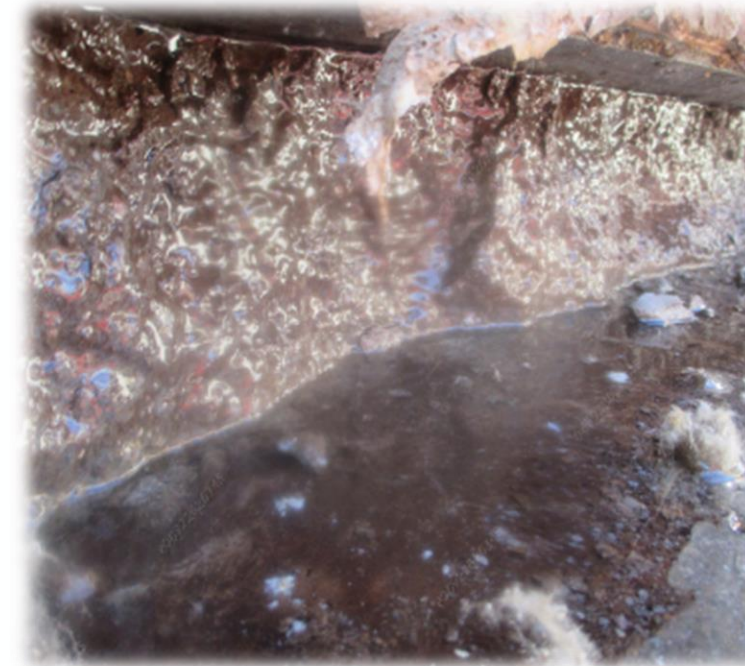
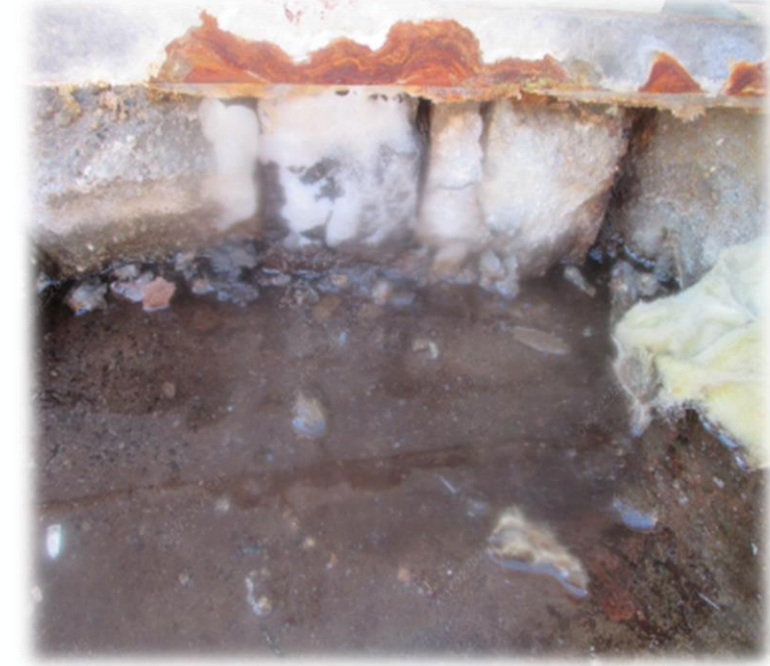
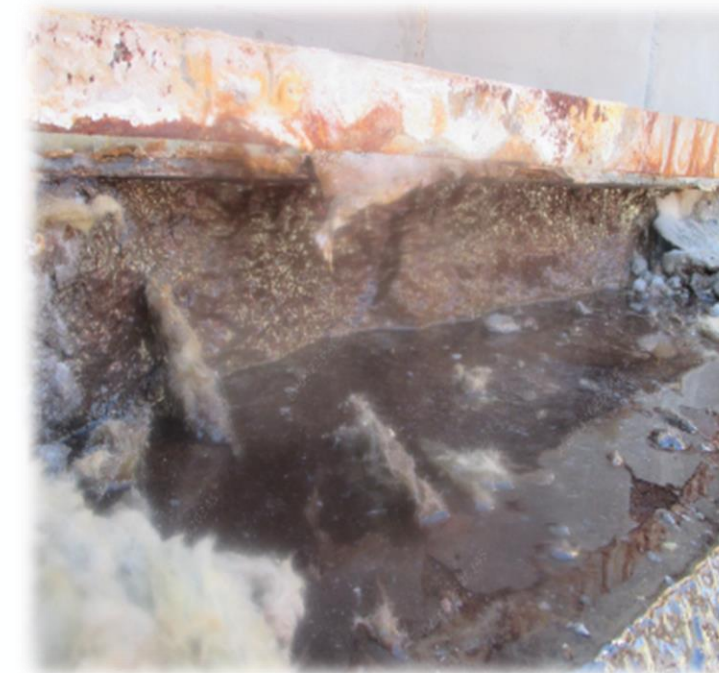
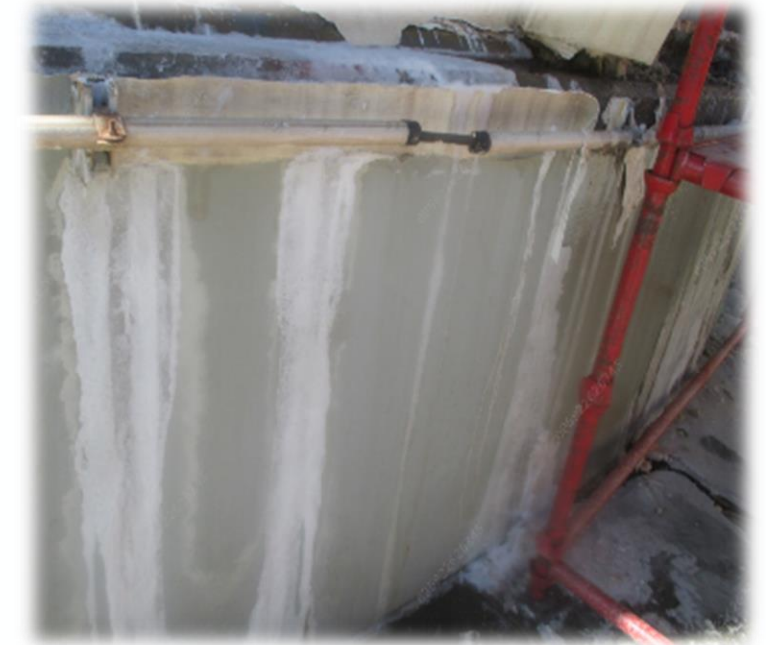
- Urea solution and ammonia smell was noticed from the bottom of the tanks from south side. Location of the leak is shown in the drawing below.
- After removing the wrapping around the foundation below the bottom plate. Broken pieces of the foundation covered with white deposit observed.
- The white deposit was found inside the dyke.
- The solution was coming from under the bottom plate
- The tank equipped with Release Prevention Barrier (RPB) including HDPE liner and drain nozzles from foundation which helped in containing the leak in the tank dyke without environmental impact

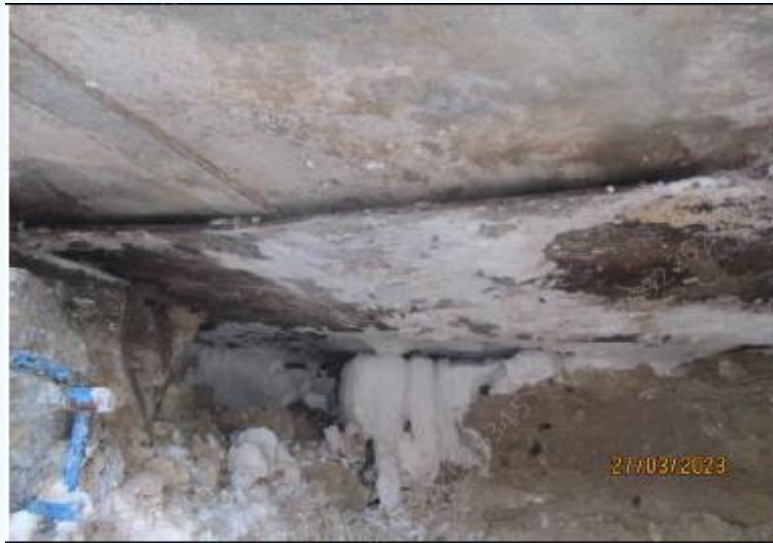
Partial removal of the concrete ring, controlled manual excavating under the tank bottom plate.

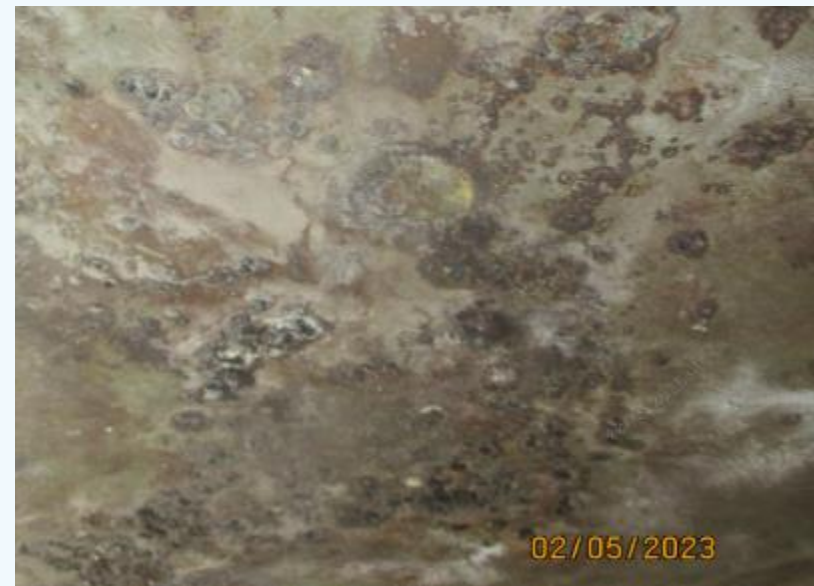
Cleaning showed high corrosion to old SS 304 plate; And pitting attack in the DSS plate

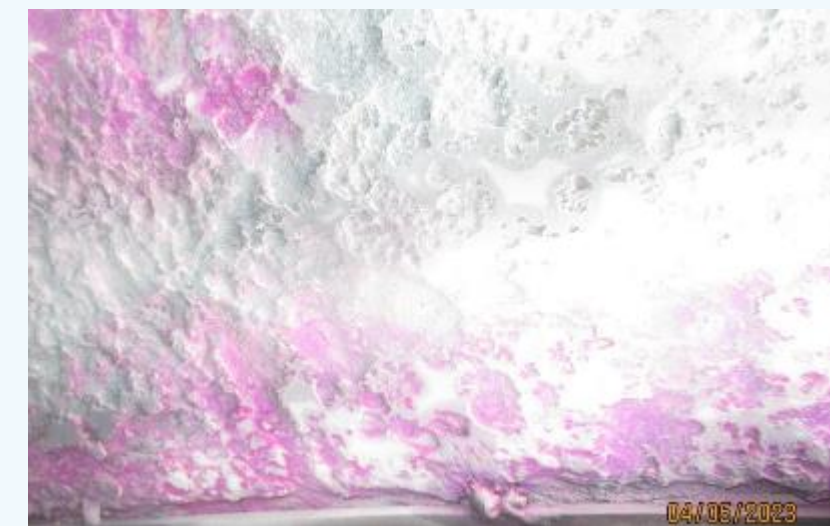
Leak from deep pits

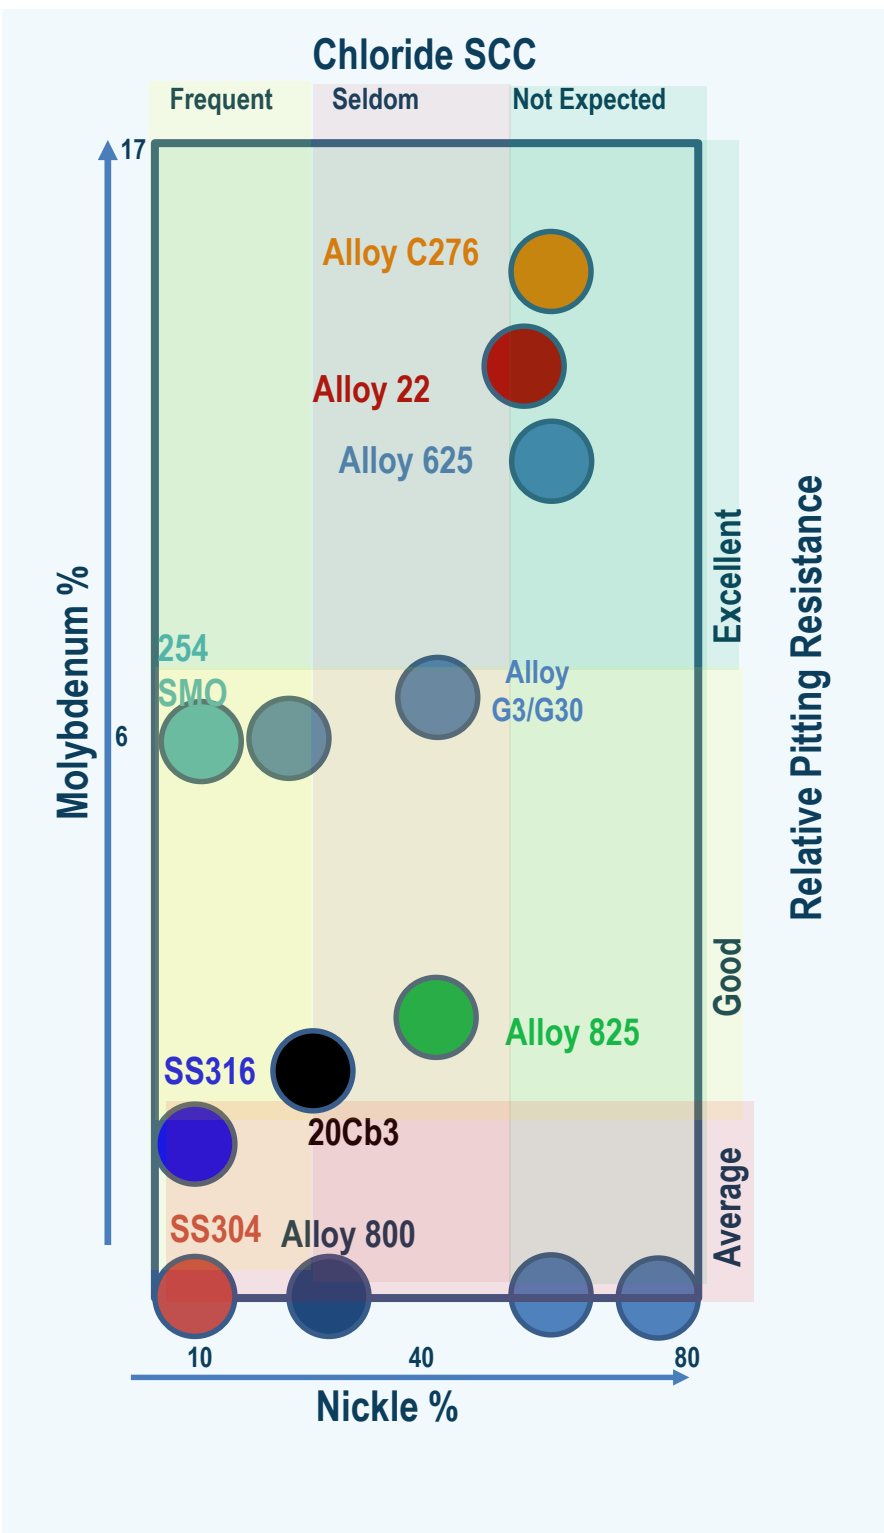
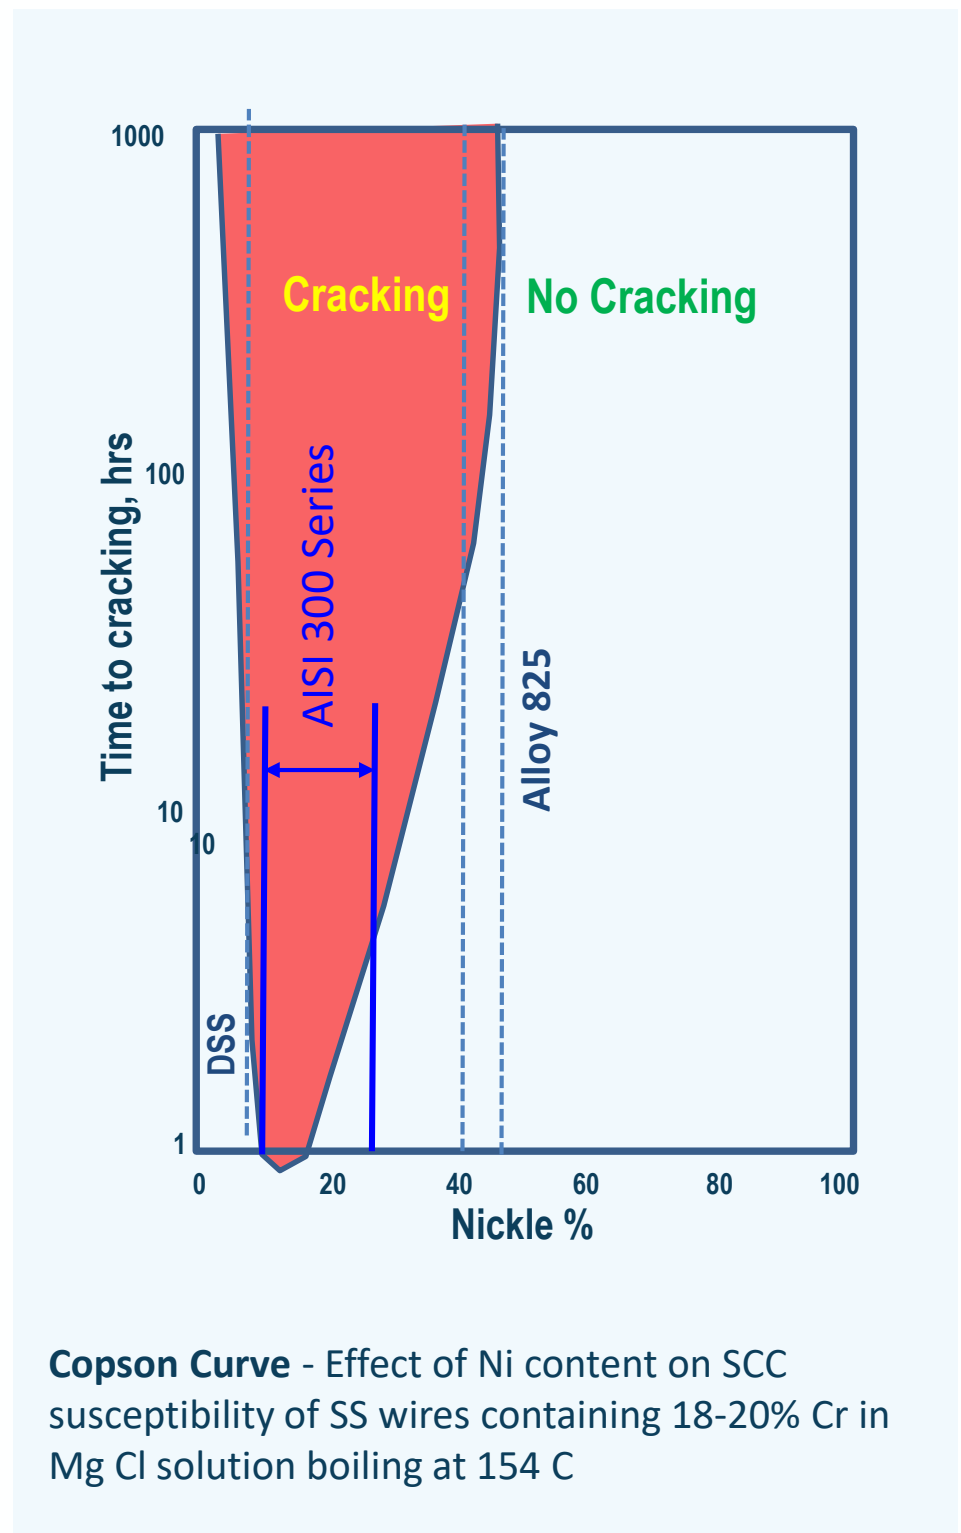
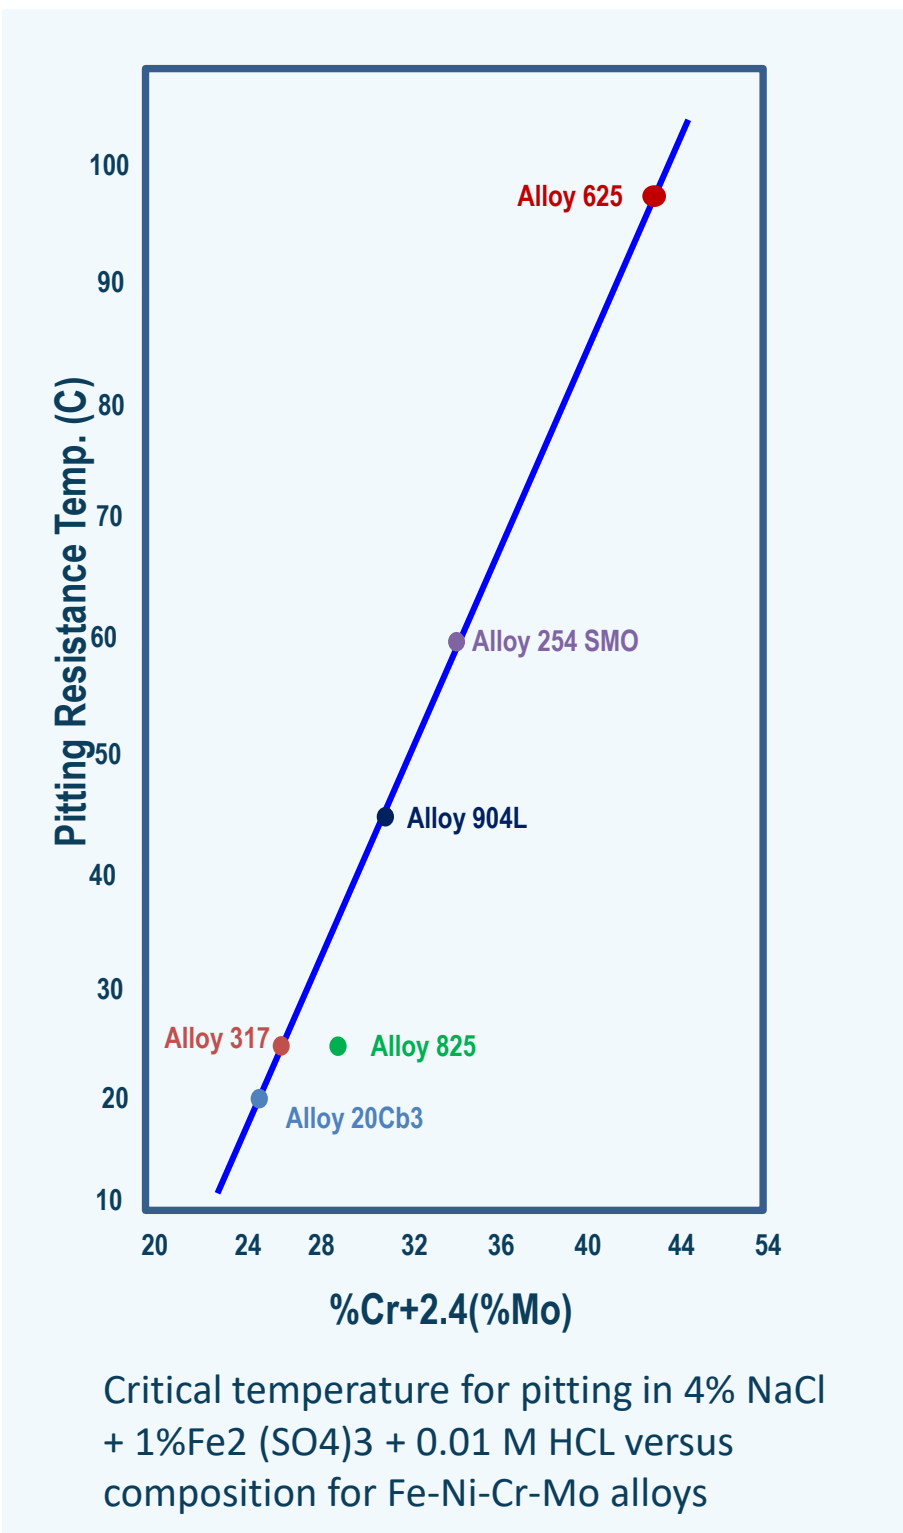
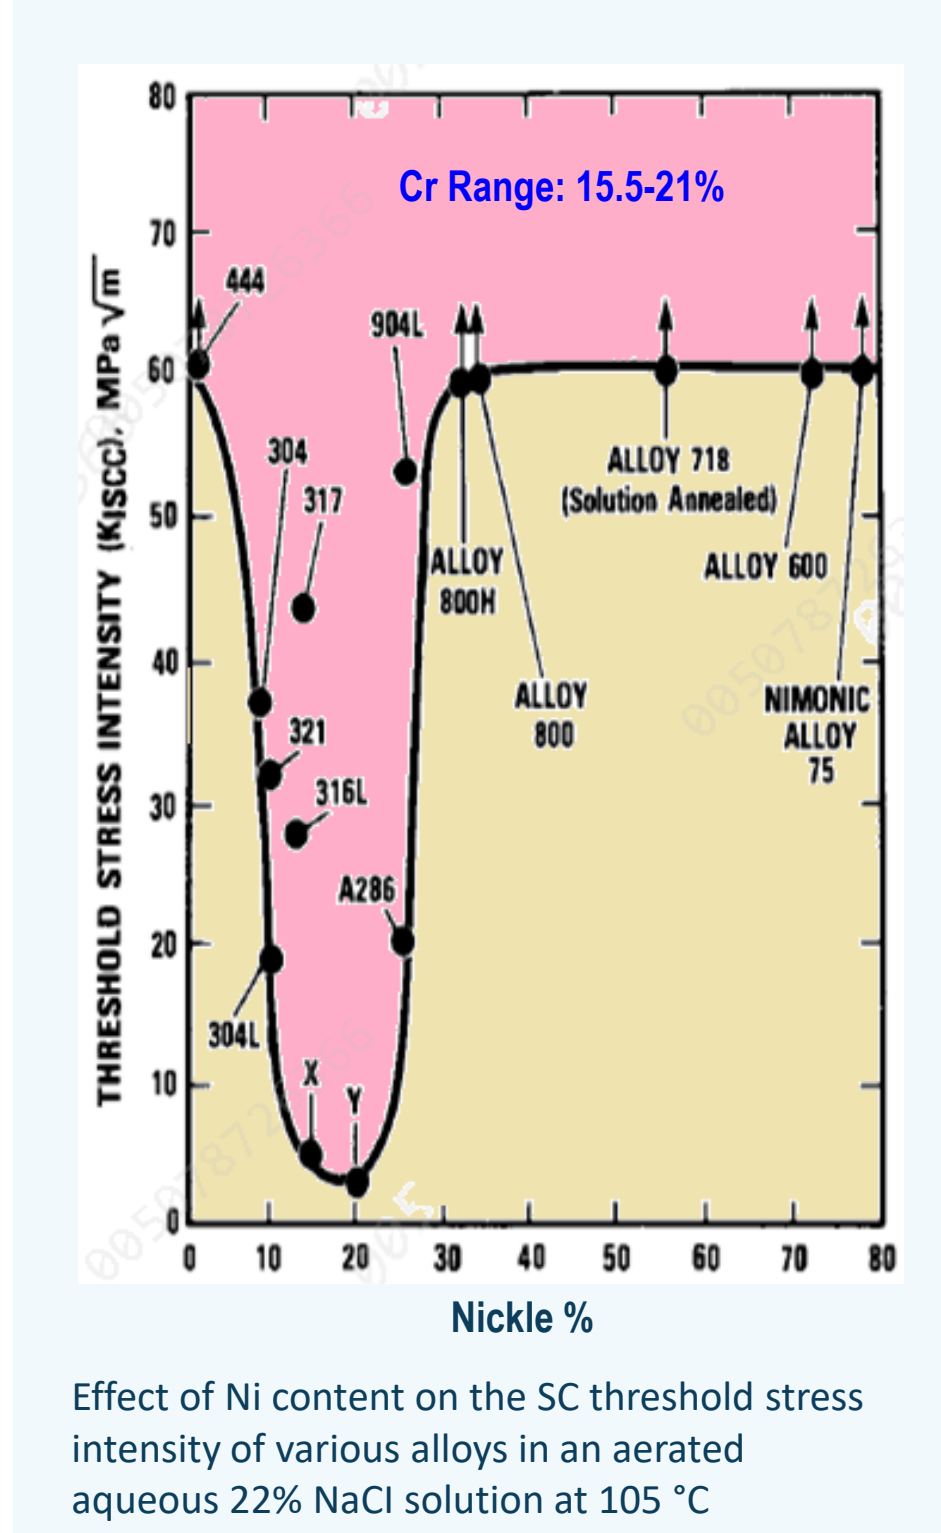
- High Ni contents (about 43%) would be required for resistance to chloride SCC. (Copson curve)
- Cr and Mo has a very good relationship to enhance critical pitting temperature in a salt solution.

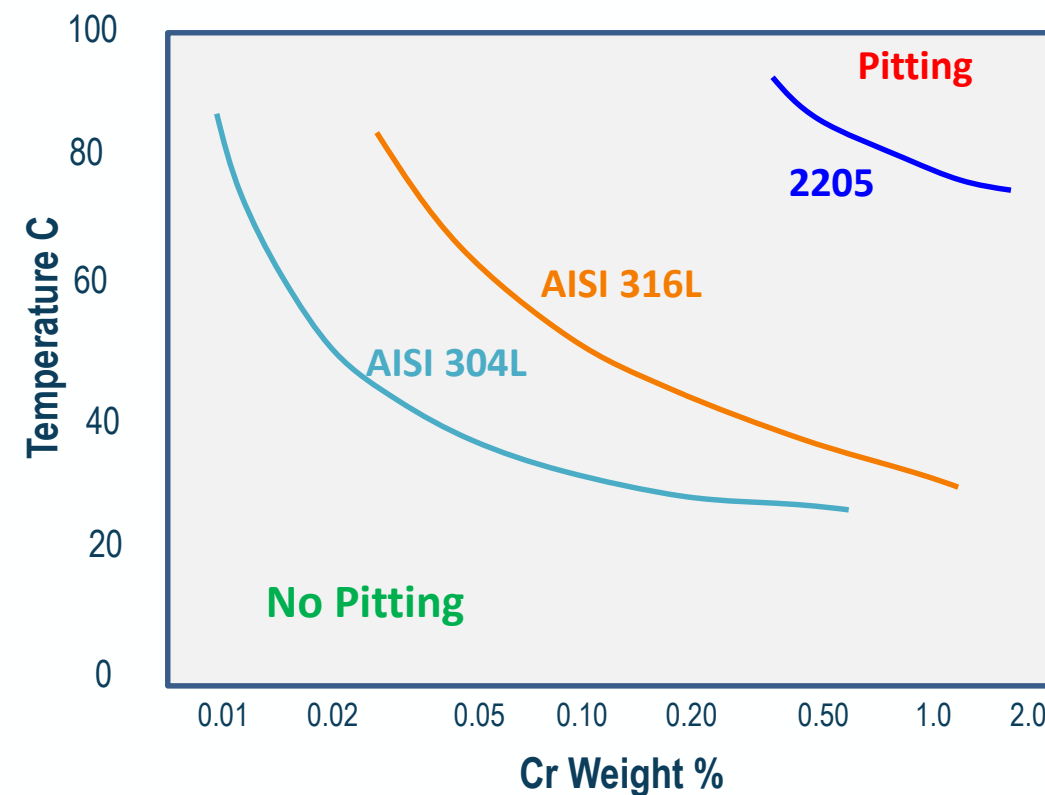
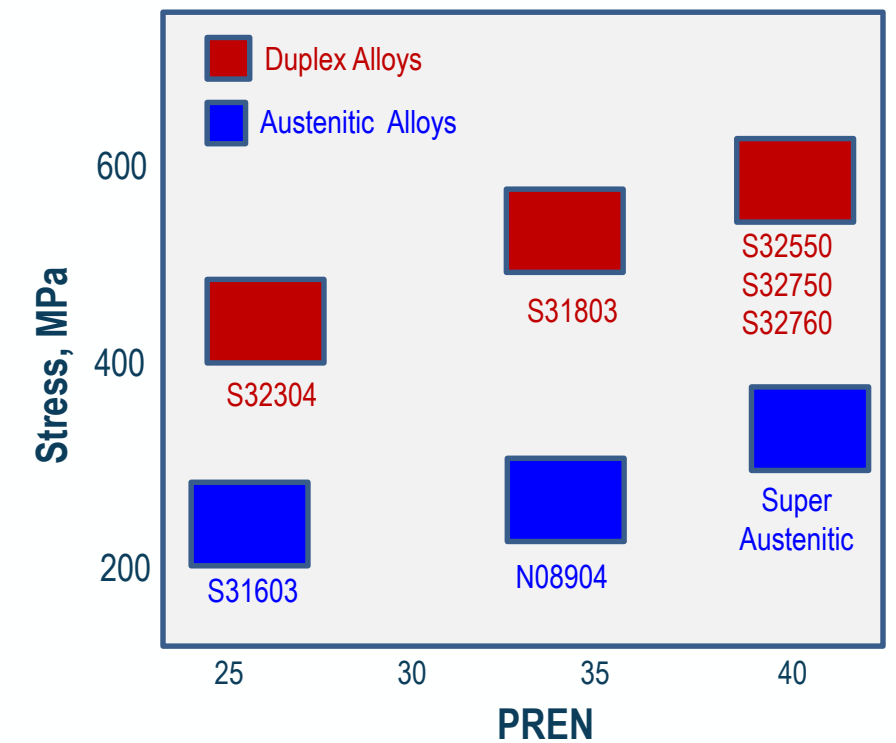
Comparison of the Proof Stress and Pitting Resistance of Duplex and Austenitic SS

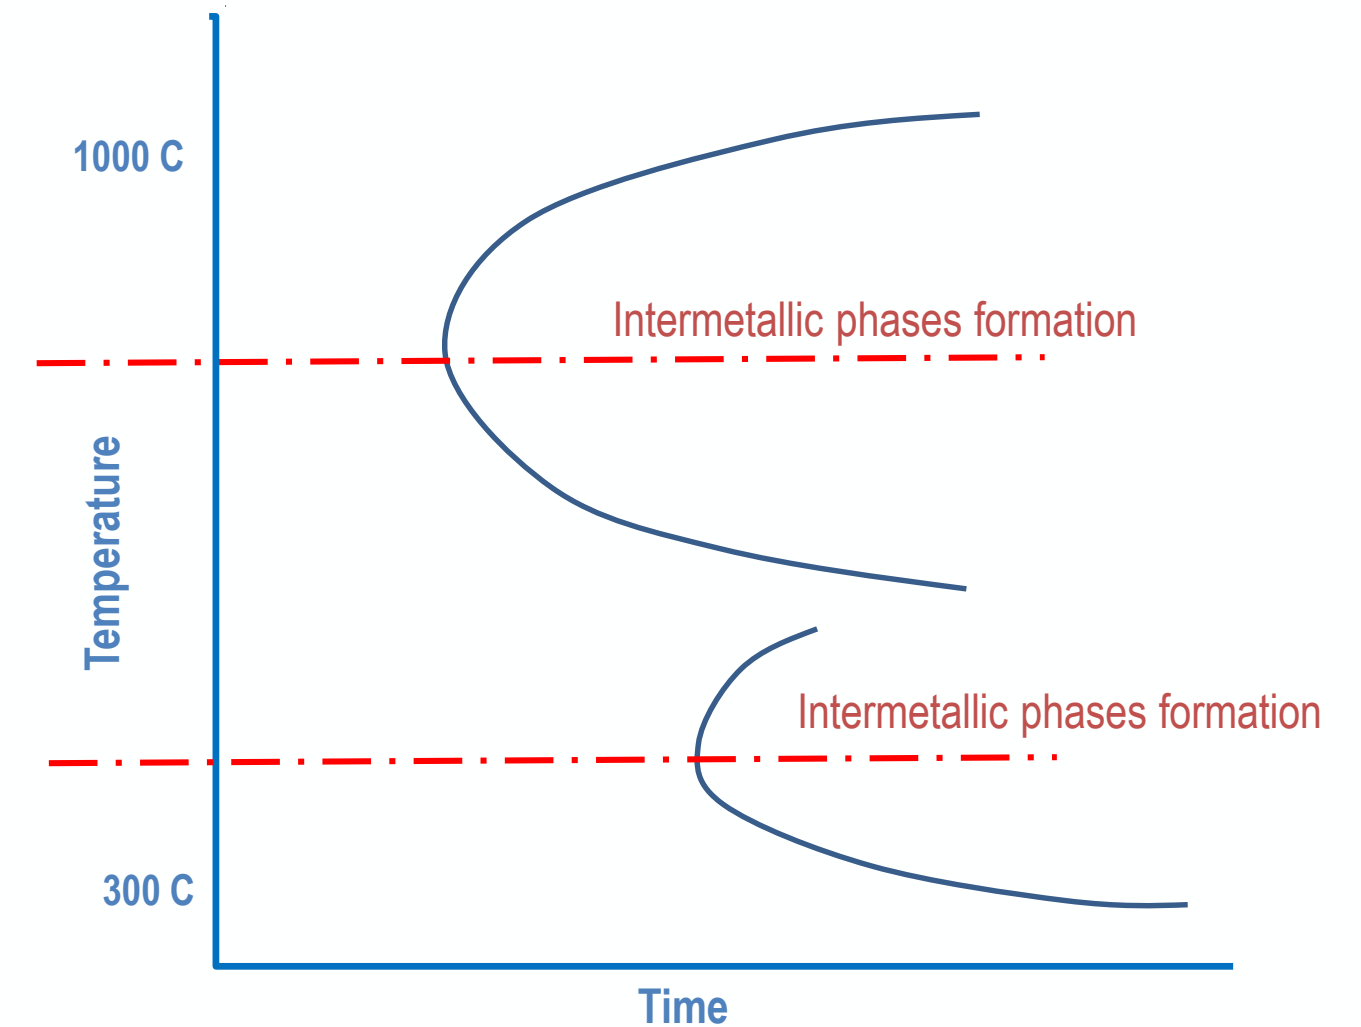
Maximum operating temperatures are limited by the susceptibility of the Ferritic phase to 475 °C (885 °F) embrittlement.

The formation of harmful intermetallic phases results from excessively high heat inputs excessive cumulative time at high temperatures. They are extremely detrimental to impact toughness and corrosion resistance.
