# JUBCOR

**Challenges and Lessons Learned in  
Corrosion Management for Urea  
Solution Storage Tank Bottom Plate**

Presented By  
**Baher Elsheikh**

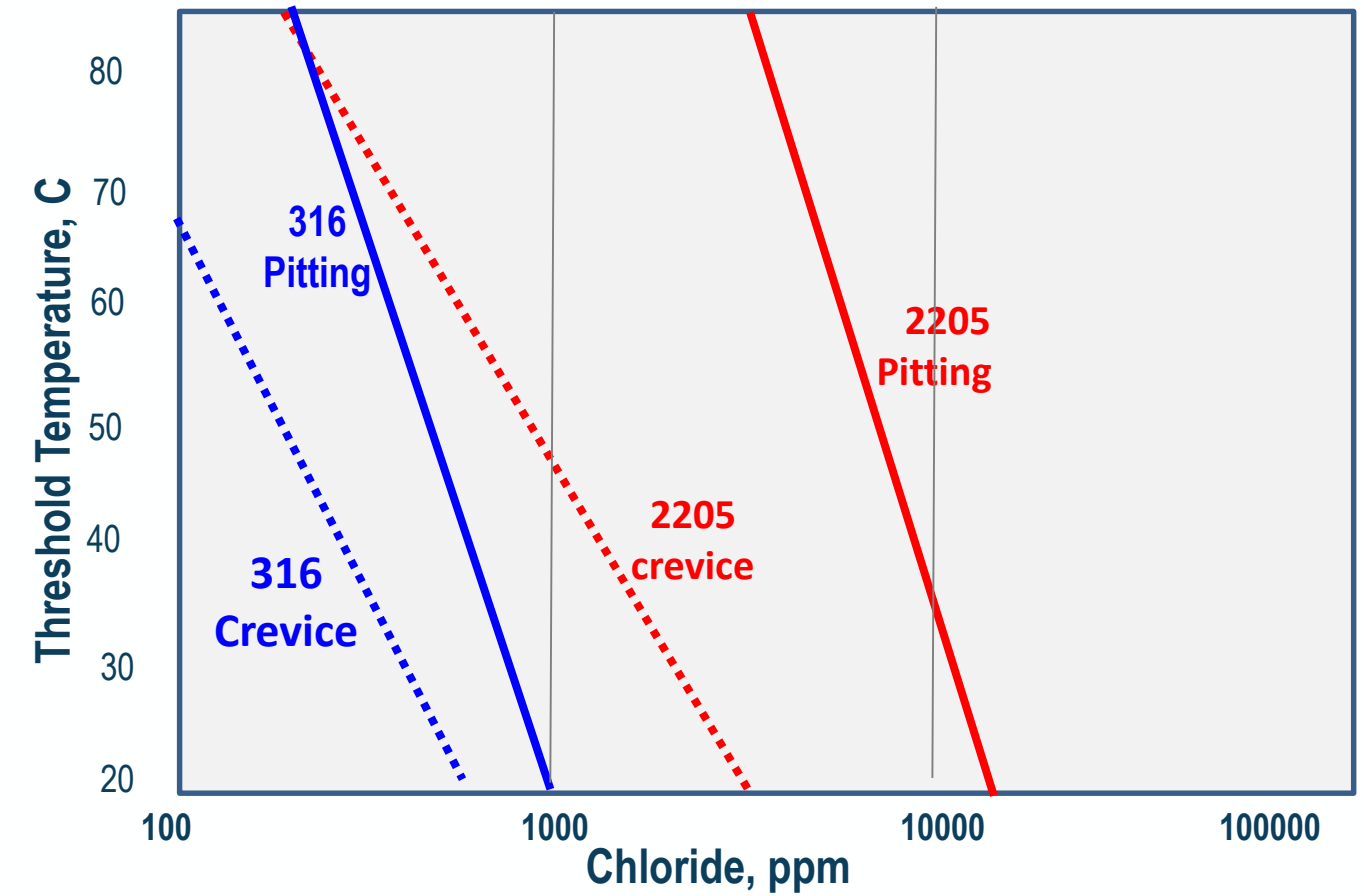
- Sand was not replaced and analysis done in 2008 showed Cl content of 700 ppm
- DSS can be subjected to chloride attack in case of Crevice and under high concentration of chloride and high temperature conditions. the parameters are allocated on the enclosed curve

- While there is no crevice, even at the high temperature (90 C) and high chloride content, pitting attack for DSS is not foreseen. Please see the solid line for 2205 in the enclosed graph. In addition to the findings where the annular plates (away from the crevice area) is not corroded.

Risk of pitting (solid line) and crevice corrosion (dashed line) of higher alloyed stainless steels in oxygen saturated waters with varying chloride levels. Dotted line is a plate heat exchanger.

- Reducing the chloride content to level lower than 100 ppm should protect DSS from being vulnerable to pitting corrosion even in crevice conditions (taking in consideration that actual chloride content can be much higher than measured values outside the crevice).
