NACE JUBAIL TECHNICAL WORKSHOP  
CORROSION UNDER INSULATION (CUI)  
10<sup>TH</sup> December, 2015

## ELIMINATE HIDDEN RISK OF CUI

Hamad Al-Alwani  
AIM Department

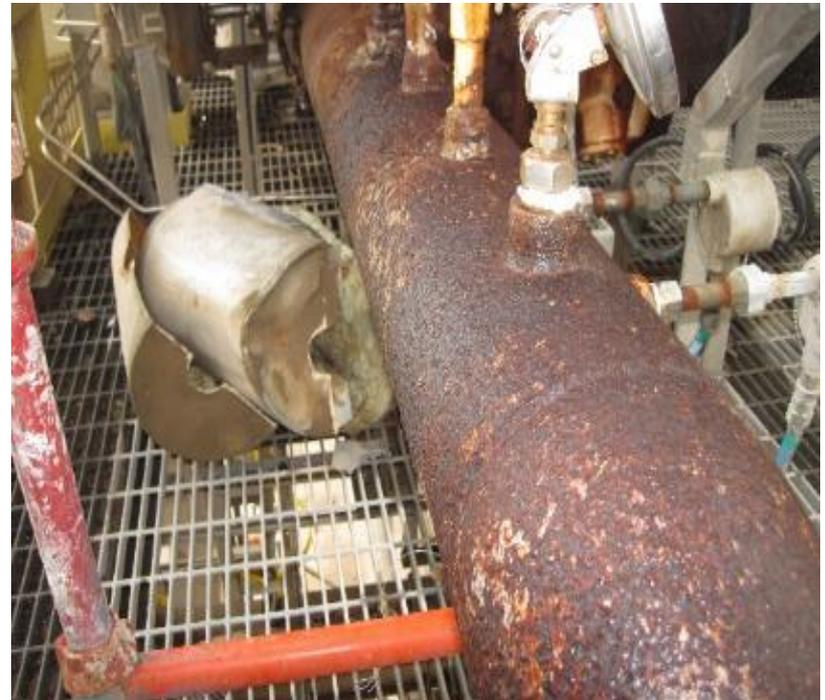
- CUI is an external corrosion that occurs under insulated carbon steel and SS equipment.
- Carbon steel:  $(-12^{\circ}\text{C}) - (175^{\circ}\text{C})$
- Stainless steel:  $(60^{\circ}\text{C}) - (205^{\circ}\text{C})$

- Water vapors condensation.
- Sweating service
- Temperature cycling.
- Poor condition of coating.
- Poor/broken insulation/cladding.

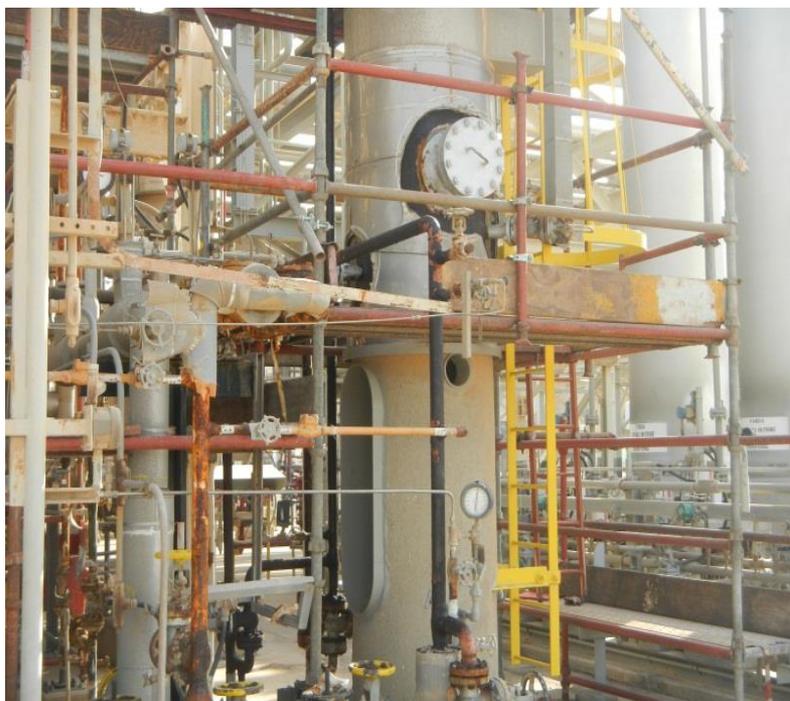
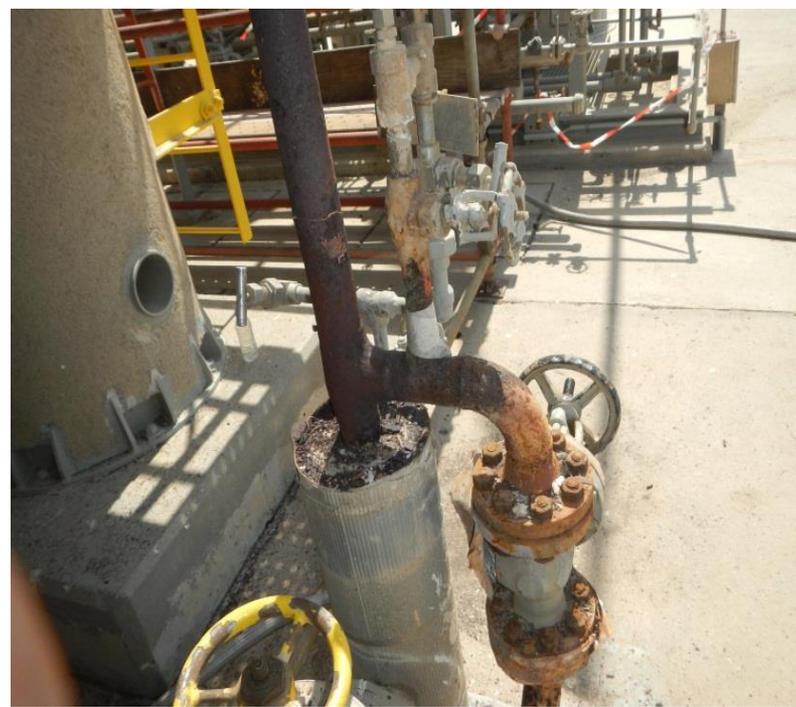
### Line H-14015-3"-C322 Leaking Drain Valve & Corroded Pipe (Hydrogen)

Line #	Line Associated Equipment	Damage	Original Thickness mm	Remaining Thickness mm	Risk Level	Risk status
H-14015-3"-C322	D-1451A	localized pitting	5.54	2.5	2	Mitigated Pipe replaced

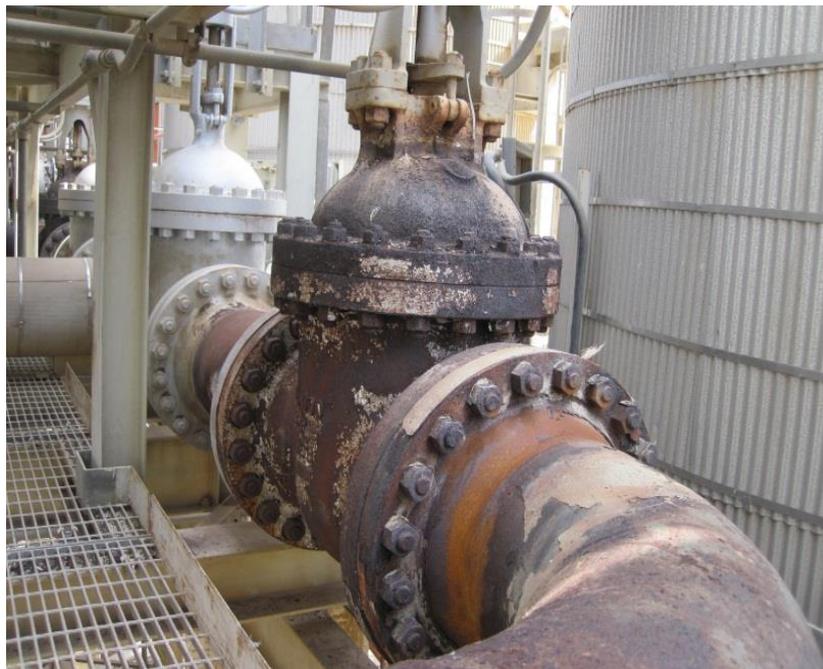
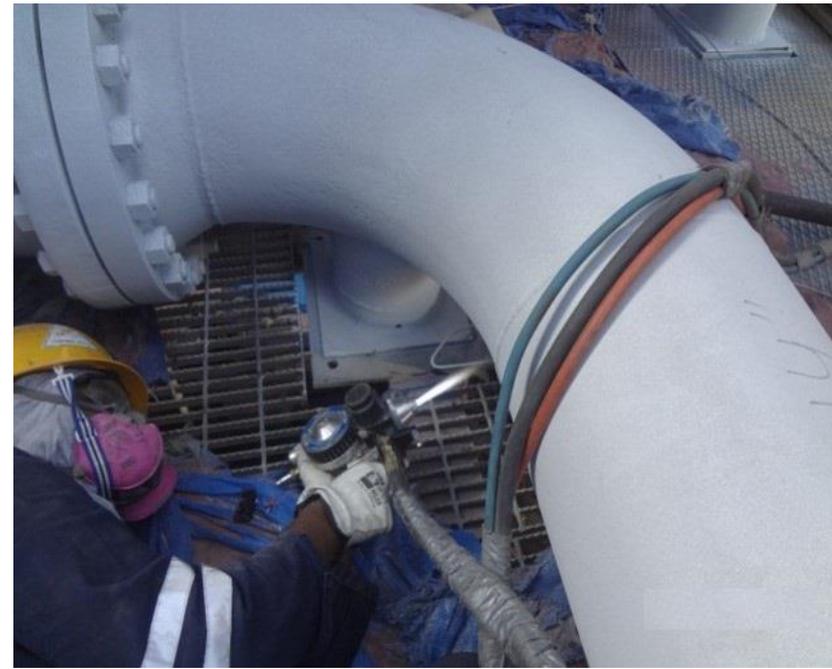
### P-13099A-14"-C322 Process (vapour)

Line #	Line Associated Equipment	Damage	Original Thickness mm	Remaining Thickness mm	Risk Level	Risk status
P-13099A-14"-C322 Process (vapour)	P-13064A-18-C322	General corrosion	9.53	5.45	2	Mitigated Pipe replaced

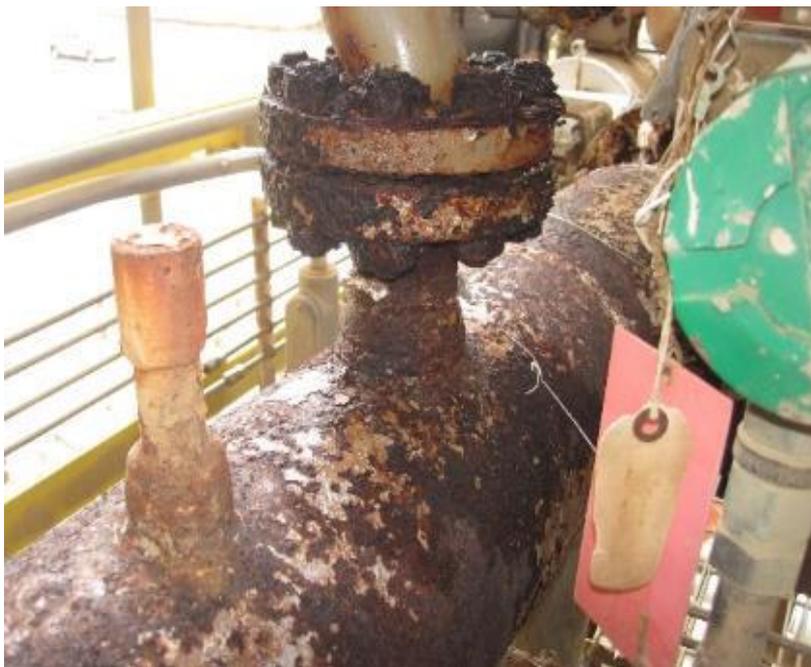
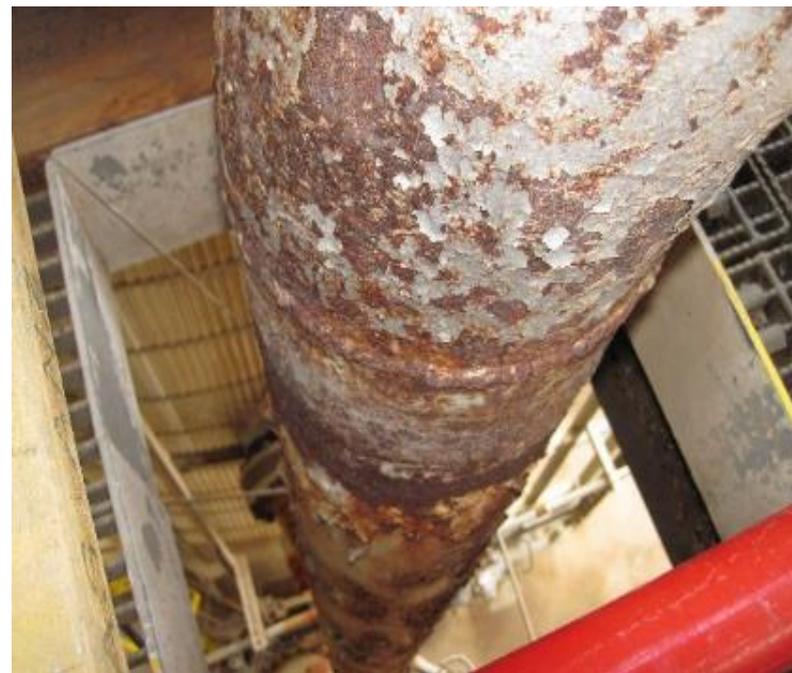
Line 2P-15166- C323

Line #	Line Associated Equipment	Damage	Original Thickness mm	Remaining I Thickness mm	Risk Level	Risk status
2P-15166- C323	D-1451A	Minor wall lost & bolts severely corroded	8.18	7.8	2	Mitigation is in progress

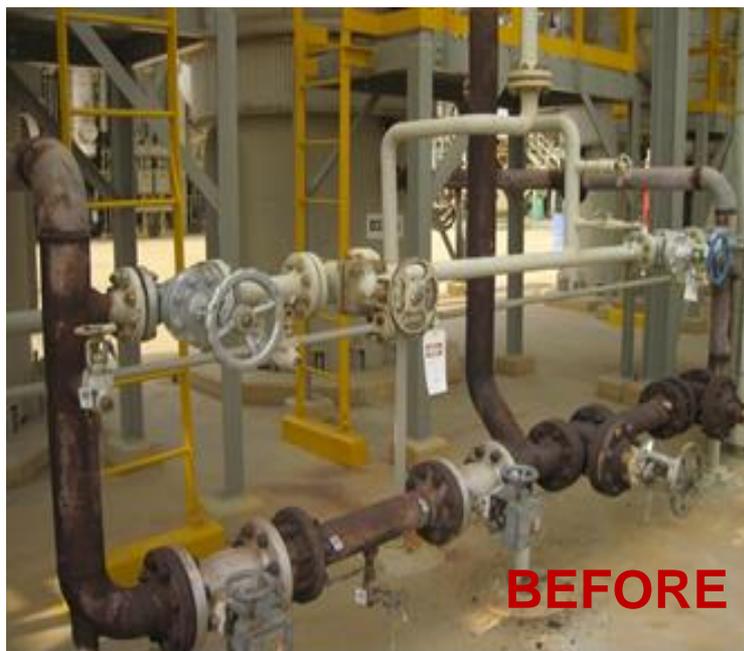
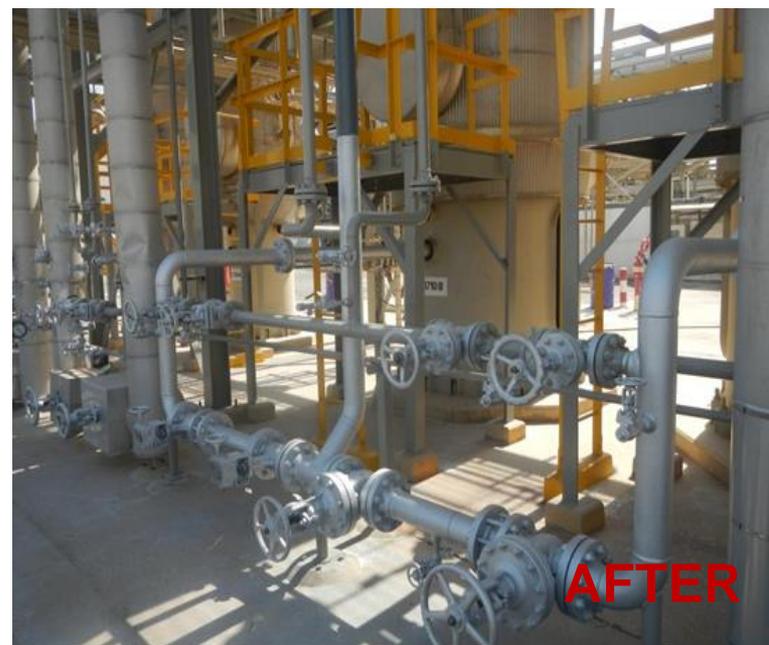
## YANPET PRACTICE WITH PP INSULATION

- Removed all PP insulation and replace it by metallic grid type.
- Personnel Protection (PP) insulation (Piping operating above 60 °C to 110 °C).
- Grid type eliminates the hidden Risk & Operator is still protected from hot surface.
- Grid type cost effective, easy to install, reuse and fast future inspection.

- I. Inspect on time.
- II. Watch insulation damage.
- III. Restoration of CUI Coatings.
- IV. Apply Thermal Spray Aluminum (TSA) on critical services.
- V. Replace PP Insulation with grid metallic type.

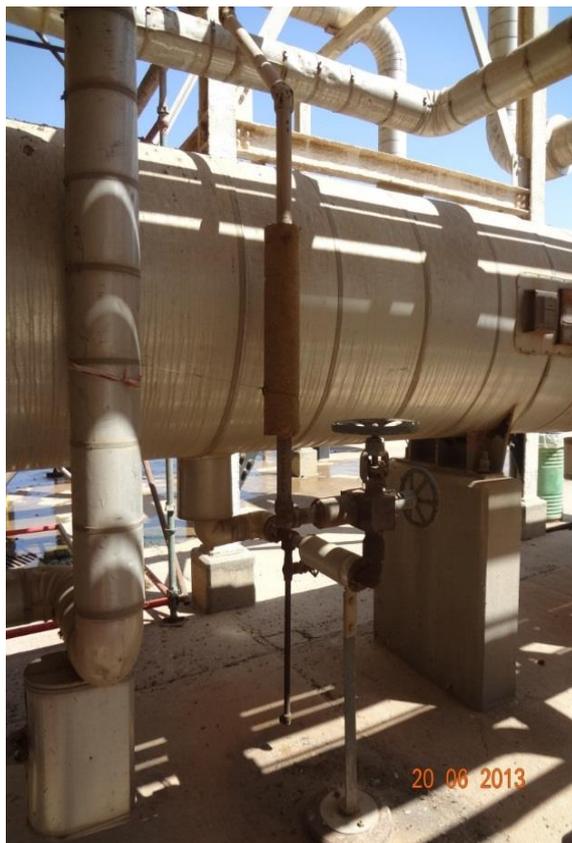
Line covered with old PP insulation

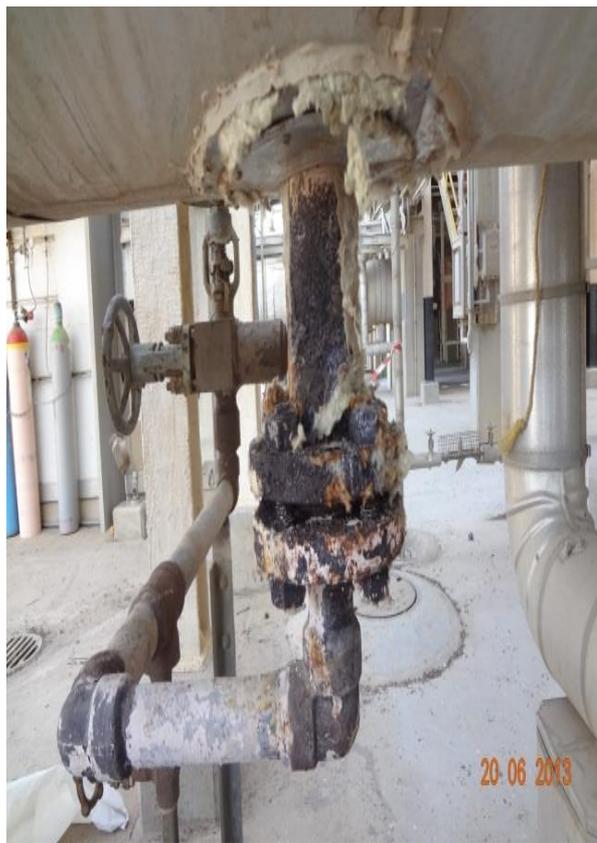
Same line after removing the insulation.
