# Composite Repair Solutions for Corrosion Under Insulation

Presented By : Mr Ron Campbell  
Belzona Polymerics Ltd

18<sup>th</sup> May 2014 **WORKSHOP**  
COATING AND LINING  
for Industrial Application

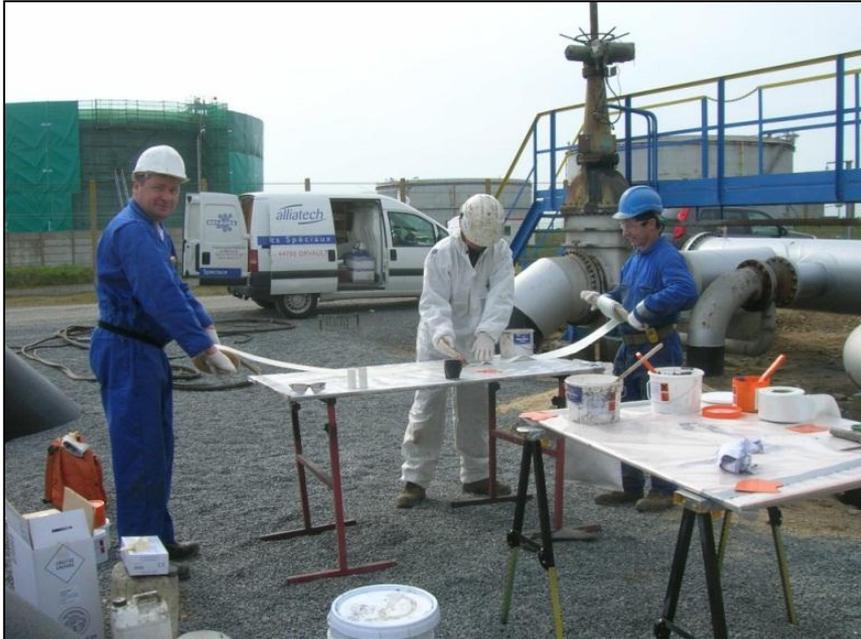
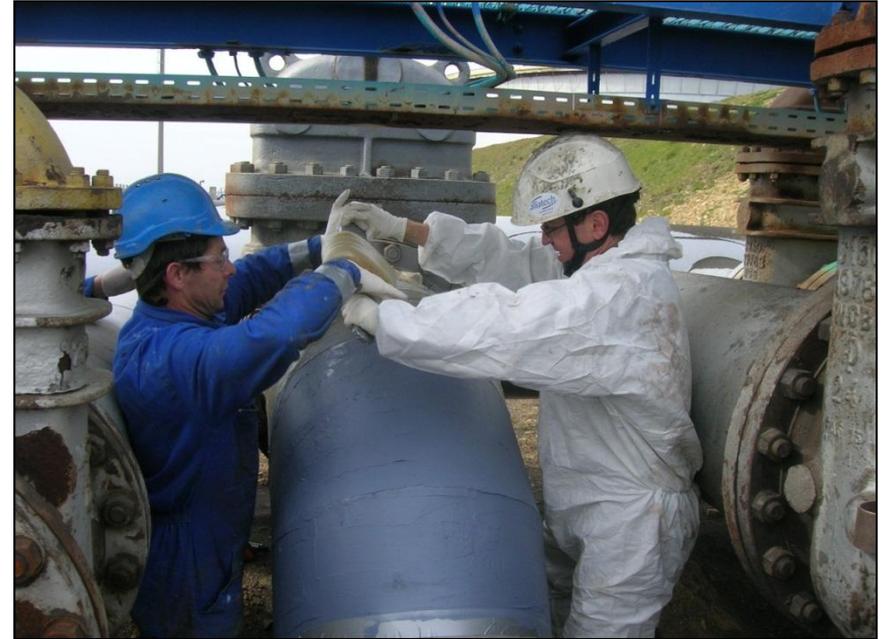
# Compliant Composite Repair Solution – Total Refinery France

Repair to 34" Crude Oil Line suffering localised wall thickness loss from 6.2mm to 2mm operating at a pressure of 19 bar. Composite repair applied at 5mm thickness and 4 layers of composite reinforcement

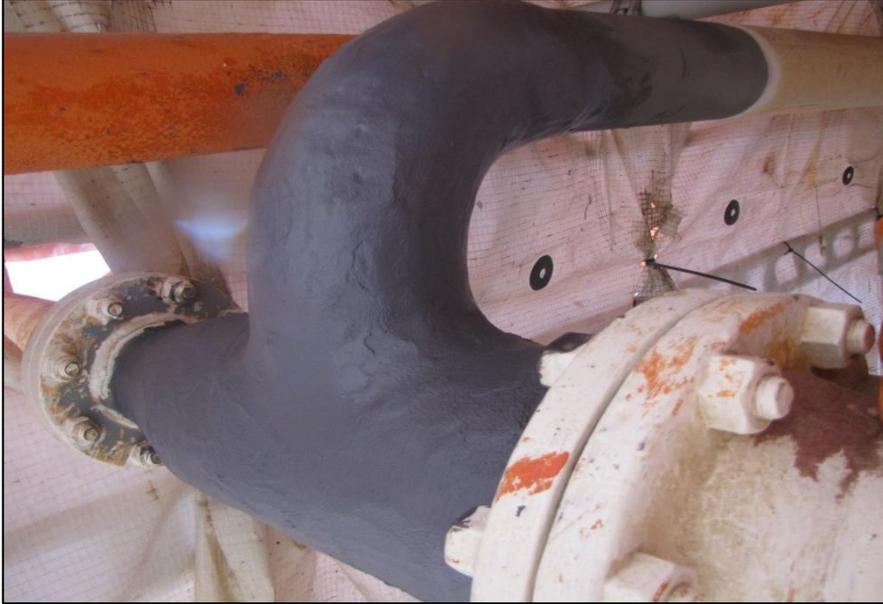
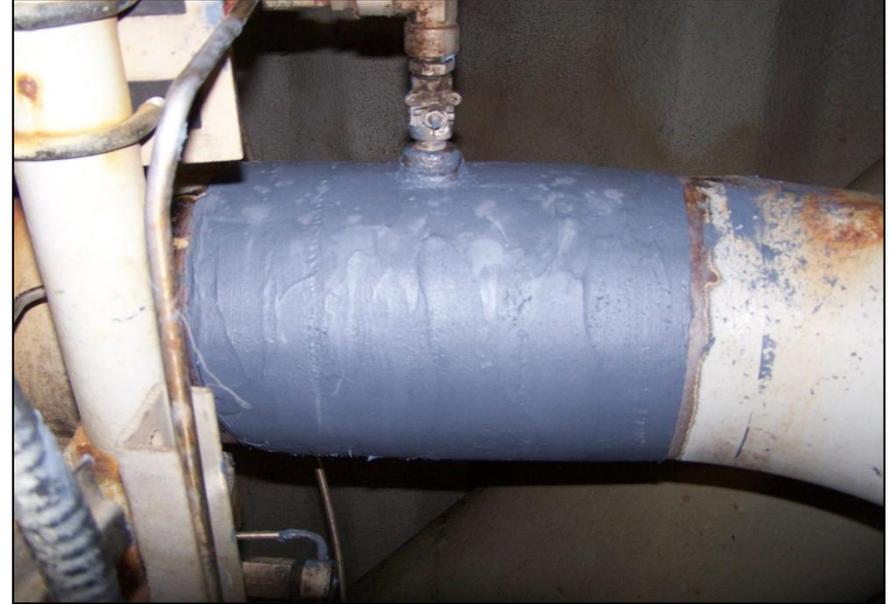
# Compliant Composite Repair Solution – Statoil Production Platform Norway

Repair to various produced water lines suffering localised wall thickness loss and through wall defects operating at a pressure of 80 bar. Composite repair applied at 14mm thickness and 6 layers of composite reinforcement

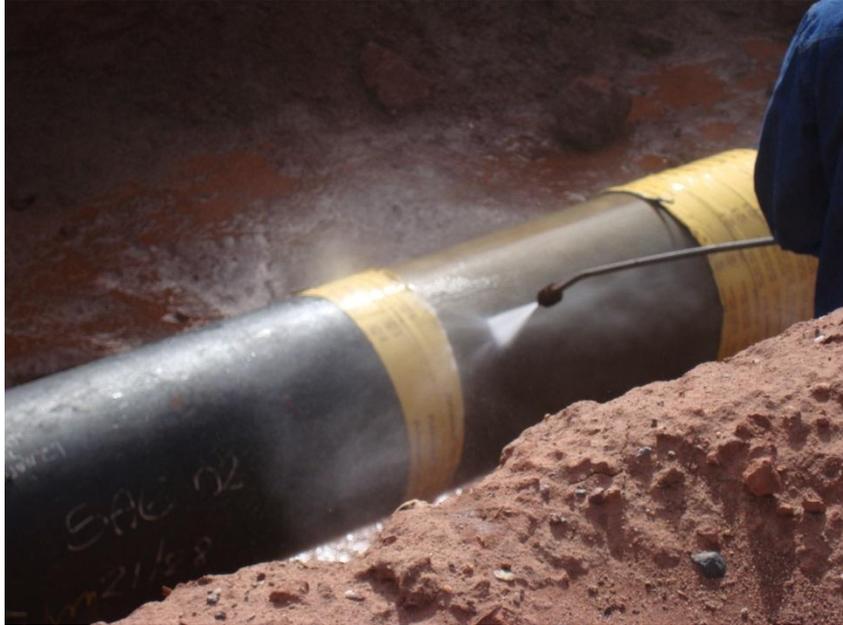
Cleaning using High Pressure  
Water Jetting

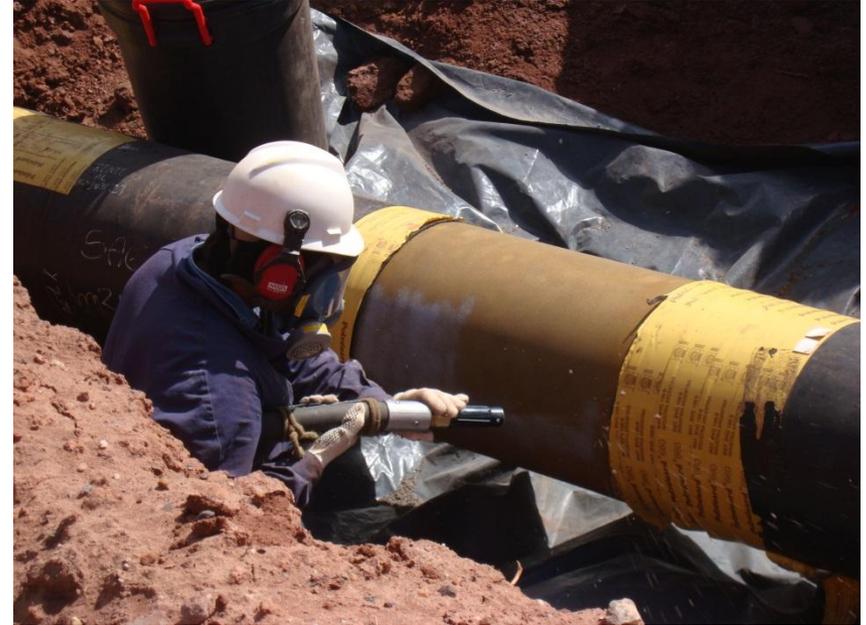
Surface Preparation using Grit Blasting  
to SA2.5 with 75 micron Profile

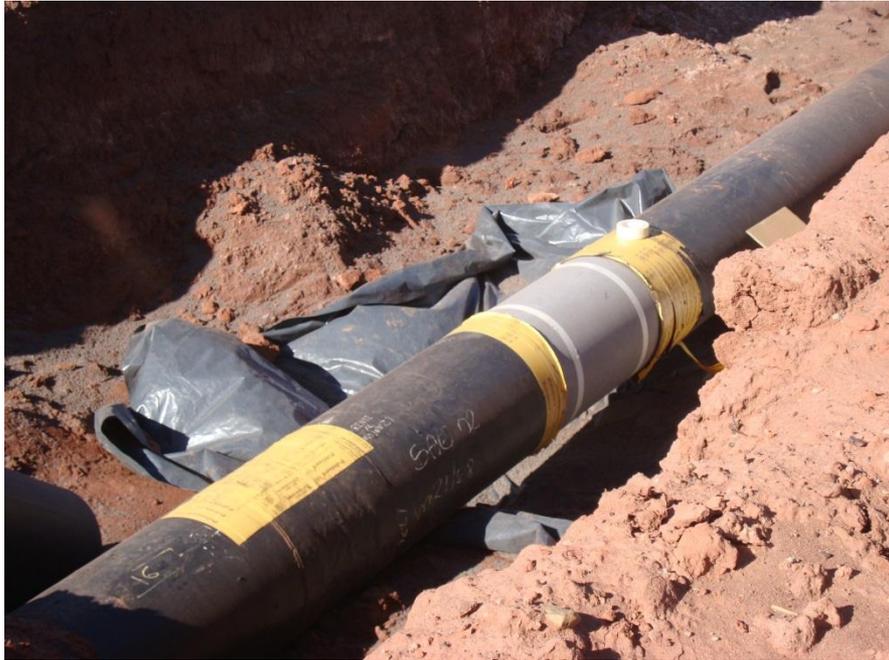
Application of Base Layer of Composite to Repair Pitting

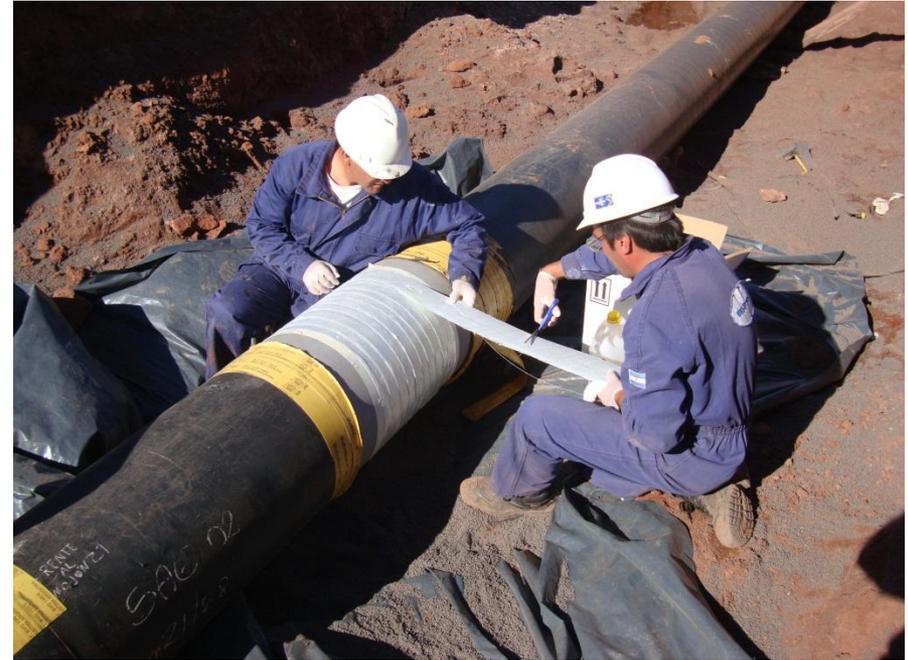
Wrapping of Composite Fibres

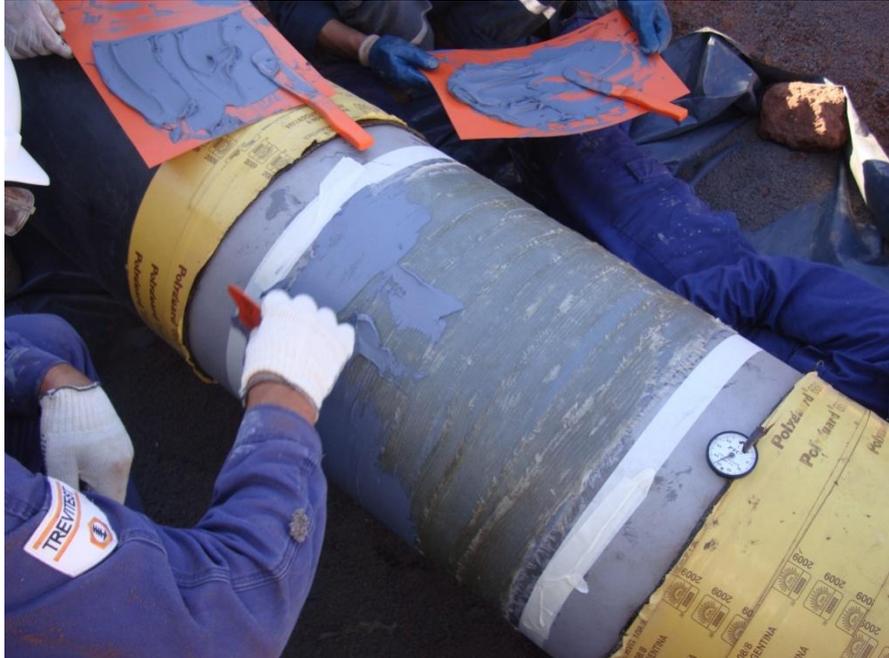
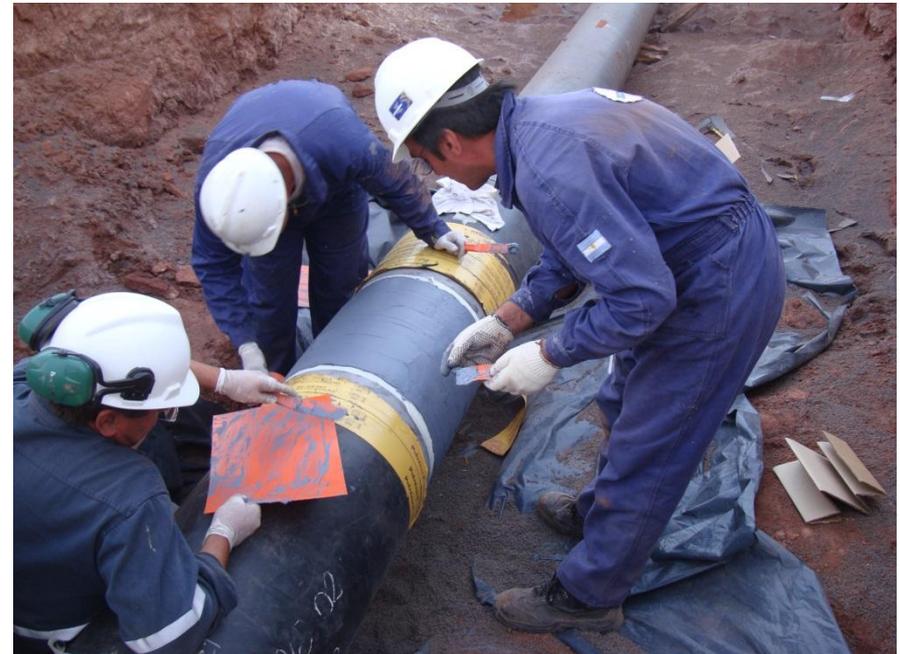
Further Layers of Composite Resins and Reinforcement Fibres applied to Complete the Application.

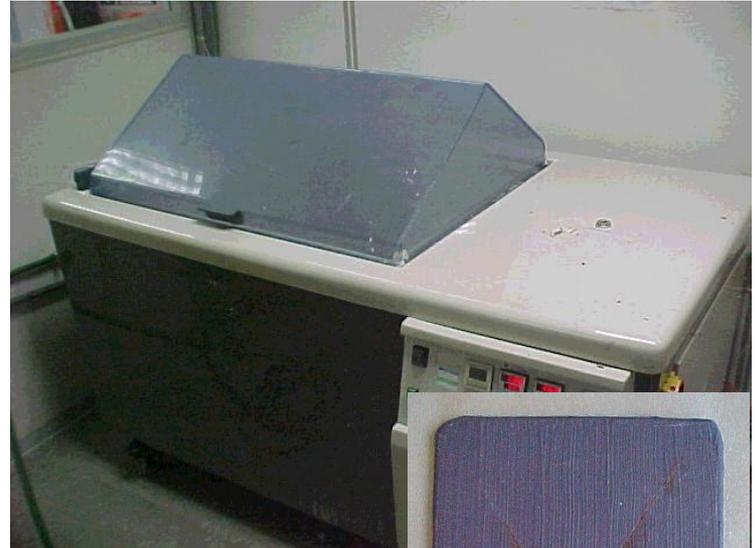
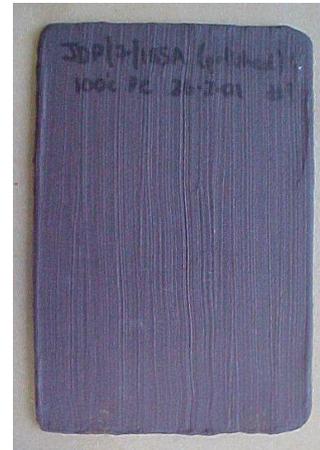
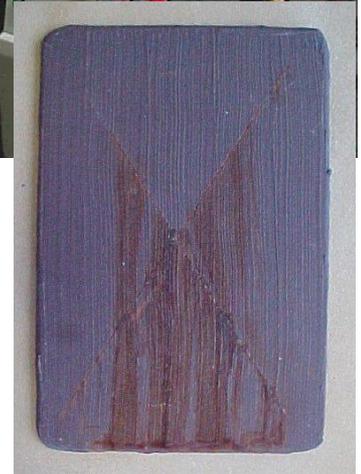
Steel test panels prepared by abrading manually (no profile)  
HA Coating applied onto hot panels and oven cured  
Panels exposed for 1000 hours at 35°C (95°F) in saturated salt fog atmosphere

No field blistering or corrosion  
Minimal corrosion creep under the scribe mark

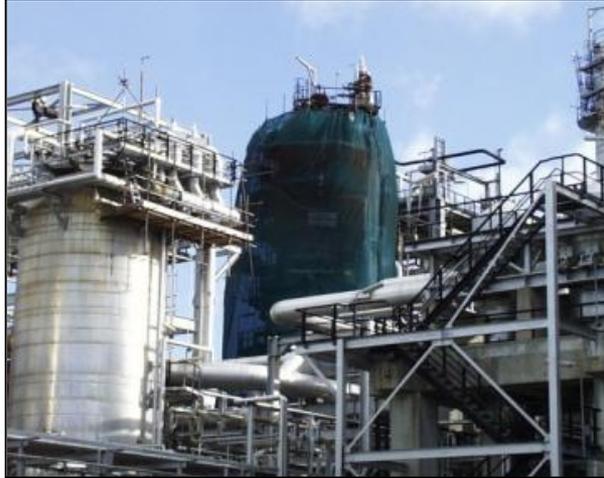
De-Asphalting Column  
in service with operating  
of 120 C

**Ongoing Inspection shows no deterioration of the coating  
after 11 years in Service.**

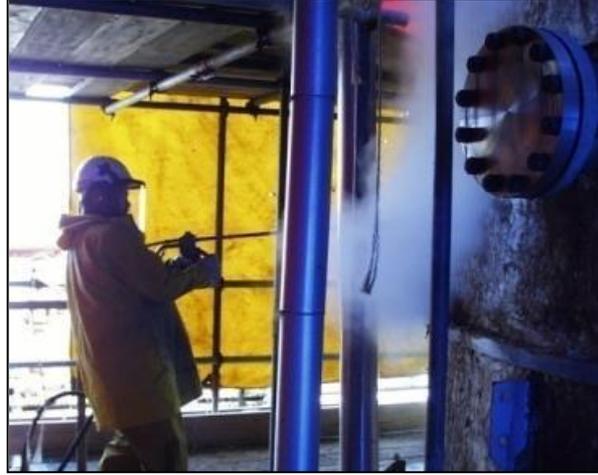
Surface Preparation Carried  
out Using High Pressure  
Water Jetting

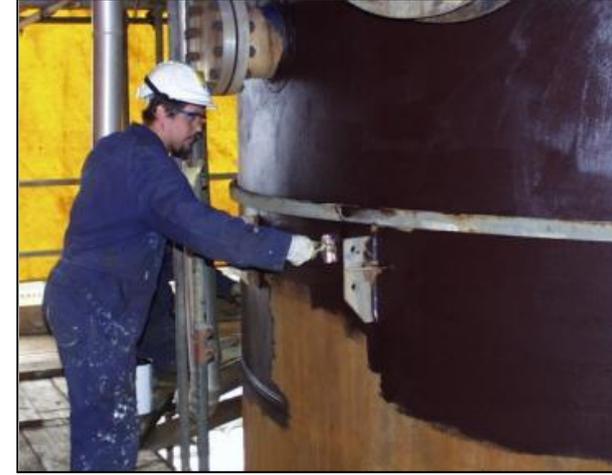
Application of Heat  
Activated Coating System  
using rollers  
and brushes

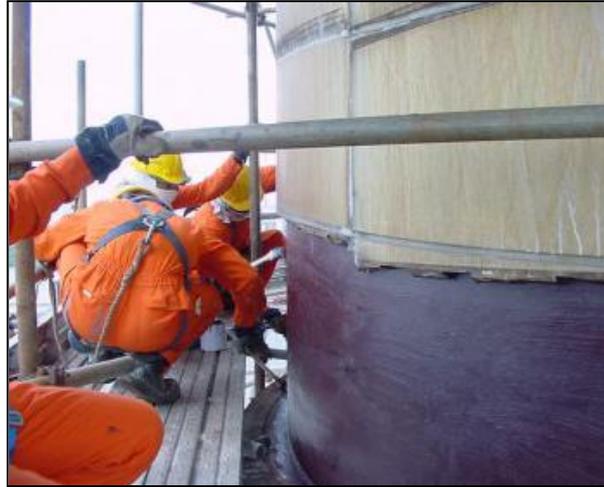
Surface preparation carried  
out using scrapers to remove  
loose rust to ST2 finish

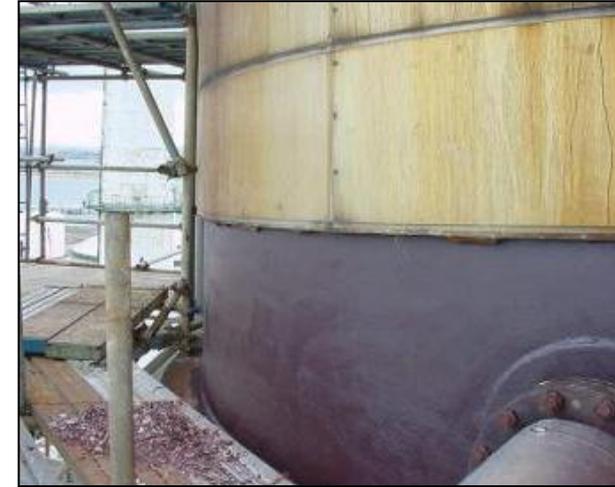
Application of Heat  
Activated Coating System  
using rollers and brushes

**Ongoing Inspection shows no deterioration of the coating  
after 13 years in Service.**

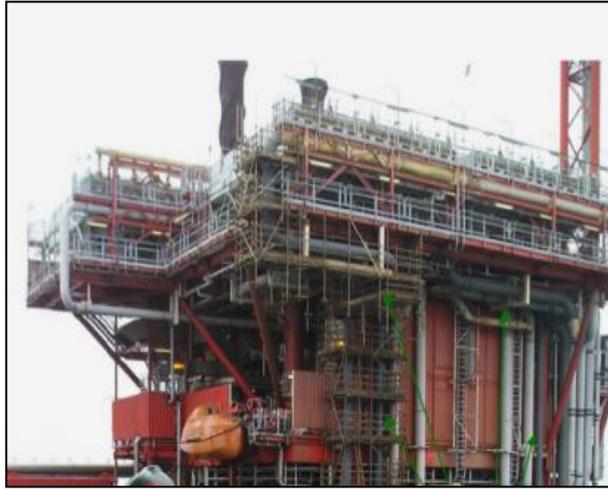
Gas - Condensate Pipework operating at temperatures up to 115C

**Ongoing Inspection shows no deterioration of the repairs and after 9 years in Service.**

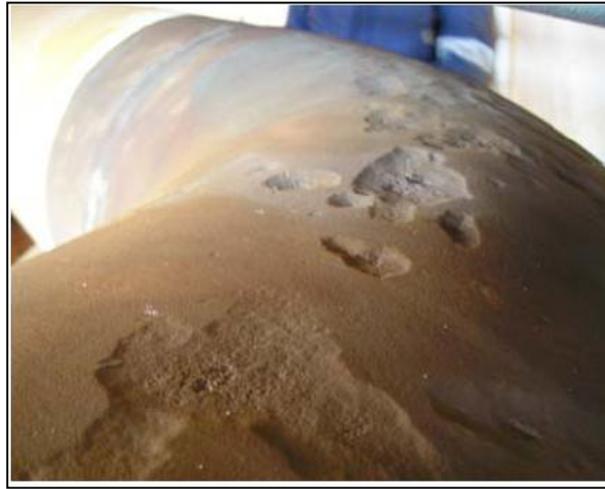
Surface preparation carried out using high pressure water jetting

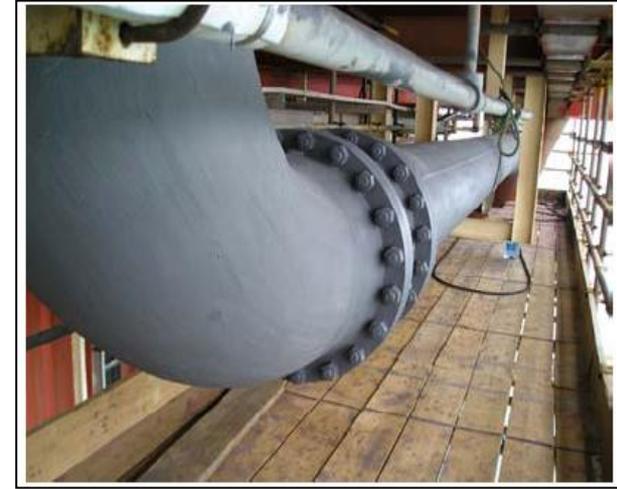
Heat Activated Composite wrapping and coating carried out on-line

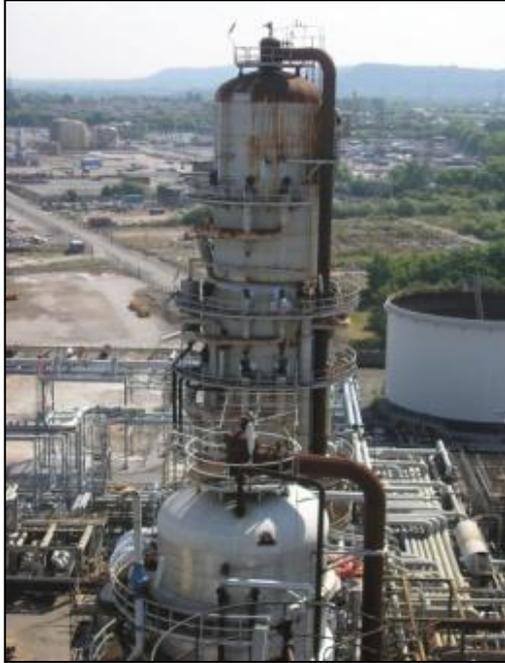
Severe CUI on distillation columns and fractionator towers operating between 50-120°C

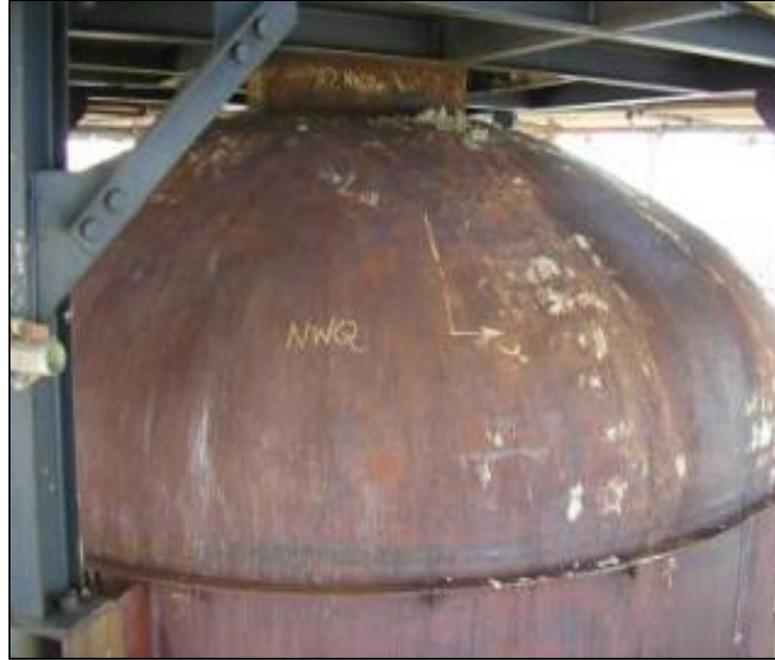
Manual preparation of the steel substrate using scrapers and wire brushes

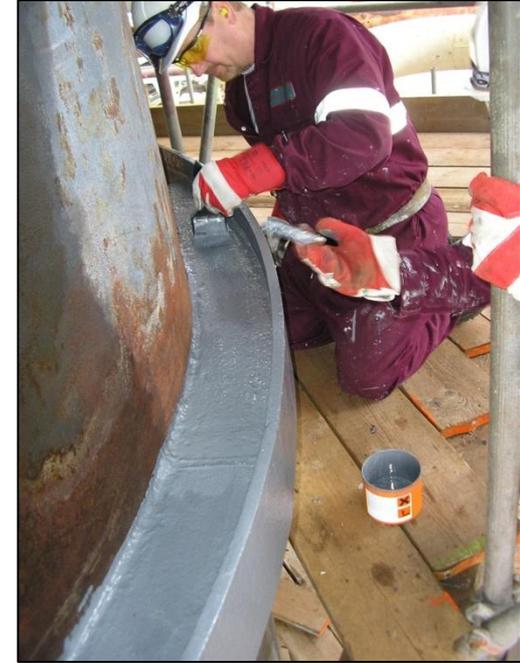
Application of Heat Activated Coating System to Manually Prepared Surfaces
