PITTING CORROSION OF CS HEAT EXCHANGER TUBE OF PROCESS GAS COOLED HEAT EXCHANGER

Prepared By: Mohammed Omer AbuALRub
Asset Engineering Dept.
SABIC Affiliate - Saudi Arabian Fertilizer Co (SAFCO)

April 2017

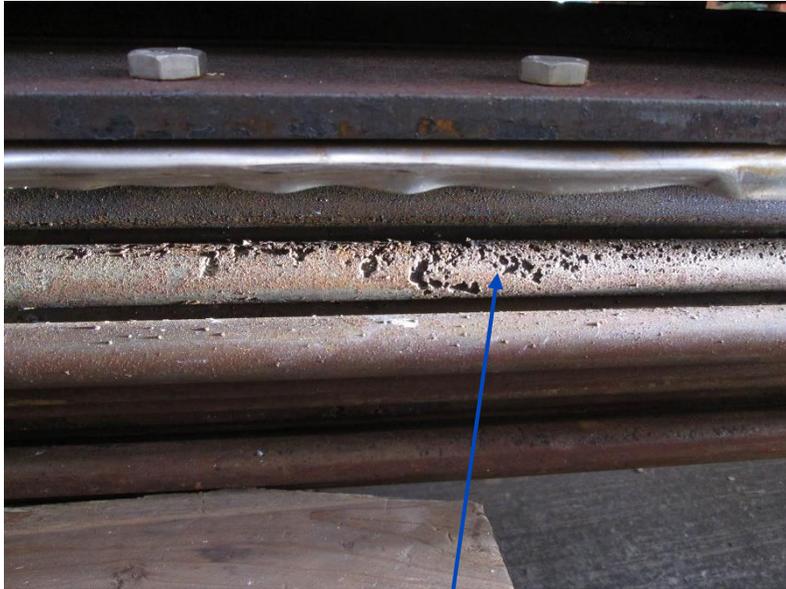
PITTING CORROSION OF CS TUBE

- Tube bundle was pulled out from the shell and localized pitting corrosion attack found on the tube external surface.
- Baffle plates found free from pitting corrosion
- Channel head and shell internal surface found free from pitting corrosion
- Tubes internal surface found free from corrosion attack
- Tube to tube sheet weld joints found free from defects
- Tubes were inspected by MFL NDT technique.

Slightly deep corrosion pits

- 1) Tubes with deep corrosion pits were plugged from both sides of the tube.
- 2) Tubes with shallow corrosion pits were left and kept under monitoring.
- 3) Shell side hydro test to ensure integrity of the tube bundle.

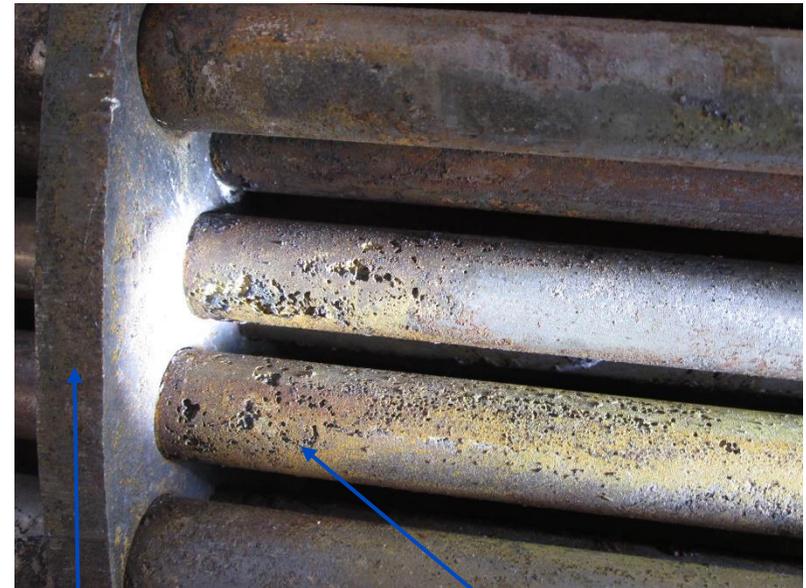
Baffle plate w/o signs
of corrosion pits

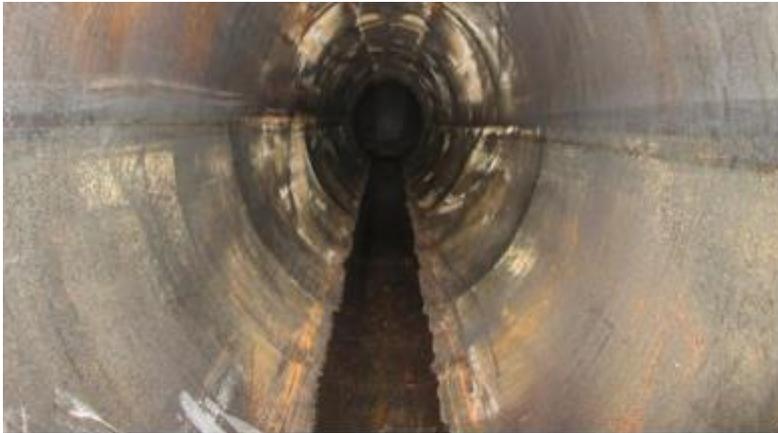
SHELL INTERNAL SURFACE

Internal surface of the shell
w/o signs of corrosion pits
