# MHG Business and Field Applications presented to NACE, Jubail Chapter December 2010

**Physical Acoustics**

## Tank testing services

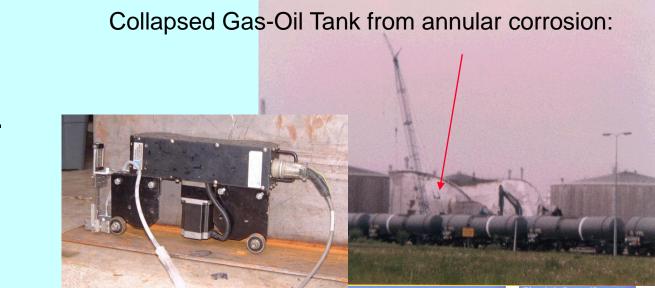
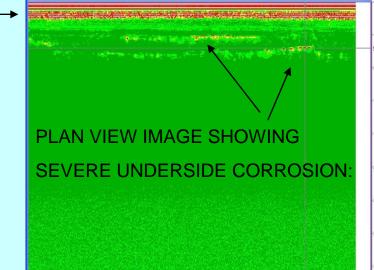
### TALRUT Annular Ring Test

- » Inspects critical area, ~30cm in.
- » Automated UT, Plan image.
- » 40 m/day.
- » Indicative, not quantitative.

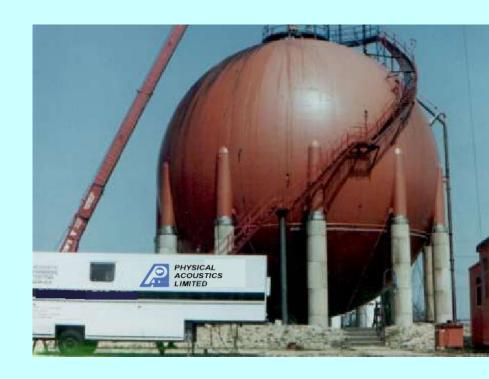
### AE-Storage Spheres and Bullets

- Majority tested on-line using MONPAC<sup>™</sup> procedure (Monsanto licence based on >1000 tests).
- Pressure raised by product or gas injection.
- Abseilers used for sensor placement.
- 95% "good" resulting in continued operation.
- >1000 tests in Europe.
- Procedure adopted by ASME for new vessels.

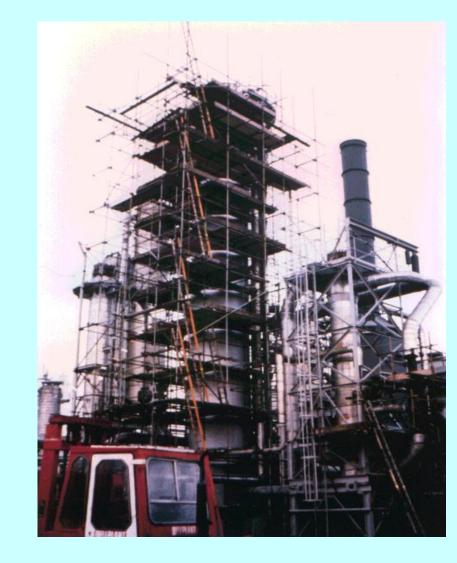
### Ammonia Converter

- Multi-layer construction not inspectable conventionally, layers transmit LF sound at higher pressures.
- Thermal stress during startup/cool-down is main concern.
- Waveguides used due to the temperature.
- "Signature" from AE source location is compared at each startup/shutdown.

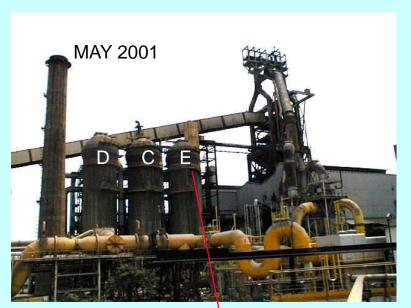
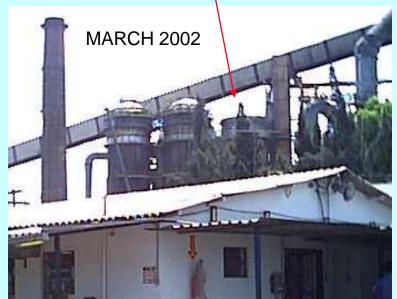
# Steel-Hot Blast Stove Dome-Example (or "don't ignore E- grades")

- Concern about nitrate Stress Corrosion Cracking.
  - » Stove Dome has blown off in several countries!!
- ~32 AE sensors on each of three stoves.
- In-service monitoring for 24 hours per stove.
- Serious problems identified by AE test, c/d/e grades.
- Results not acted upon.
- Stove dome blows off 10 months later!!!

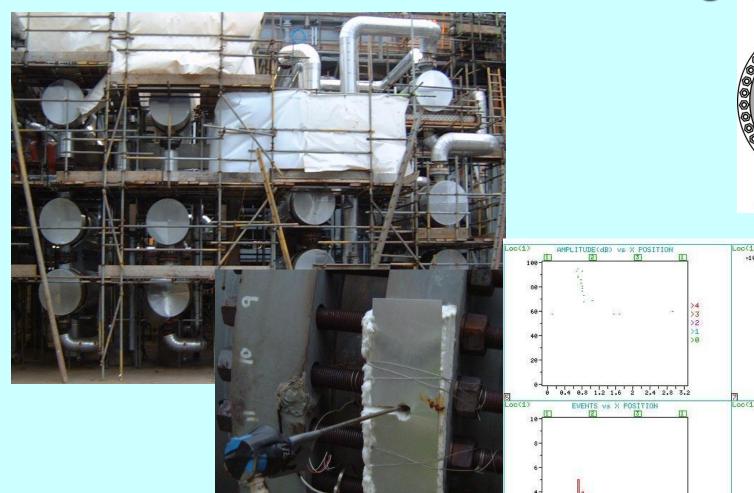
14 Heat Exchangers-Bolt Cracking Extended Permanent Monitoring

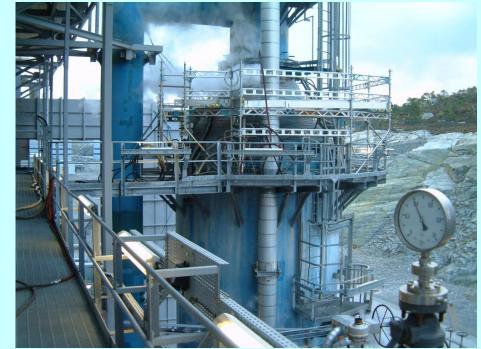
### Methanol Secondary Reformer Continuous "Alarm" Monitoring

- Refractory lined vessel.
- Hydrogen and steam at 40 bar and 780>1300 deg.C.
- 100mm thick shell.
- "Blow-Out" at another unit is reason for alarm system.
- Refractory failure results in shell burn-through in less than 2 minutes.
- Thermal monitoring too slow to stop burner.

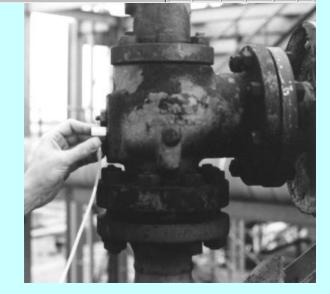
# VPAC-Quantification of through-

valve leakage

- BP Licence.
- Intrinsically safe.
- Simple/quick.
- Quantitative: litres/min.
- >500 systems in use.
- Savings:
  - » BP Kwinana 14k tons/yr.
  - » Mobil US \$3m to \$12m/site.
  - » Shell UK 3-5 systems/site.

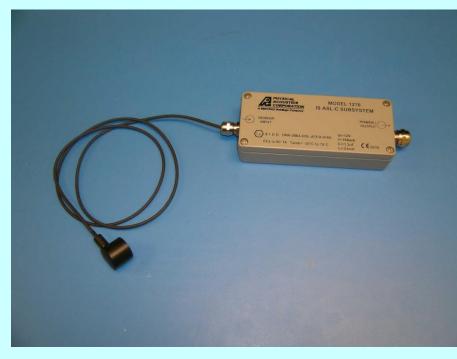
# Process Monitoring and Leak detection 1276-IS-ASL (Series of I.S. systems)

- ASL series has 4-20ma output to DCS or PIE.
- Intrinsically Safe, uses standard barriers.
- Custom configurations for:
  - » Leakage through valves.
  - » Leakage in pressure systems.
  - » Airborne leakage in boilers.
  - » Airborne leakage in offshore modules\*.
  - » Simple Particle Monitoring to control erosion.
  - » Pig detection and monitoring.
  - » Burners.
  - » Mixing and blending operations of minerals and pharmaceuticals.
- 1276 I.S. pre-amplifier and sensors for AE monitoring.

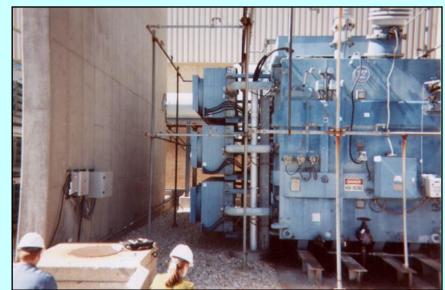
### Power Transformers

- R+D, procedure verification:
  - >>500 tests since 1982
- Code: EPRI recommended practice.
- Acceptance: EPRI, all XF Manuf.,
- Usage:
  - » GEC Alstrom
  - » ABB
  - » VA Tech
  - » NP, NGC, other generators and distributors, I.C.I. (chlorine) etc
- Method:
  - » AE during normal operation.
  - » AE during test.
  - » AE continuous monitoring.

AE due to winding fault, and source location from a range-changer fault.
