Rehabilitation and Cathodic Protection of Reinforced Concrete Seawater Cooling Towers

NACE -JUBAIL SECTION
JUBAIL Intercontinental Hotel, September 27, 2010

Dr. Zia Chaudhary
MATERIALS & CORROSION SECTION
SABIC TECHNOLOGY CENTER-JUBAIL

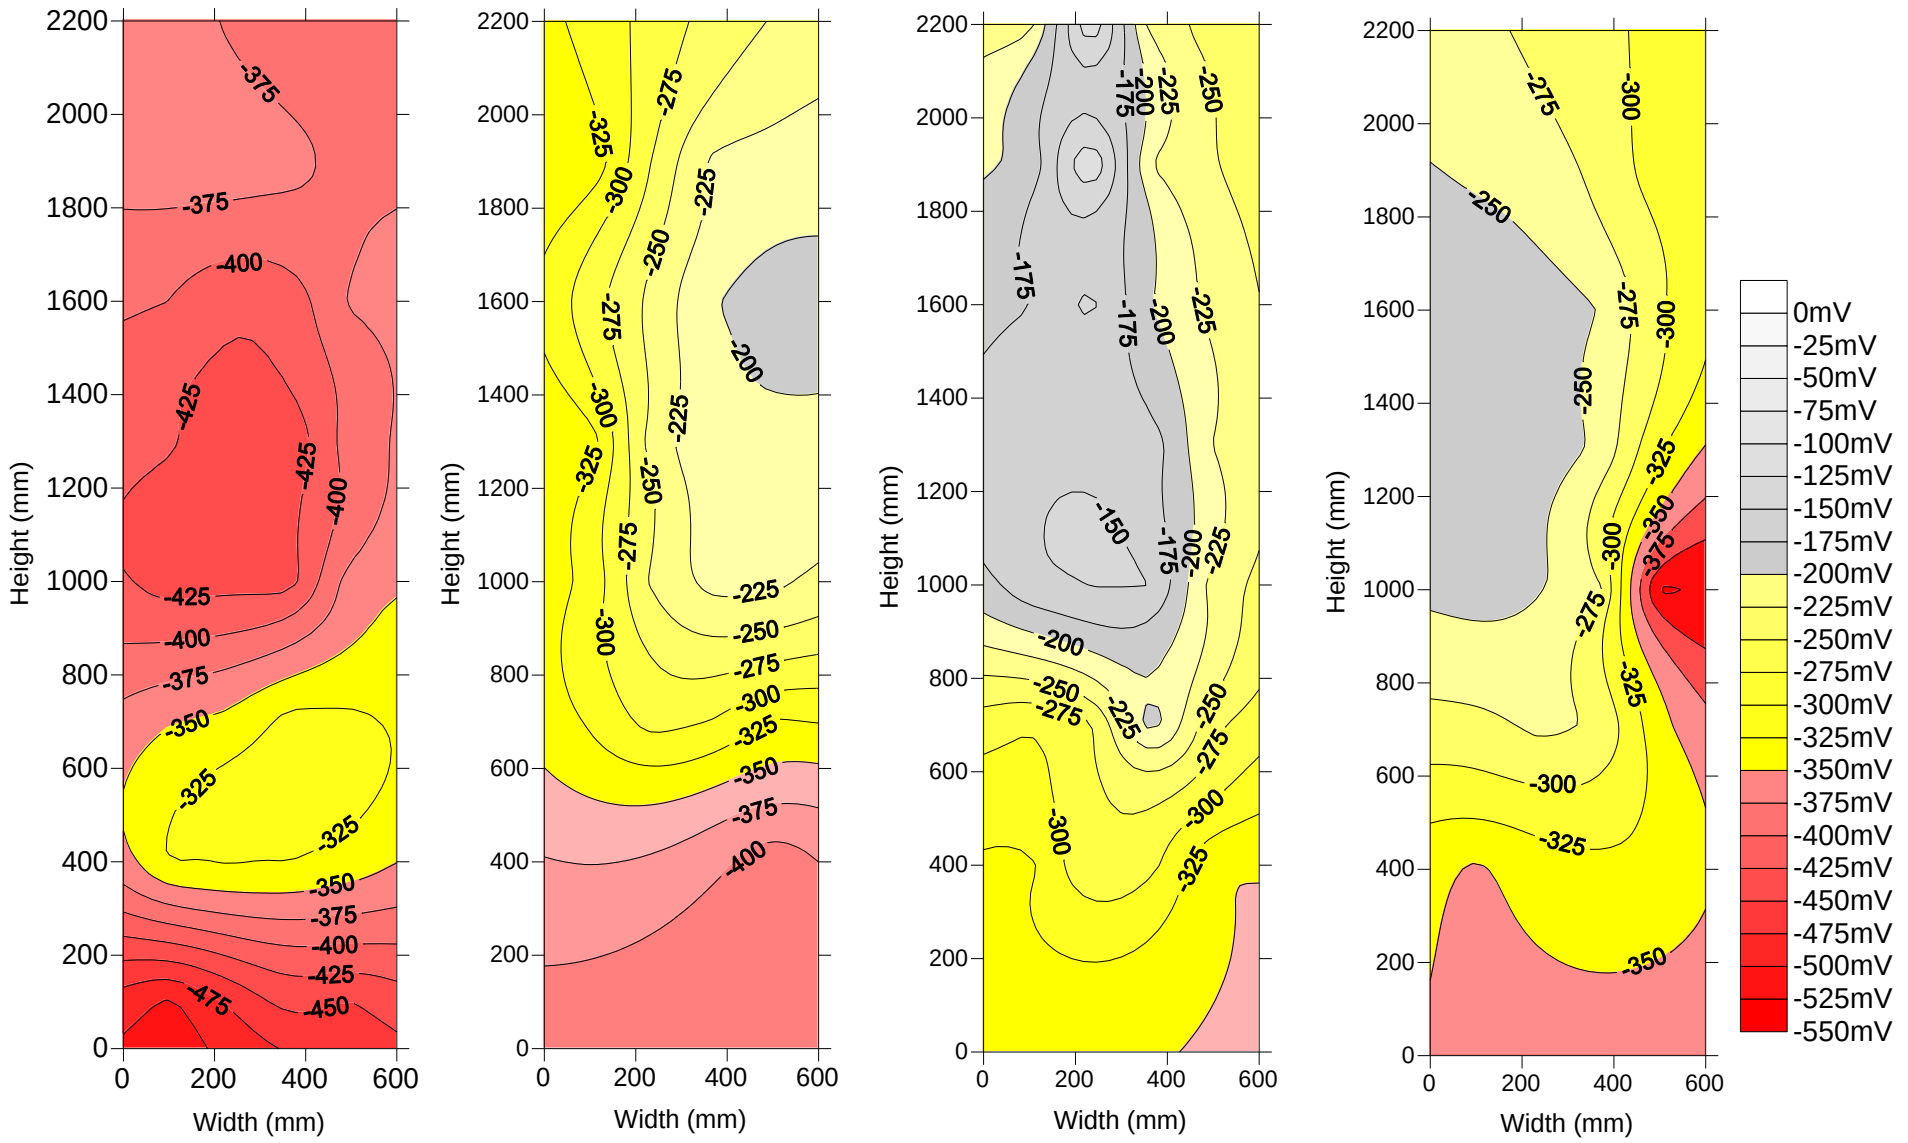
POTENTIAL MAP OF COLUMN#2.

Investigation	Observation
Steel Half-Cell Potentials (HCP)	44% data showed 95% corrosion risk. 40% data showed 50% corrosion risk.
Corrosion Rate (CR)	60% results showed "High" CR >1.0 uA/cm^2 20% results showed "moderate to high" CR i.e., 0.5 to 1.0 uA/cm^2 .

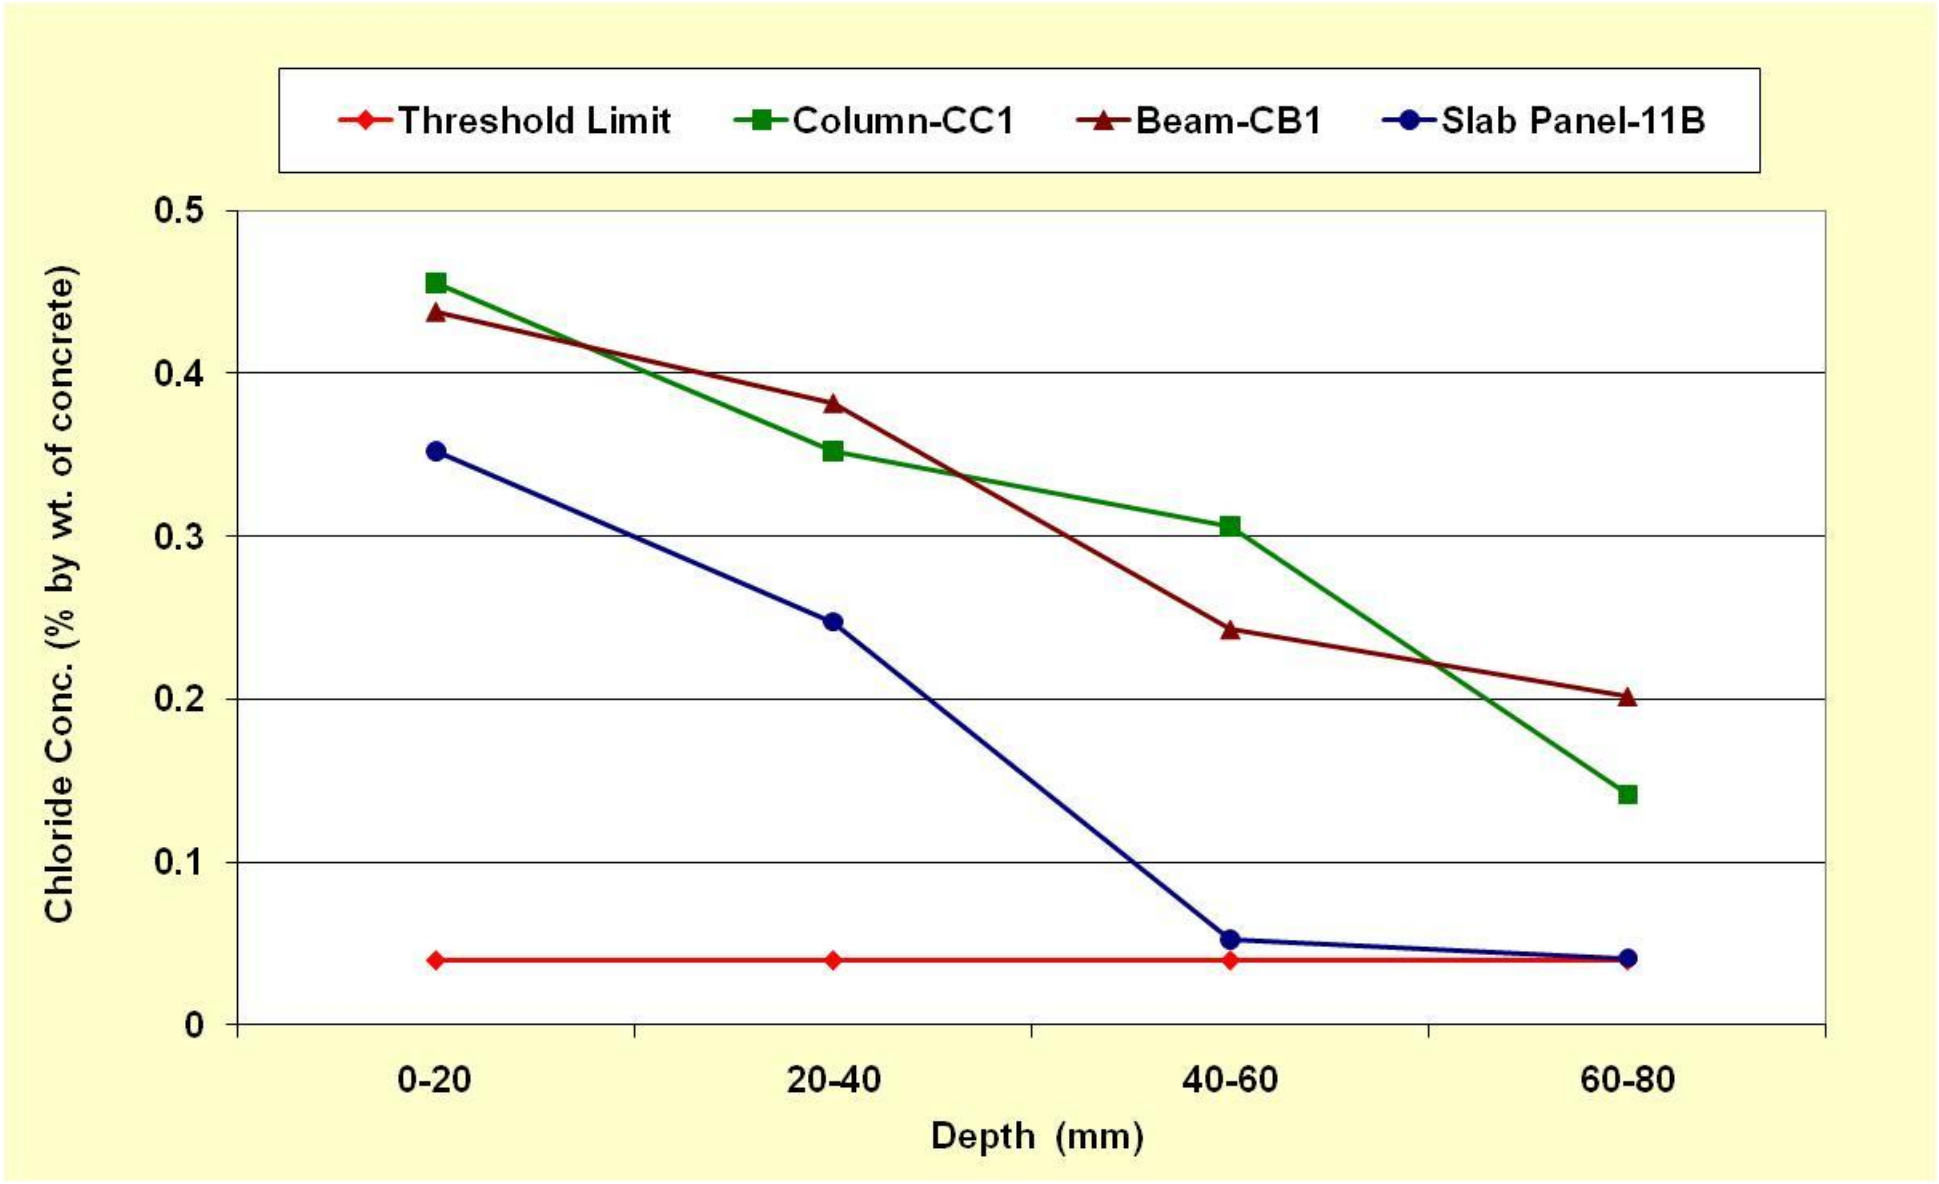
CHLORIDE PROFILES: Column, Beam, & Slab

Investigation	Observation
Average Chloride Content at Rebar Depth	Slab panels: 0.051% by wt. of concrete Beams: 0.18% by wt. of concrete Columns: 0.13% by wt. of concrete 2 to 4 times > threshold limit of 0.04%, by wt. of concrete .

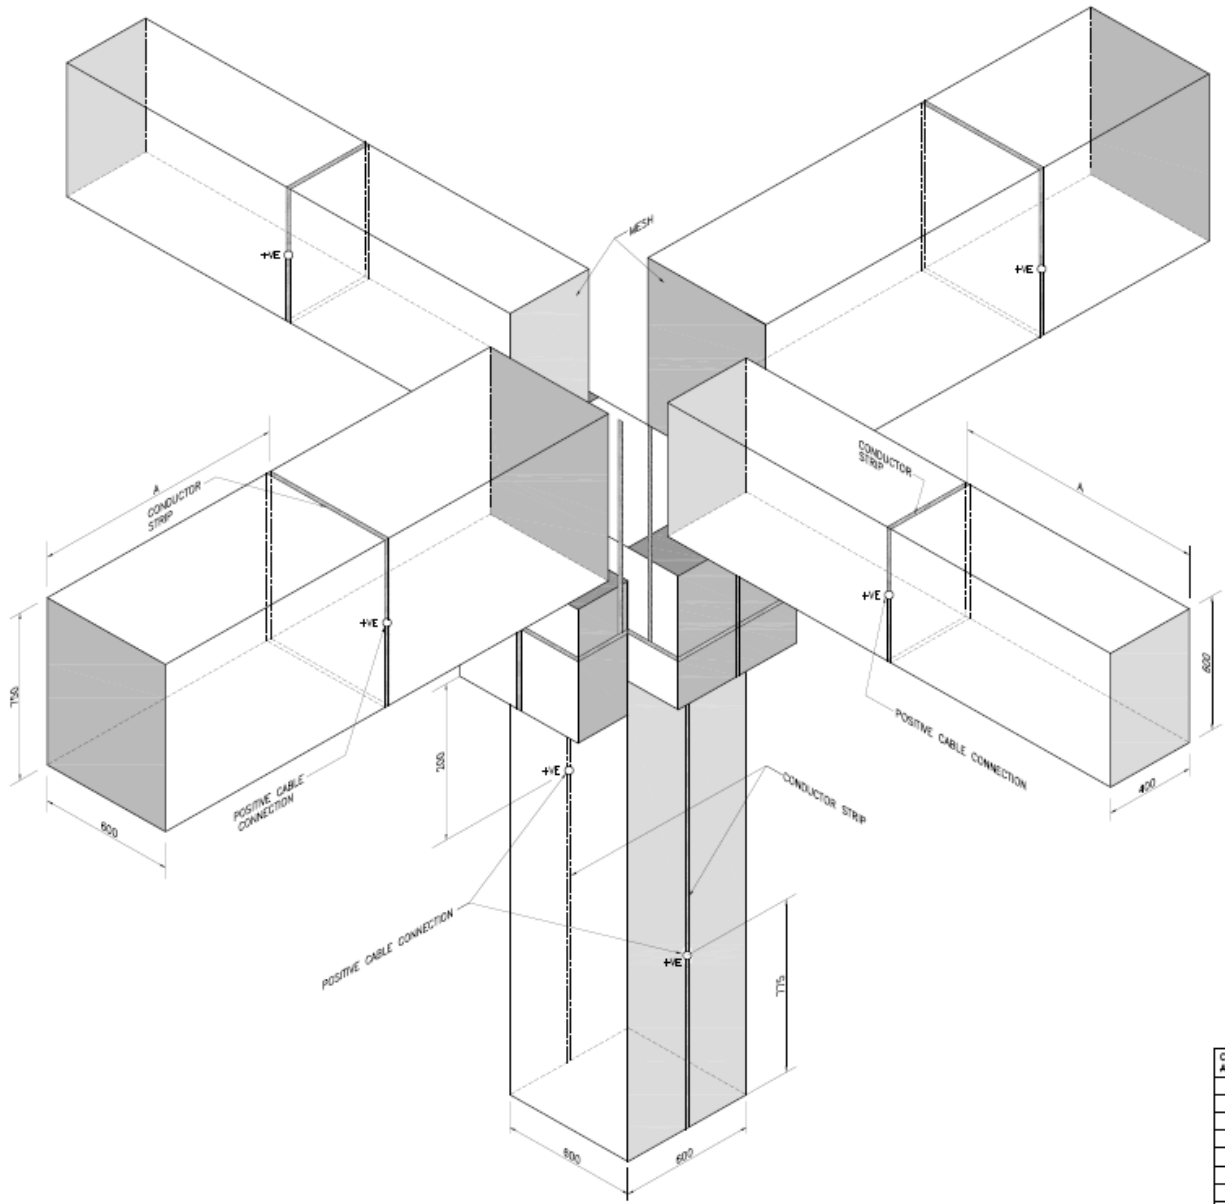
AREA B: *TYPICAL ANODE LAYOUT ON BEAMS & COLUMNS*

TYPICAL BEAM CORBEL COLUMN INTERFACE SHOWING CONDUCTOR STRIP & POSITIVE CABLE CONNECTION DETAIL
