# FIBER REINFORCED PLASTIC (FRP) FORUM & EXPO

## Rupture of NaOCl FRP Pipe

Omar R. Aldulaijan  
Inspection Engineer - SIPCHEM   **AMPP™** JUBAIL  
CHAPTER SAUDI ARABIA  
October 18, 2023

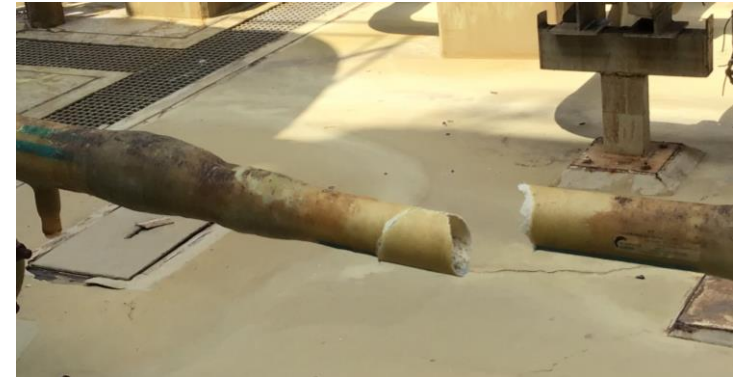
After 10 years

The rupture happened in May 2023

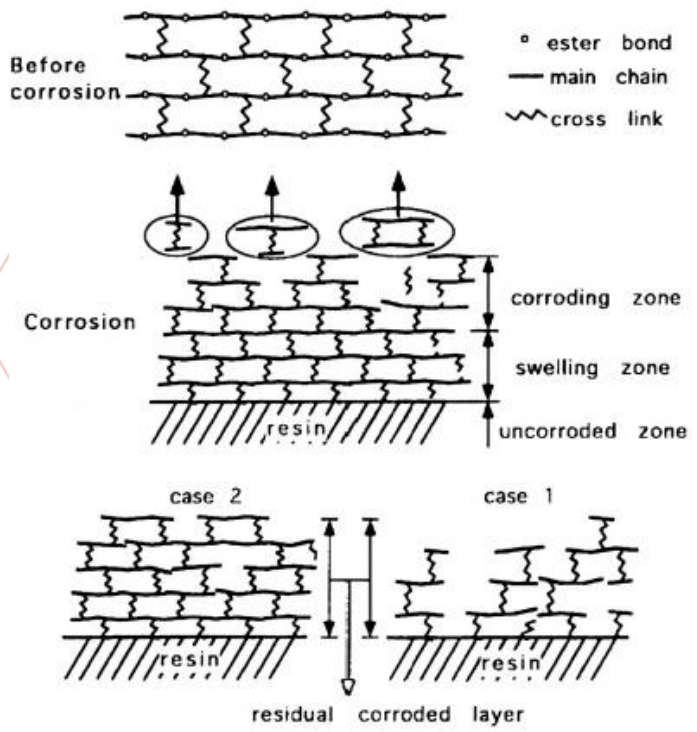
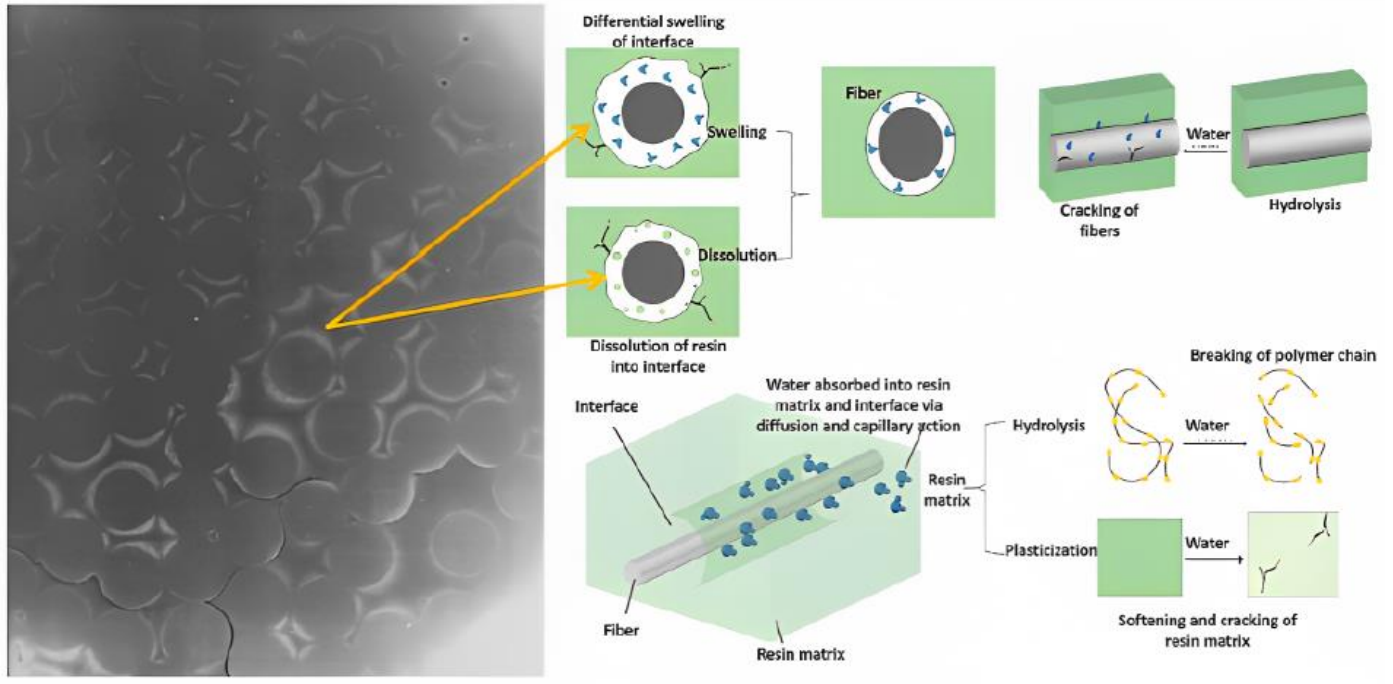
# Lap Analysis - Corrosion and Degradation Process

- A significant thickness reduction from the pipe interior.
- DIN-16965-5 specifies minimum thickness of internal corrosion barrier to be 2.5mm.
- The thickness reduction of 2.6mm implied that the corrosion barrier was compromised in the failed pipe sample.

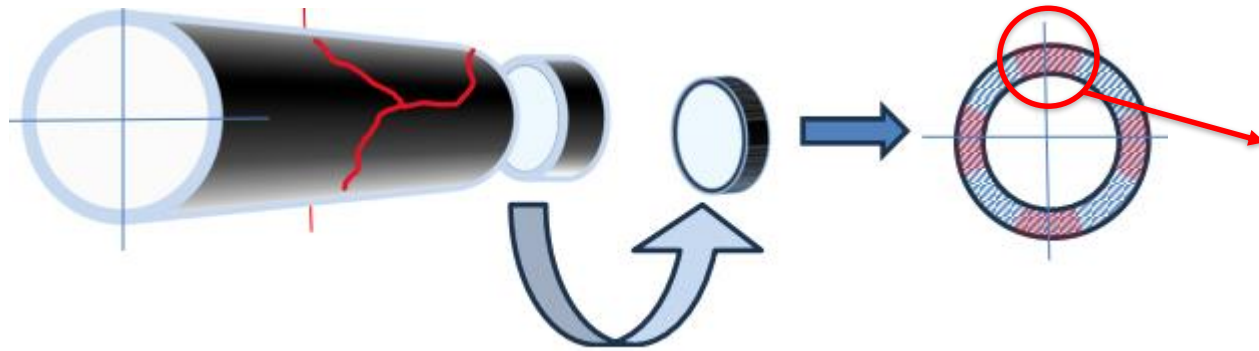
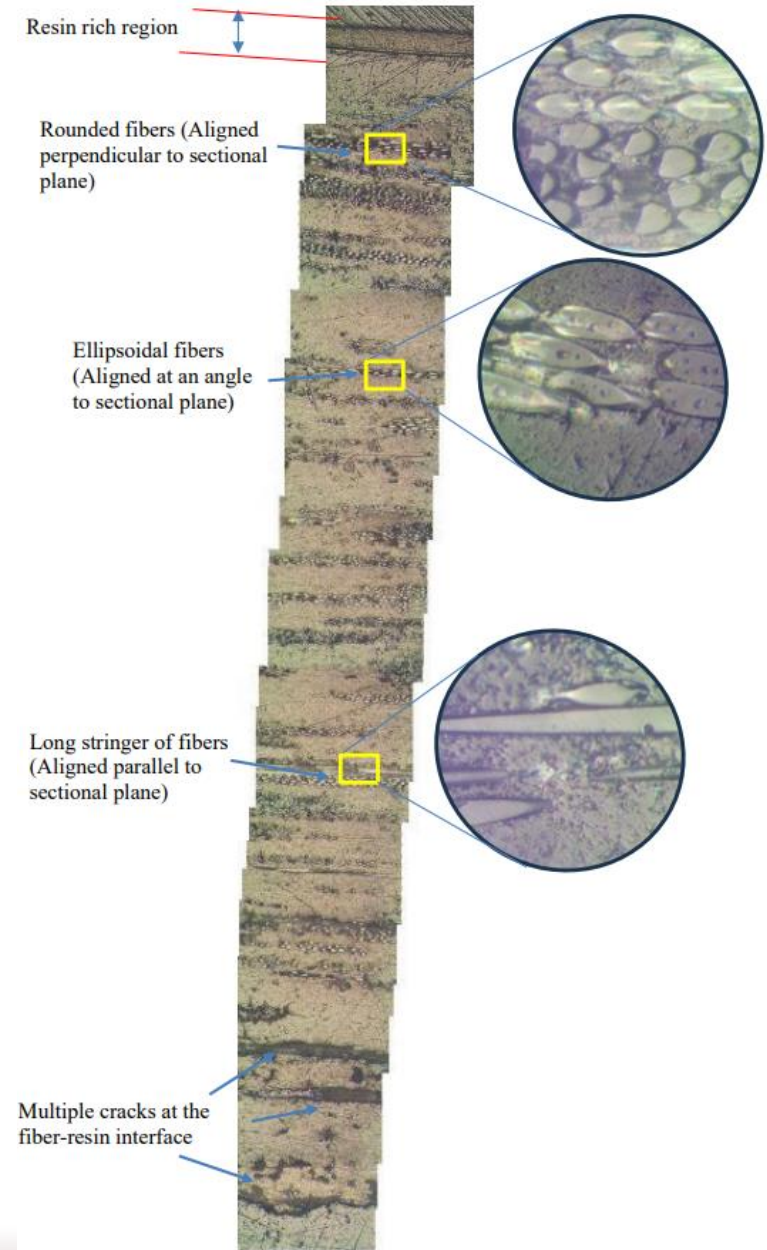
# Lap Analysis - Micro Examination

- **Visual Examination:** High absorption of water.
- **Dimensional Measurements:** Reduction of the pipe thickness.
- **FTIR:** Pipe ID got deteriorated.
- **EDS:** The organic nature of the scale.
- **SEM:** The failure happened in brittle fracture.
- **Micro Examination:** Multiple cracks in the resin matrix.

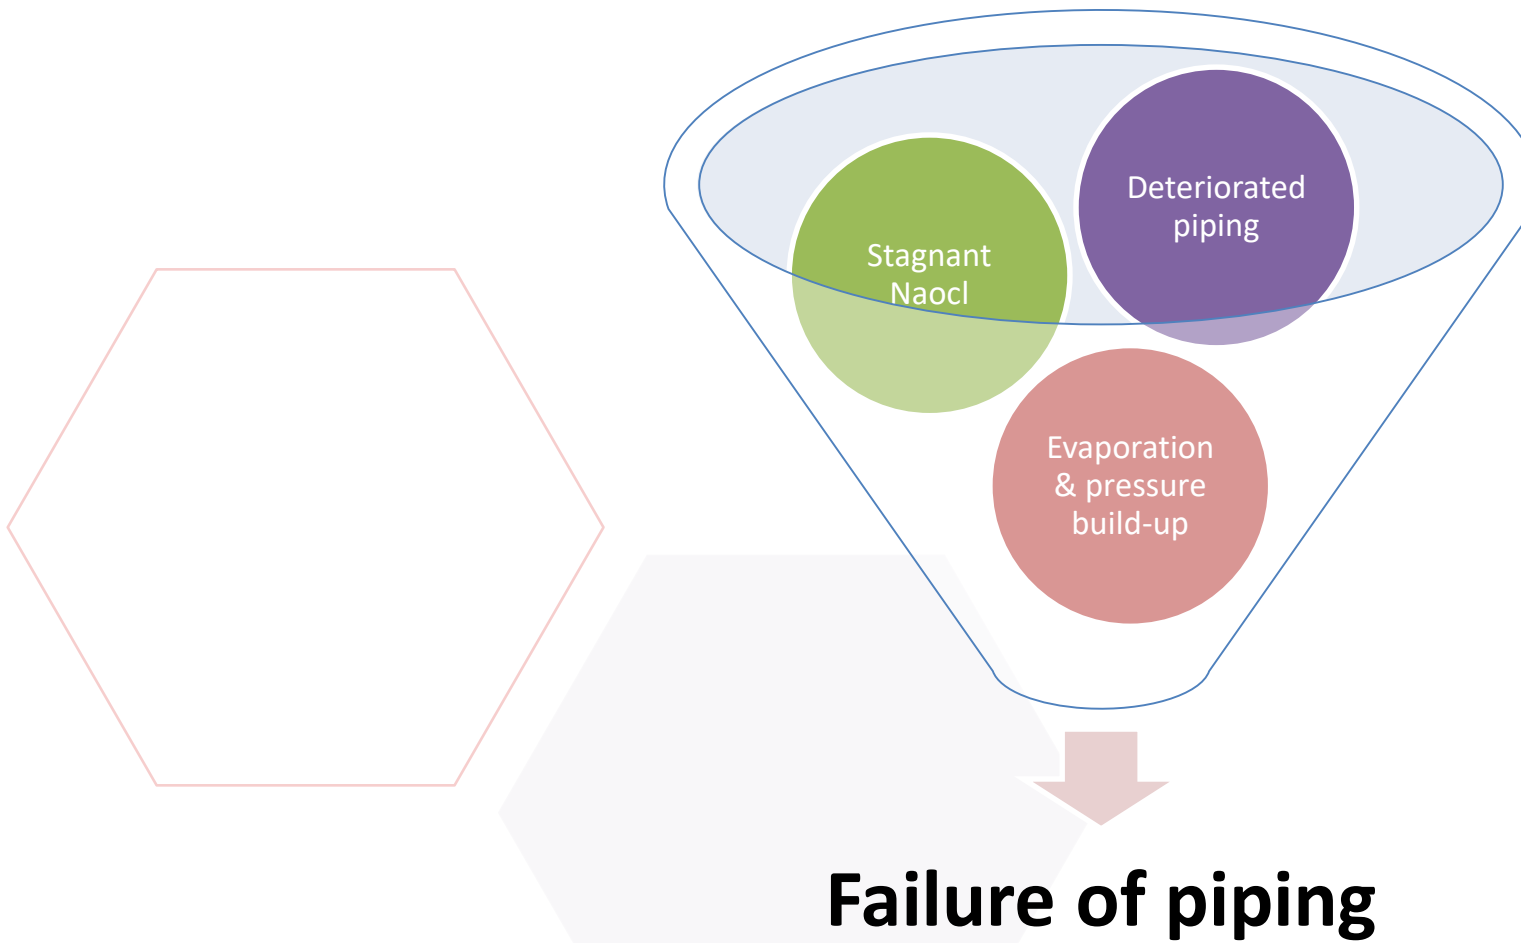
# Conclusion

## Failure of piping

Sodium hypochlorite solution is high corrosive process and it's pressurized when heated. And the process was kept in the system without venting while the weather temperature heating the process, so the pressure bulled up, and the failure happened. And since the corrosion barrier was compromised in the pipe with the time, so that accelerate the failure.

- Revise the SOP to include a clause that ensures venting the system in Idle condition.
- Adding a line to the system and include PSV with a rupture disk as a safety precaution.
- Establish PM for the unit piping for integrity management.
- Developing Ultrasonic based NDT techniques to assess the condition of internal corrosion barrier for the piping.
