Deterioration of Reinforced Concrete Structure with Built in Cathodic Prevention System

Saad Alshehri, SABIC

Background: Cooling Tower Details & Problem

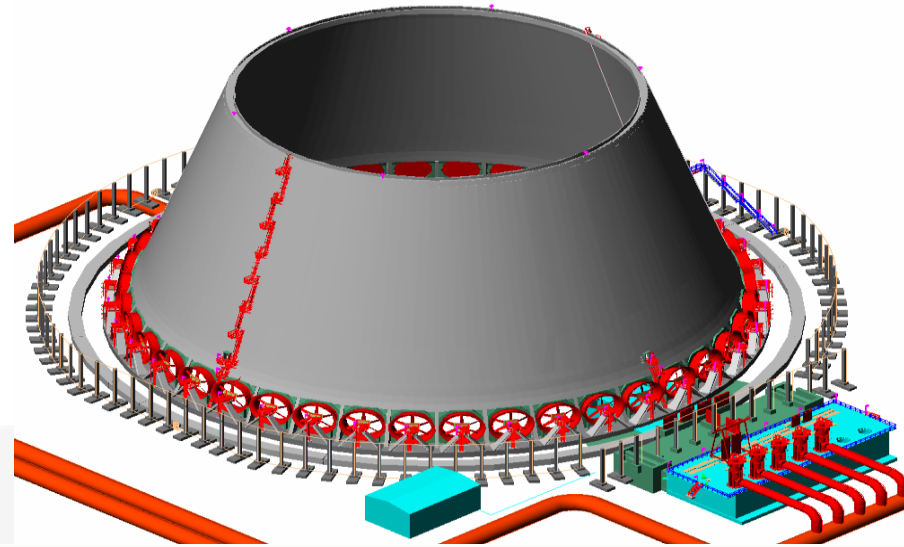
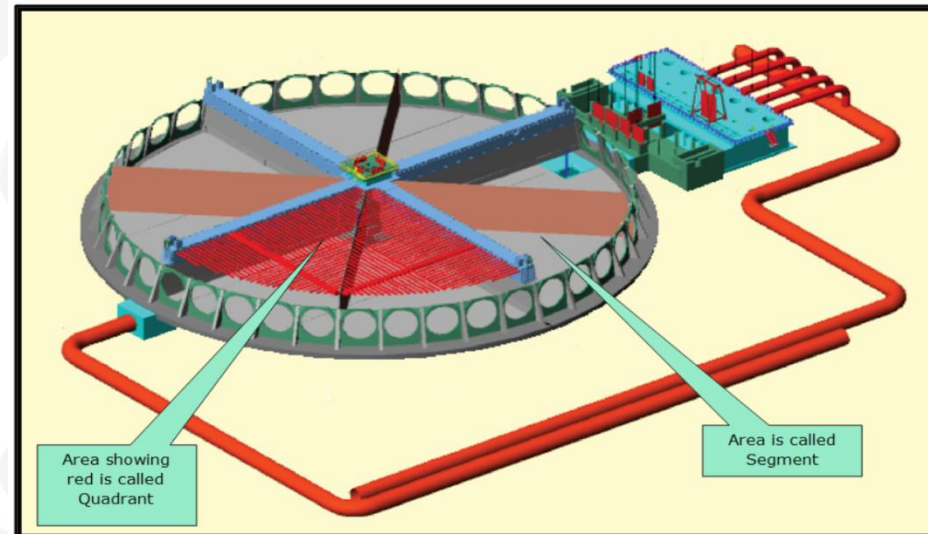
- Cooling tower:
 - 71.5 m high
 - 124m ring beam diam.
 - Consist of 32 shells
 - Consist of 4 quadrants
 - Constructed with built-in cathodic protection (CP)
 - Energized: 2009

- **Problem:**
 - Since commissioning Sharq have encountered technical problems with the ETCP power supplies and RMS in SHARQ 3rd expansion and they could not succeed to rectify all problems.
 - Commissioning acceptance of the CP system from SABIC MCE was on hold till the vendor(CTS) rectify TR and RMS issues.
 - Electrical cable tray damage in 2012 and rectified .
 - CP power system turned off for repair but not Re-energized

- Structure without CP system for almost a year .
- In 2014 fan foundations found Severely cracked and delaminated.
- In 2015 reported Spalling of damaged Concrete from top ring (72 m height)
- Investigation team (MCE/Sharq -Inspection & civil) formed to analyze the root causes for these cracks and concrete delamination.
