Crevice Corrosion of Chlorine Recuperator Tubes

Faisal S. Al-Otaibi

Section Head, Inspection – Sipchem

February 28, 2022

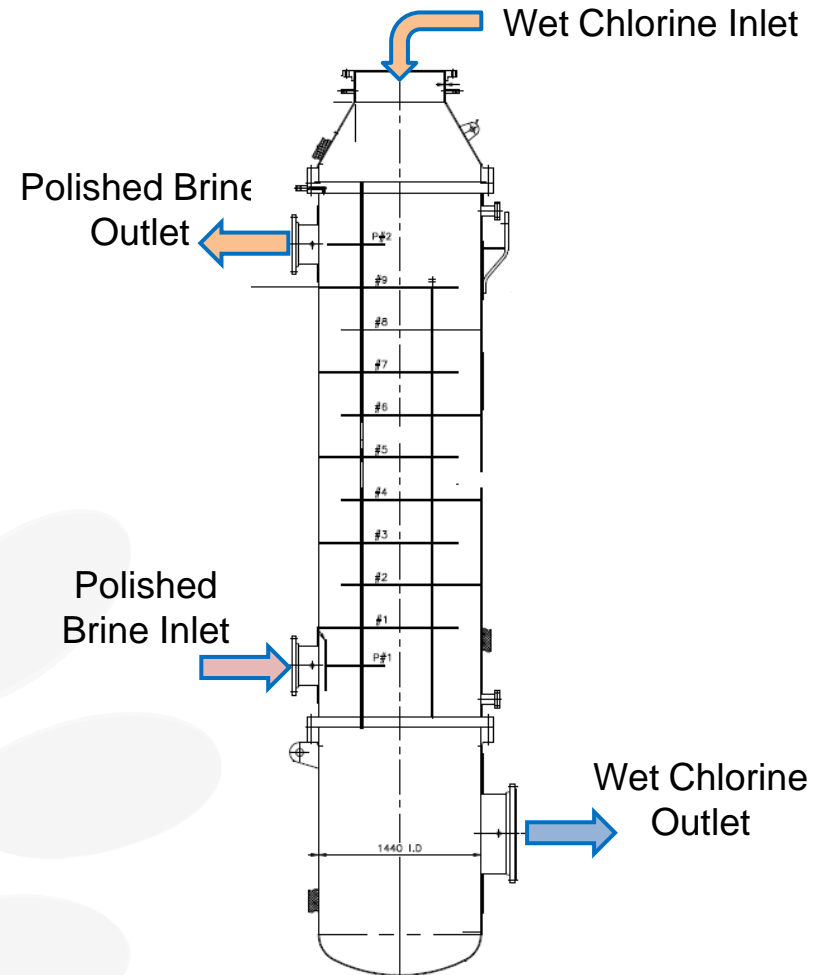
After the separation of brine to NA & Cl using electrolysis, wet chlorine goes through drying process which include boiling it to a certain temperature to achieve separation from the moisture, the vapor of water is cooled through three exchangers, one is E12103 chlorine recuperator using polished brine, where wet chlorine (tube side) enters the exchanger at 87C and leaves it 60 C. And the polished brine (shell side) enters at 55 C and leaves at 63 C.
