Jubcor Presentation

IMPROVED COMPRESSOR IMPELLER DESIGN TO
OVERCOME SULPHIDE STRESS CRACKING (SSC)

Presented By:
Ahmad AlNasser

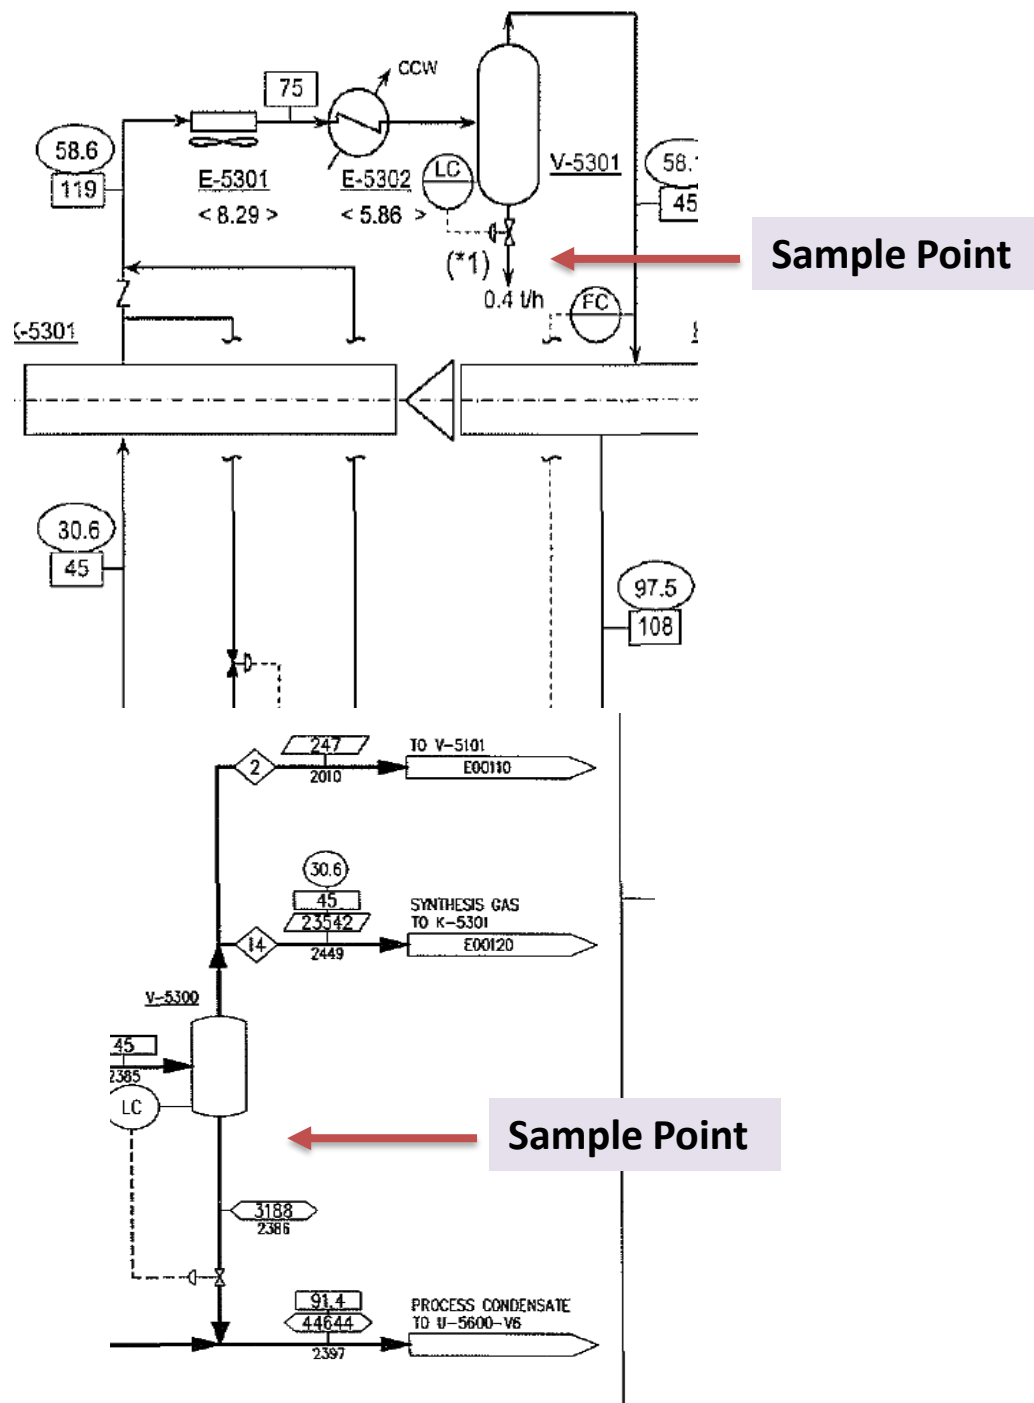
Up normal operating condition (liquid ingress , gas impurities and deviation from design components).

- O, Fe, C are the major observed components in fracture area.
- Na, Mg, Al, Cl, Ca, Ti, Cd observed as minor and are not included in Rotor materials. Its added from process gas impurities.

- Control suction temperature to K-5301-LP between 45~50 °C in all session to reduce condensate impact (Dew point of SG : 41°C, Suction temperature to be raised to 48~50°C if possible as it will reduce the aqueous phase in gas more.
- Control level of V-5300 & V-5301 below 25 ~ 20 % during start up and normal operation .
- Increase Process condensate recycling with fresh water that support reduce Cl , Na impurities.
- **Short Term** : Repair the rotor with cut back the 1st stage impeller and rebalance it.
- **Long Term**: Modify both 1st & 2nd stage impeller to weld less (17-4 PH SS) material with reduced hardness ≤ 33 HRC.
