# JUBCOR

CARBAMATE CORROSION OF STAINLESS-STEEL UREA  
GRADE WELDS DUE TO IMPROPER WELDING

# LEAK OF UREA HPCC-A

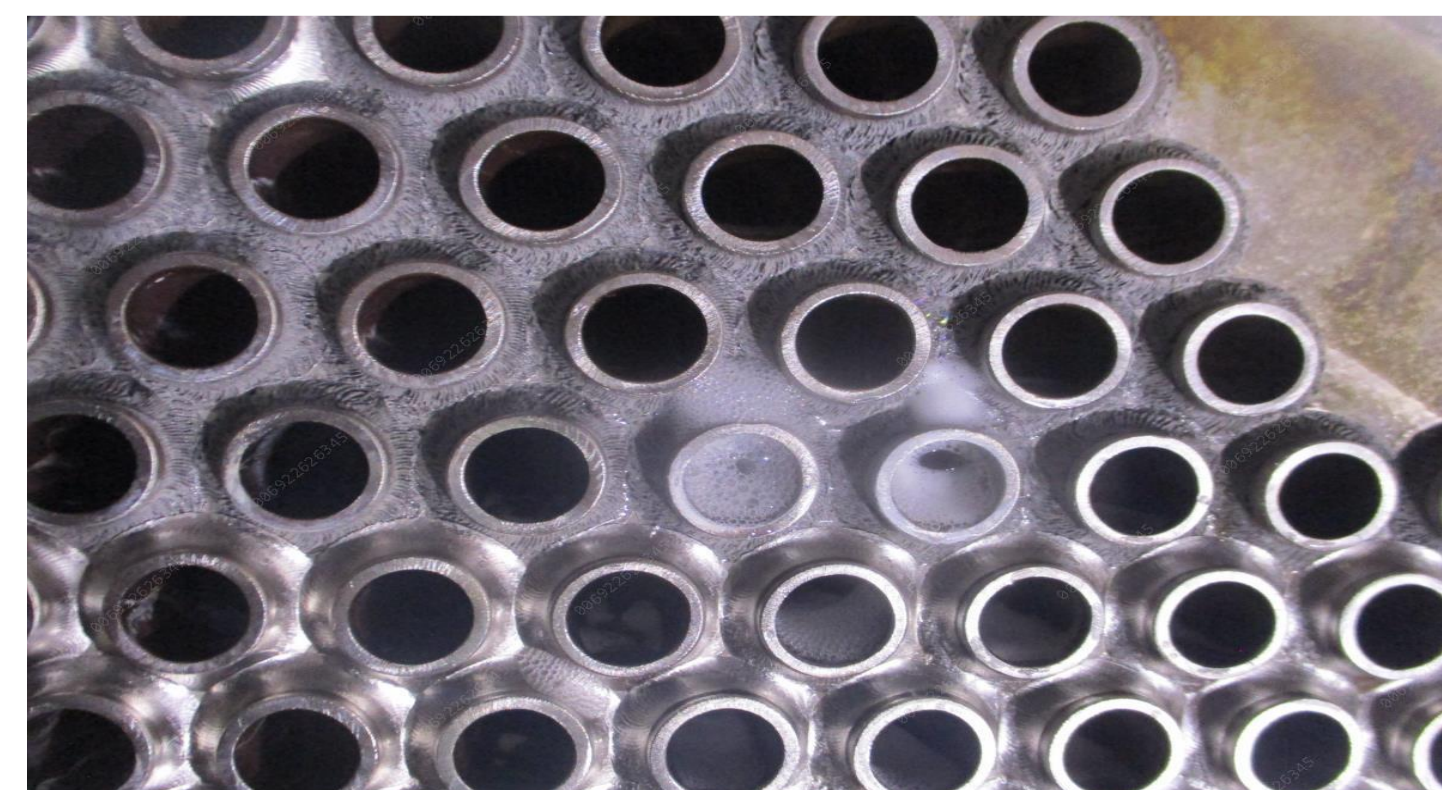
During initial inspection, the exchanger was tested by pneumatic test at 4.9kg/cm<sup>2</sup> to identify the leak locations. Nine tubes were found leaking from TTS weld. Row number and tube number of each tube found leaking during the test is shown in Table.1. The condition of the TTS weld of the leaking tubes showed signs of corrosion as shown in the photos below Fig. 1 and 2. 72 TTS welds found corroded in upper part of the tube sheet. The location of the corroded TTS is shown in marked tube sheet layout.

corroded TTS in the upper part of inlet tube sheet

Corroded TTS welds were repaired by fusing the existing weld without filler wire and apply two weld passes on the existing weld and ensuring the interpass temperature does not exceed 100°C and using 1.6mm filler wire diameter. Welding was done using 25.22.2 filler wire of 1.6mm diameter. Filler wire material was verified by PMI prior to welding. The weld repair was tested by DPT and found accepted. Ferrite was measured and found to be less than 0.3.

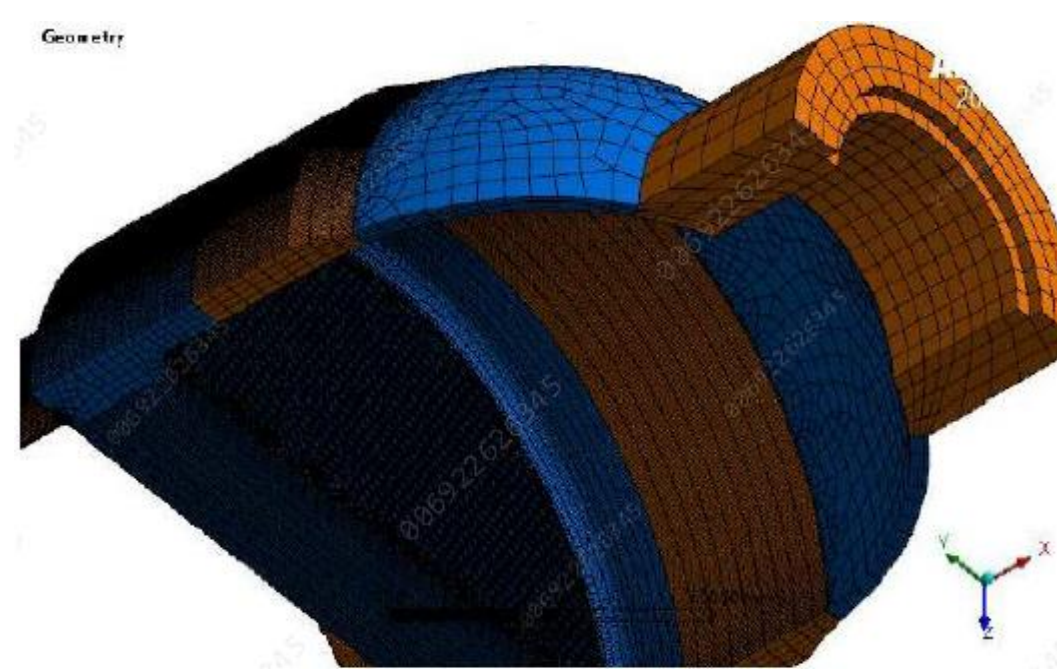
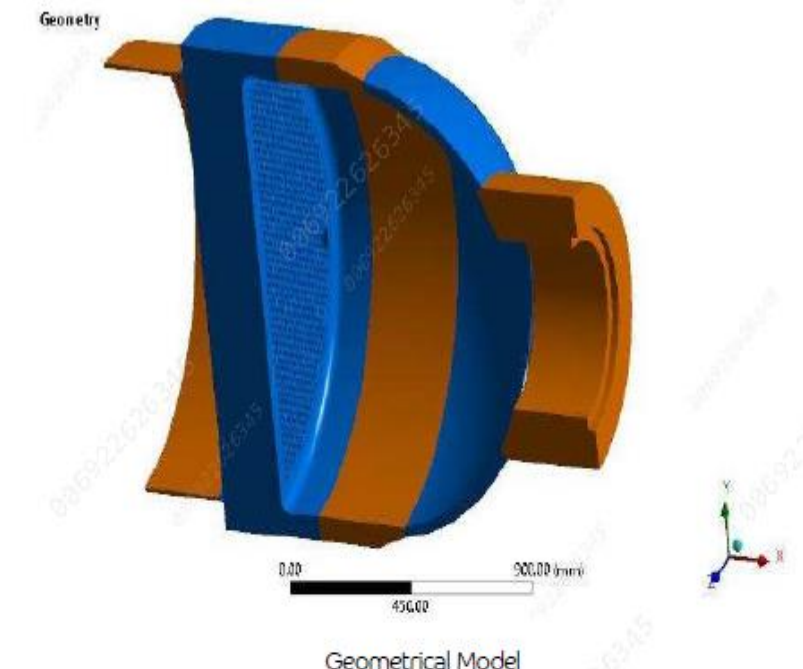
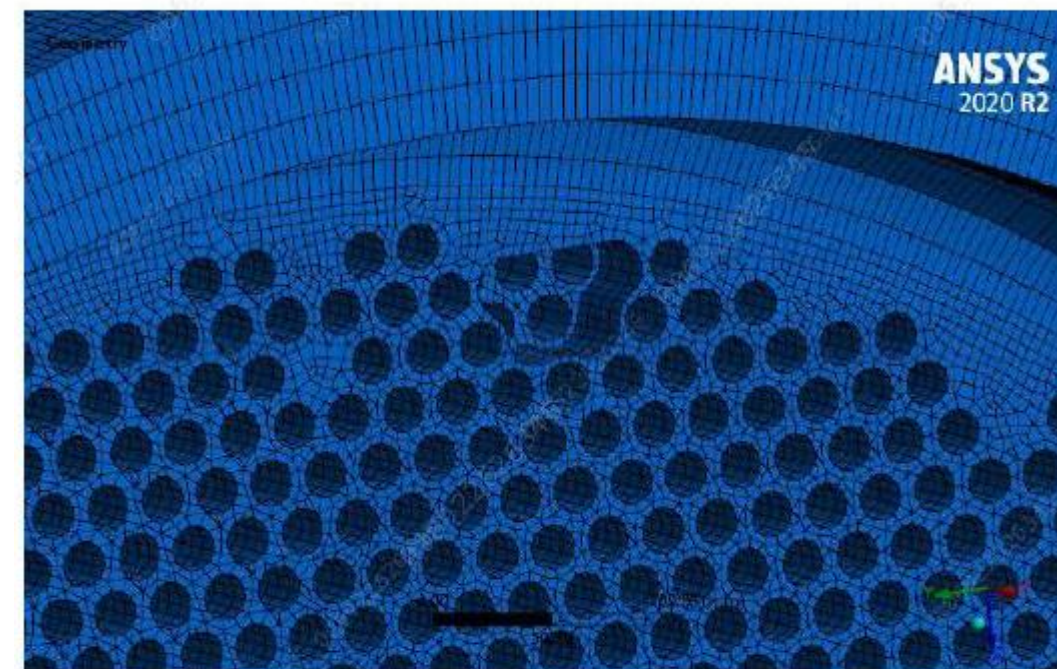
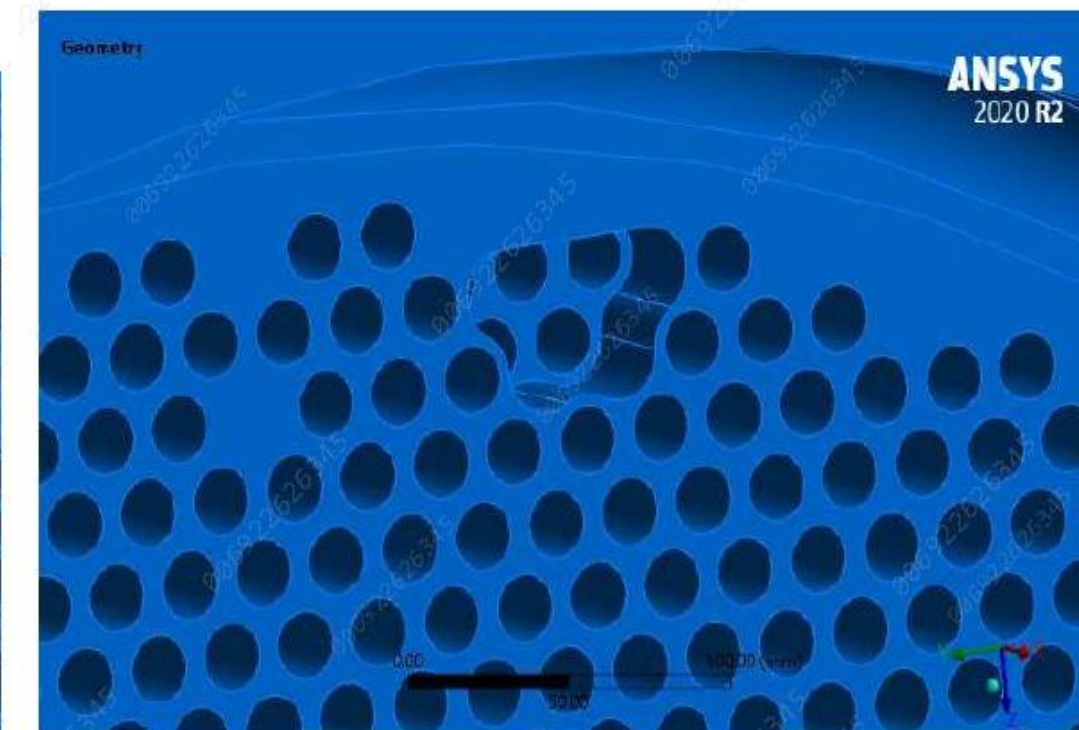
FE Analysis was conducted to check the compliance of the tube sheet with the existing cavity and the pass partition box with the code prescribed stress limits.

FEA proved that the components are in compliance with the criteria according to ASME sec. VIII Div.2.

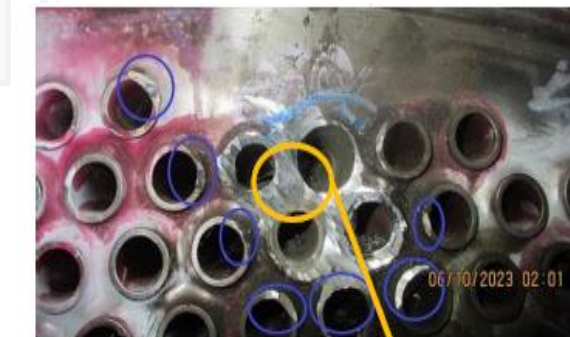
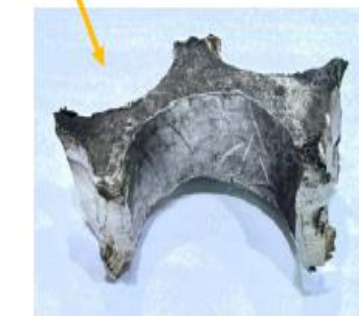
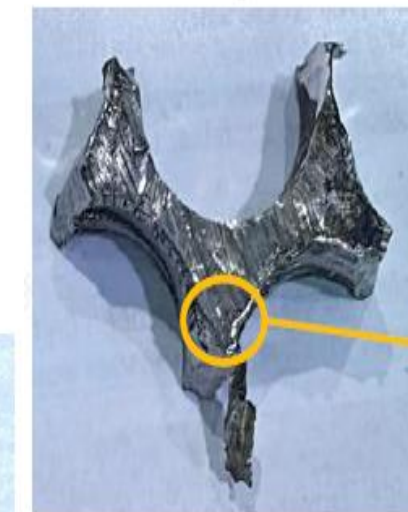
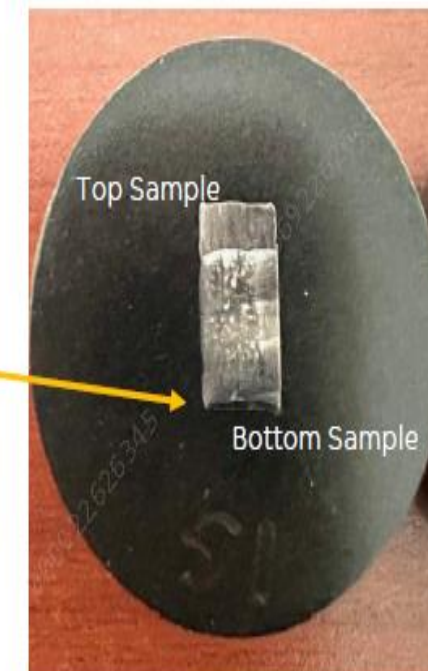
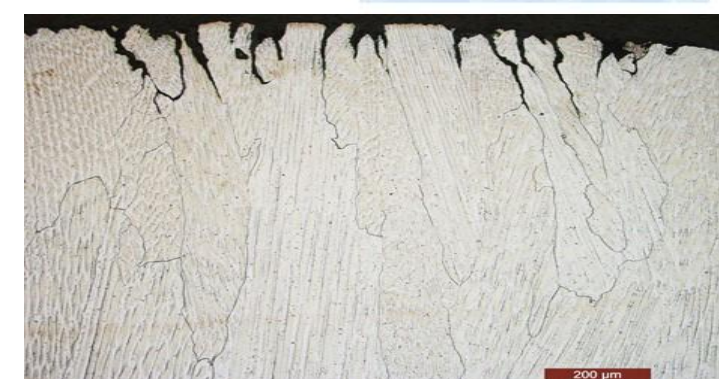
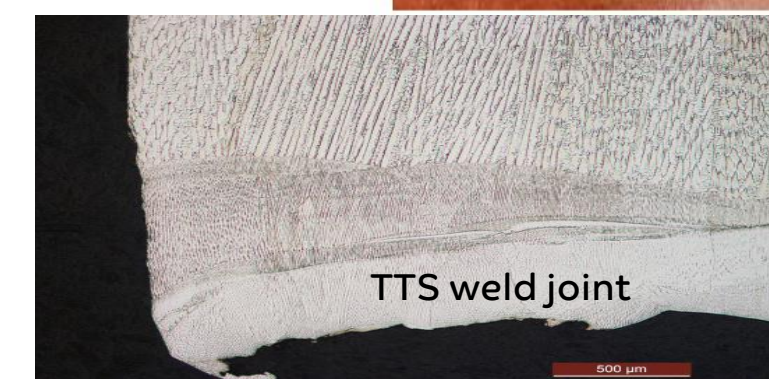
- The chemical composition result of the TTS weld material does not match the specification of the design filler wire material ASTM A312 grade S31050.
- Signs of corrosion were observed on a selected area which is at the top of the inlet urea process side suggesting that there was a mixing of filler wires used during the fabrication.
- The analysis of the weld at the front side of the tube sheet showed high nickel, moly, and less other elements.
- the result of the weld at the tube sheet is different from the subsequence welds.
- **Based on the above analysis, it was concluded that the root cause was due to using improper filler wire during fabrication**
