JUBCOR

Premature Failure of Radiant Shield Boiler Tubes in a Reformer Convection Section

A Failure Analysis Case Study

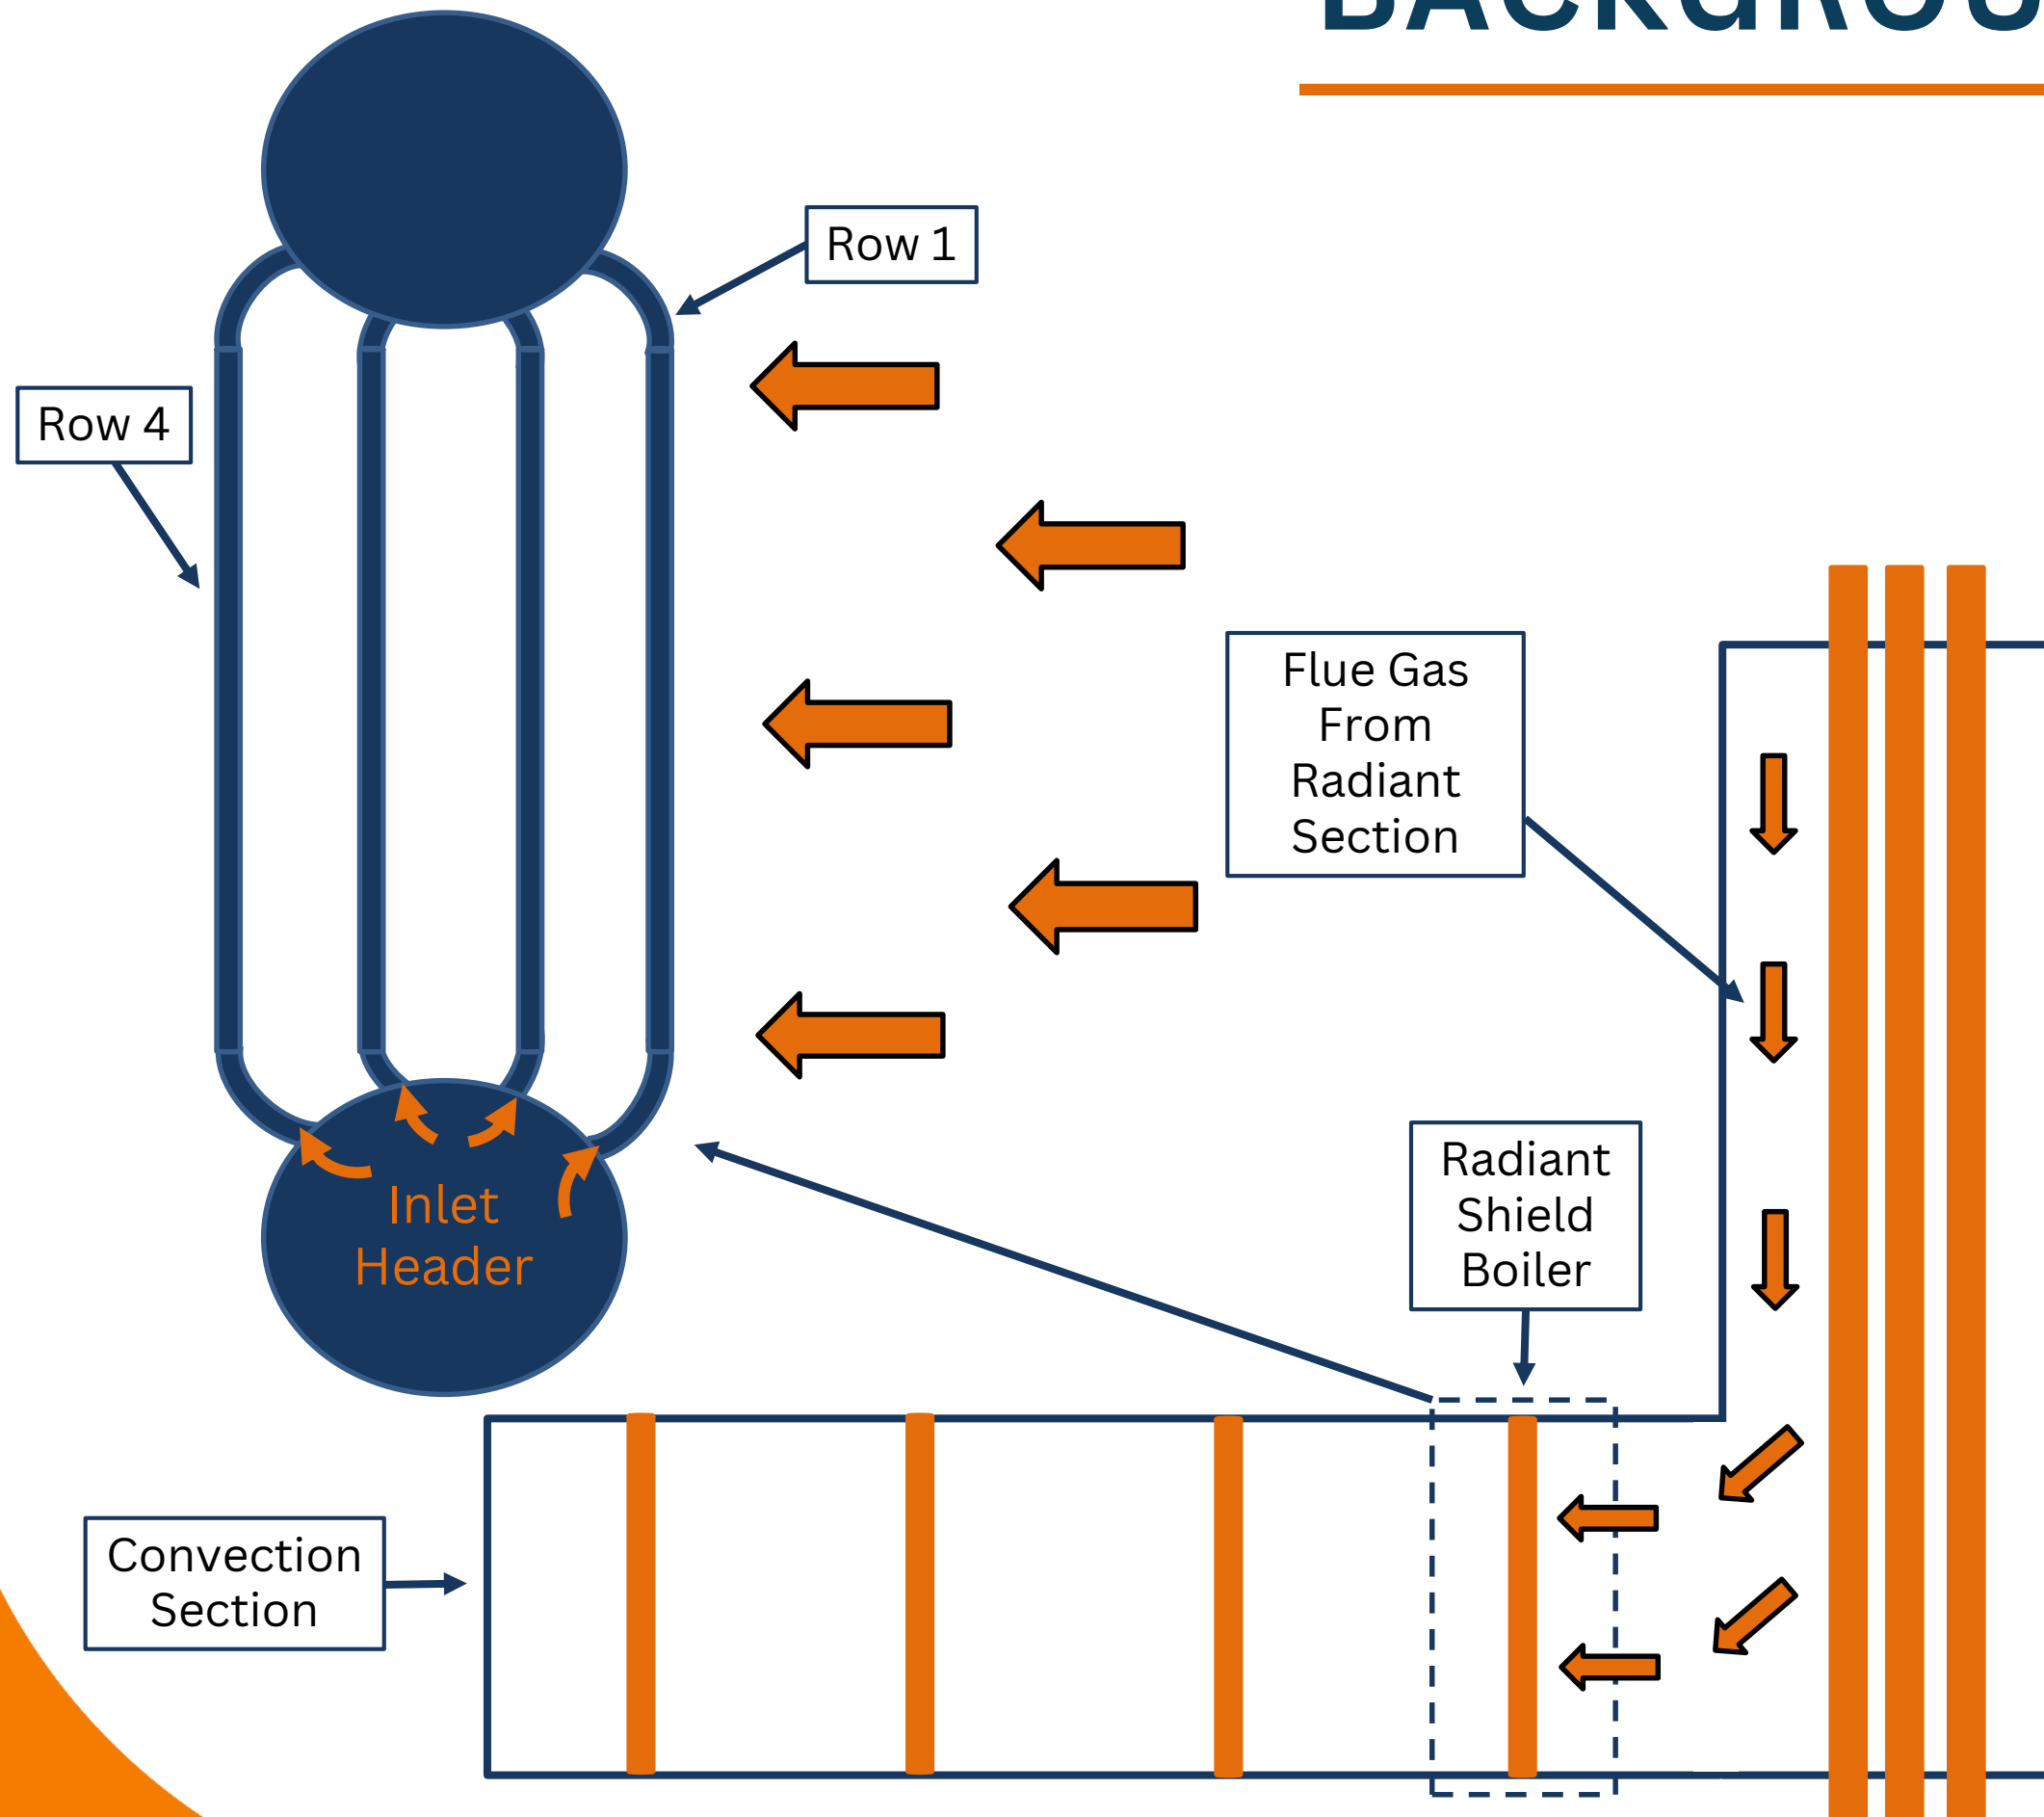
- Boiler water from the steam drum flows inside the tubes from the inlet header (bottom).
- Heating on the external surface is through flue gas from the radiant section.
- The boiler has 4 rows of tubes with Row 1 being on the upstream side (US) and Row 4 being on the downstream side (relative to flue gas flow direction)
- The failures occurred on Row 1
- The material of construction is ASME SA 210 Gr C

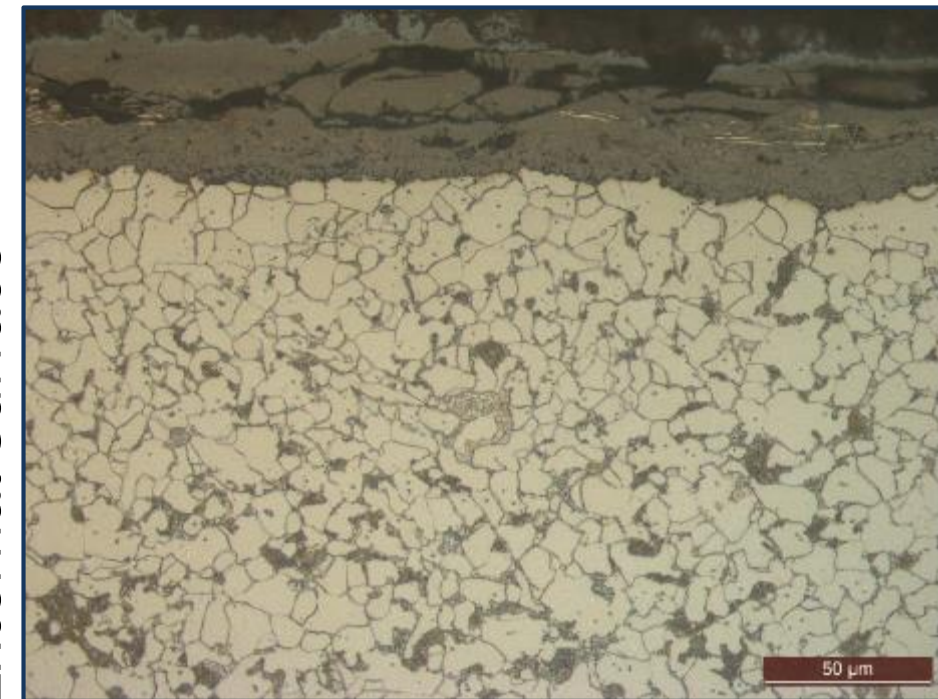
External Surface

Row 4, Tube 1 – Trans. - US

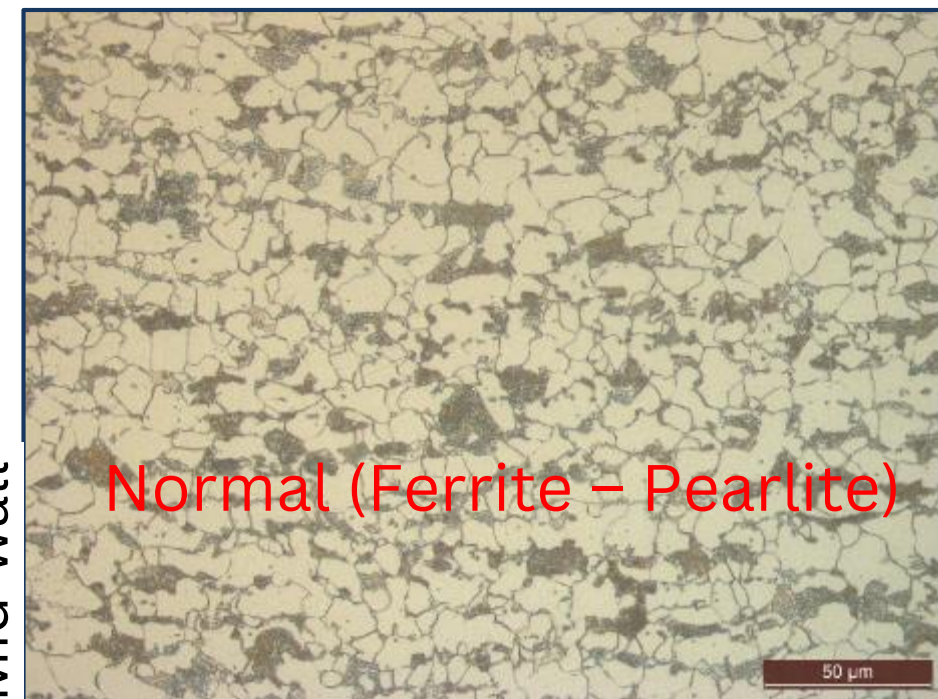
Mid-wall

Normal (Ferrite – Pearlite)

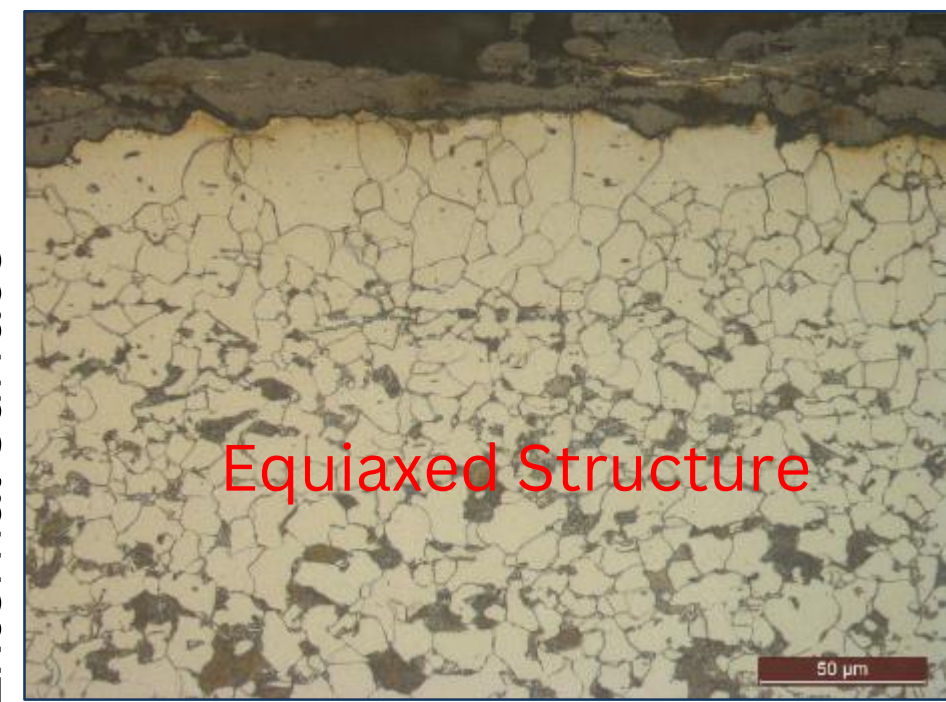
External Surface

Row 4, Tube 1 – Long. - US

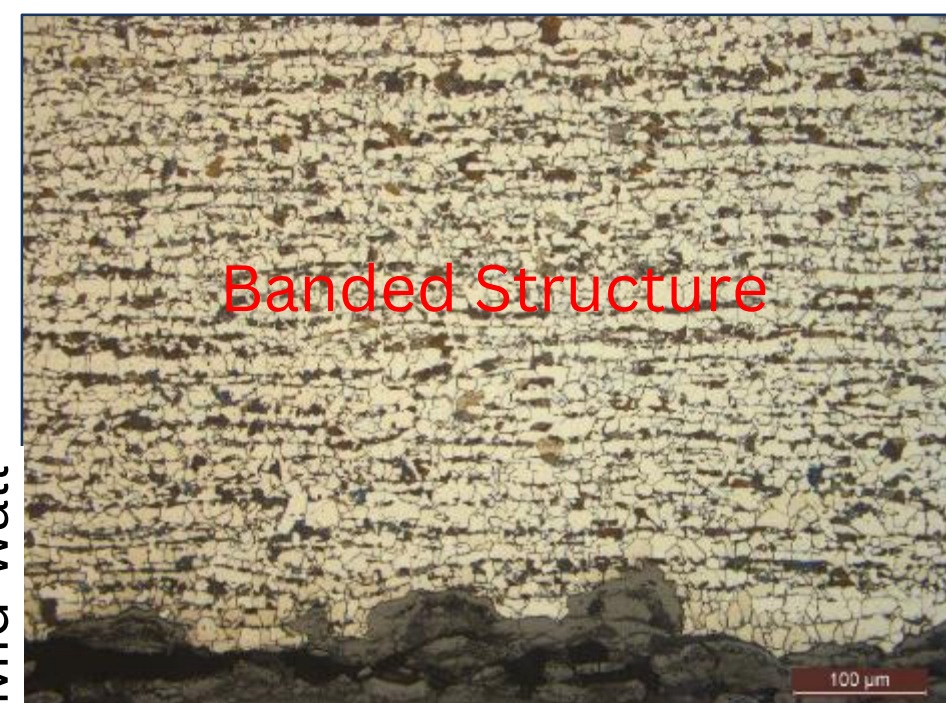
Mid-wall

- Banded structure – Normal ; Equiaxed structure – recrystallization occurred
- Transformation – phase transformation occurred ; Transformation occurs above 720°C.
- The microstructure indicates overheating.

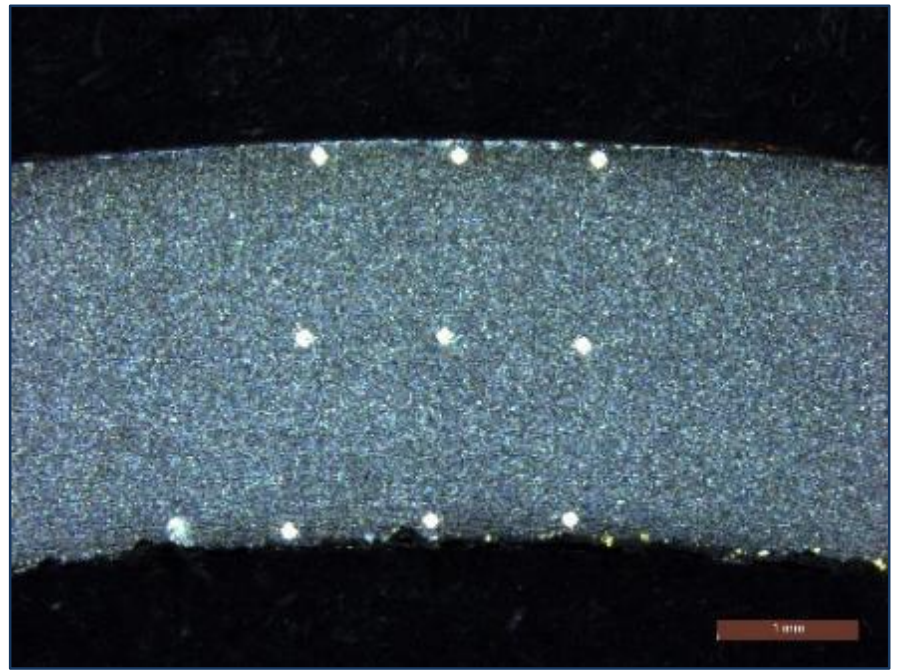
Row 4, Tube 1 – US

Sample/HV	ID	Middle	OD
Row 4, Tube 1, US	129	142	131
Row 4, Tube 1, DS	176	166	151
Row 1, Tube 47, Bulge	175	151	111
Row 1, Tube 78, Crack	267	202	126
