# JUBCOR

## Flow-Accelerated Corrosion in Steam Generating Plants

WTIIRA, Sep 2024

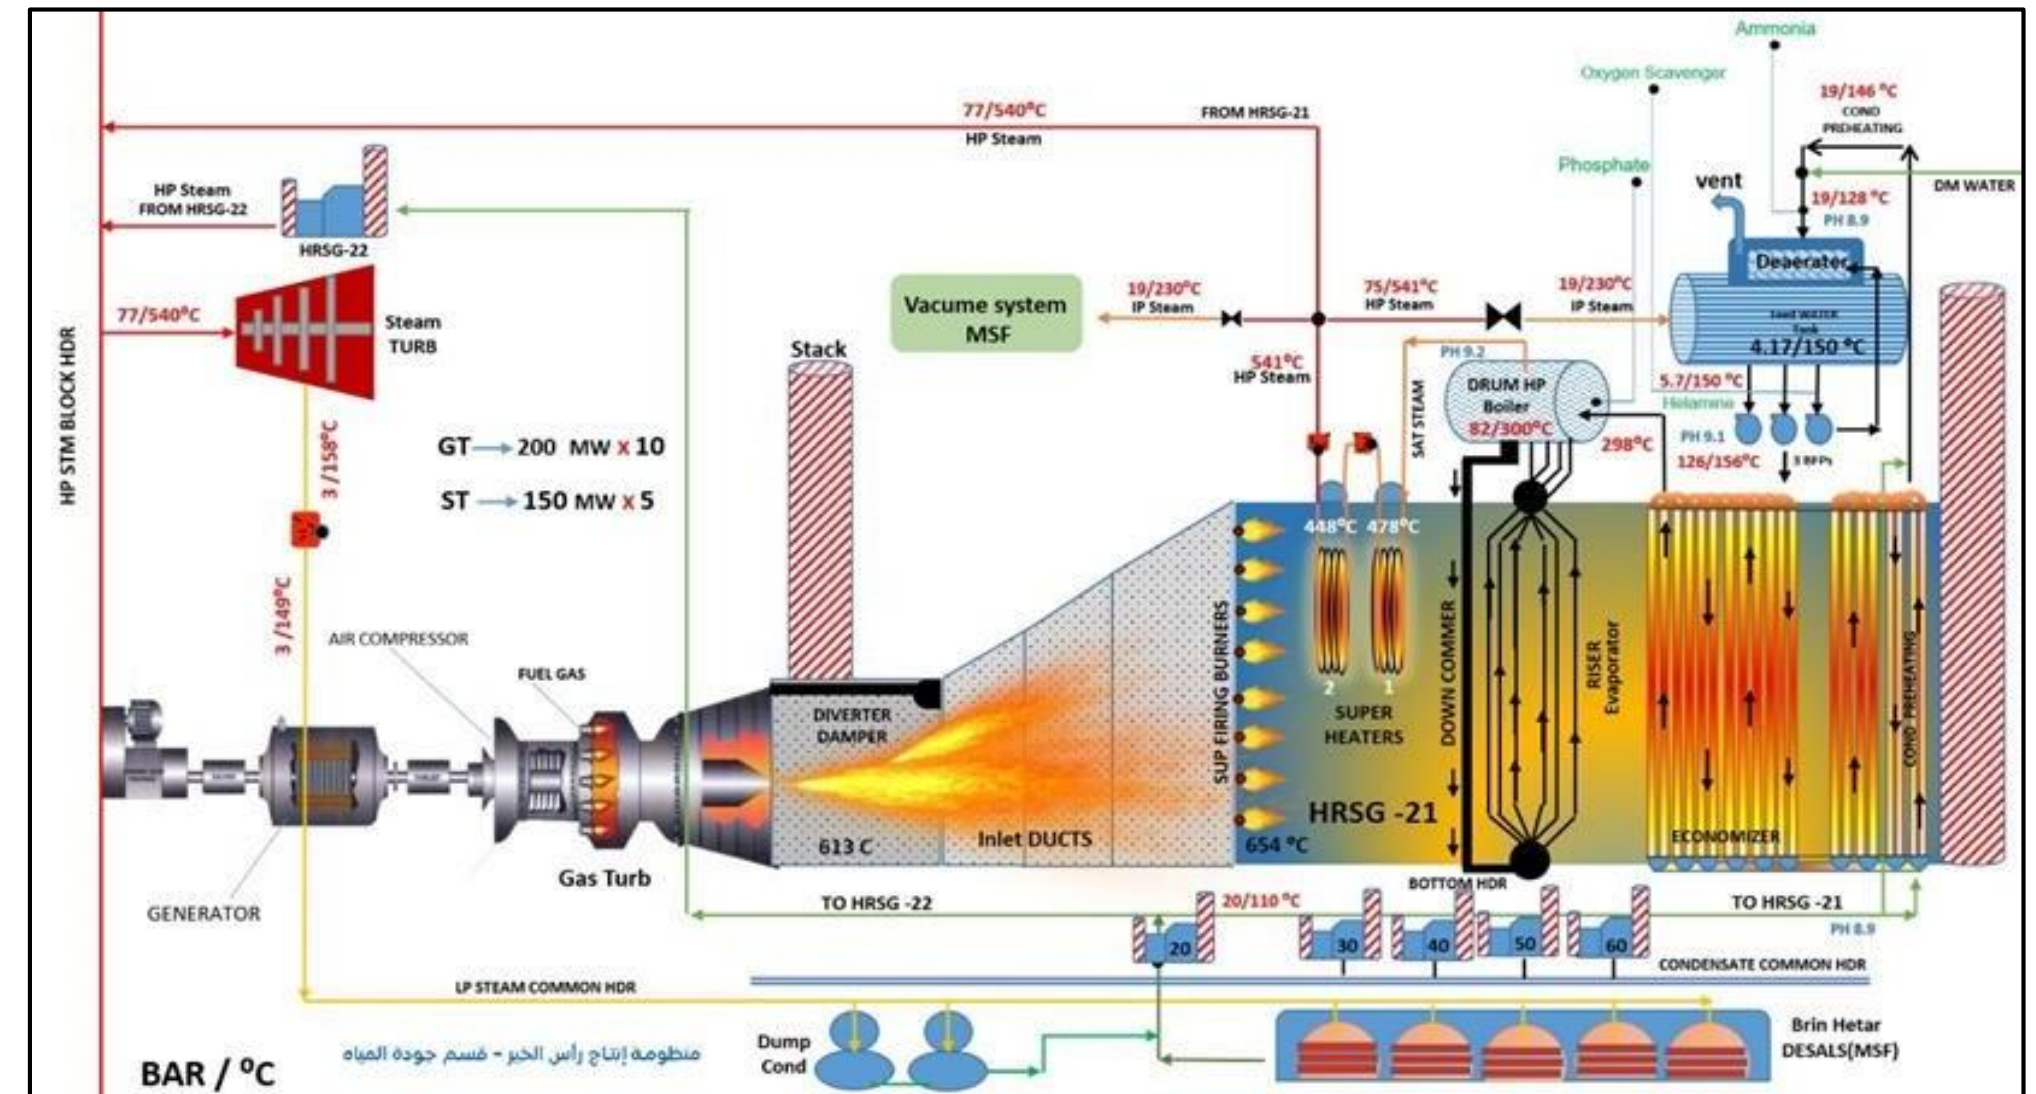
- A Heat recovery steam generator (HRSG) is utilized to produce steam that runs the turbine to generate electricity.
- Heat is exchanged between the hot flue gases and the network of water lines through the tube walls.
- Failures due to flow-accelerated corrosion (FAC) were experienced in multiple HRSGs. Consequently, a failure investigation was carried out.
