MHG Business and Field  
Applications  
presented to  
NACE, Jubail Chapter  
December 2010

Physical Acoustics

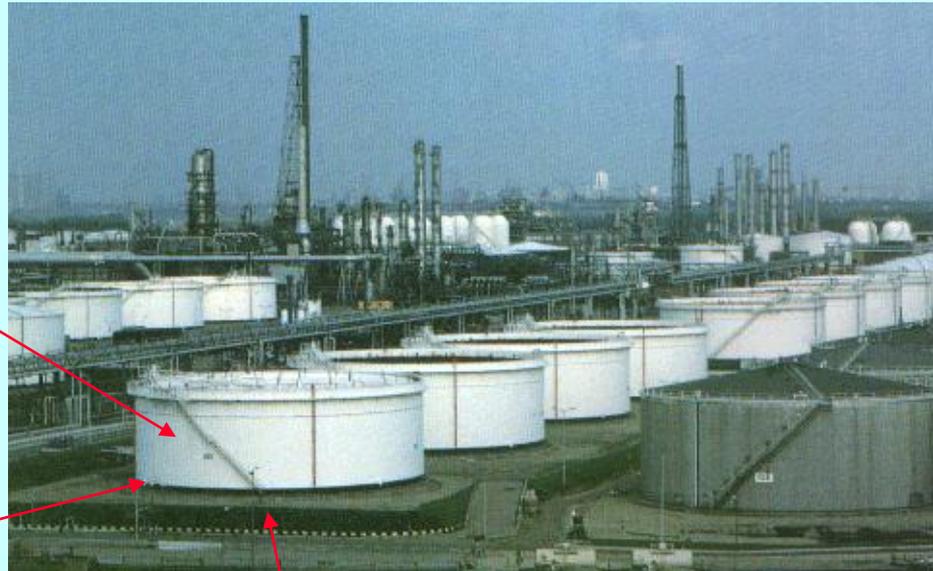
# In-Service Tank Testing

## *Maintenance Planning for Tank Farms*

### **SHELL:** LSI (UT) Corrosion Mapping

**NOTE:** If All Tests Show Good condition the Period In-Service is Extended, delaying costly cleaning for internal inspection.

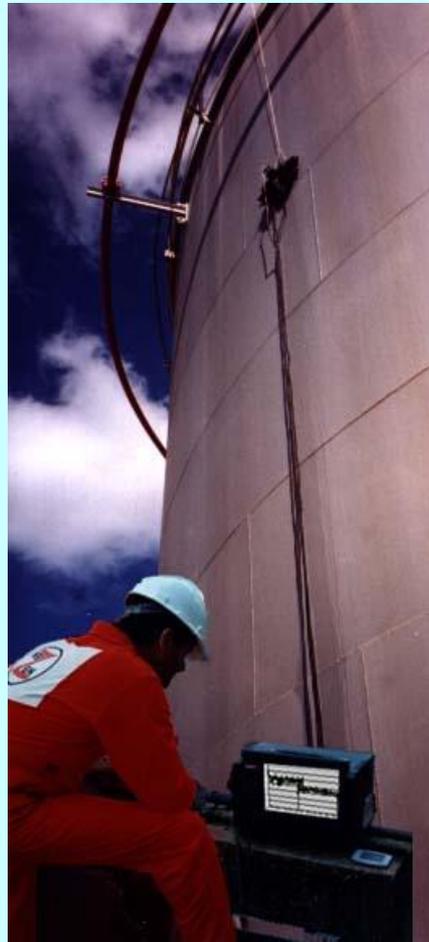
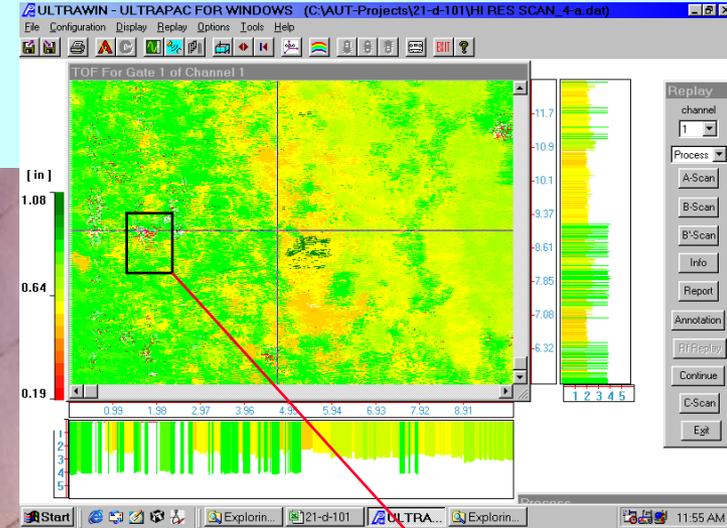
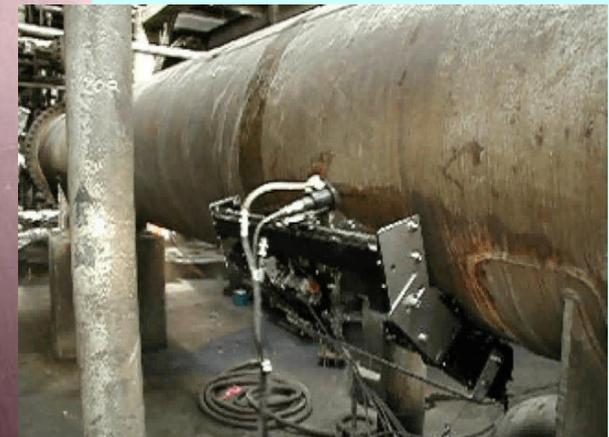
# Shell LSI-UT Fast Corrosion Mapping

- LSI-UT Mapping:
  - » Ground level access.
  - » C-Scan at up to 5000 sq.cm per minute (*10,000 with LSI-2*).
  - » Quantitative results.
  - » Identifies HAZ corrosion.
  - » Can run horizontal for weld HAZ inspection.
  - » Export to Excel or UTIA for FFS calculations.
  - » Operates on poor surfaces.

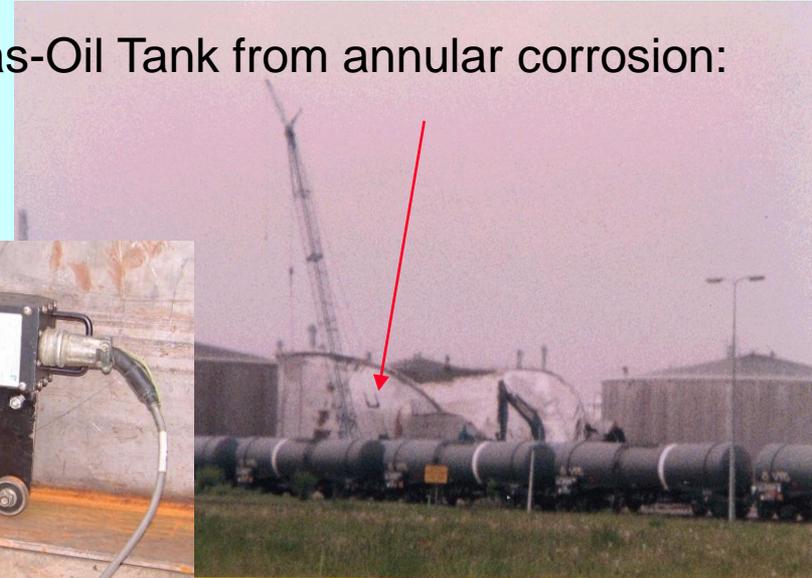
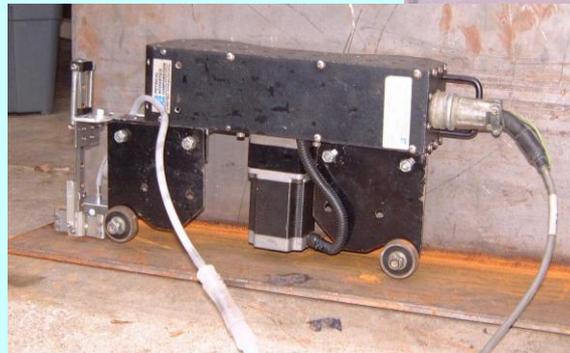
# TALRUT Annular Ring Test

Collapsed Gas-Oil Tank from annular corrosion:

- TALRUT
  - » Inspects critical area, ~30cm in.
  - » Automated UT, Plan image.
  - » 40 m/day.
  - » Indicative, not quantitative.

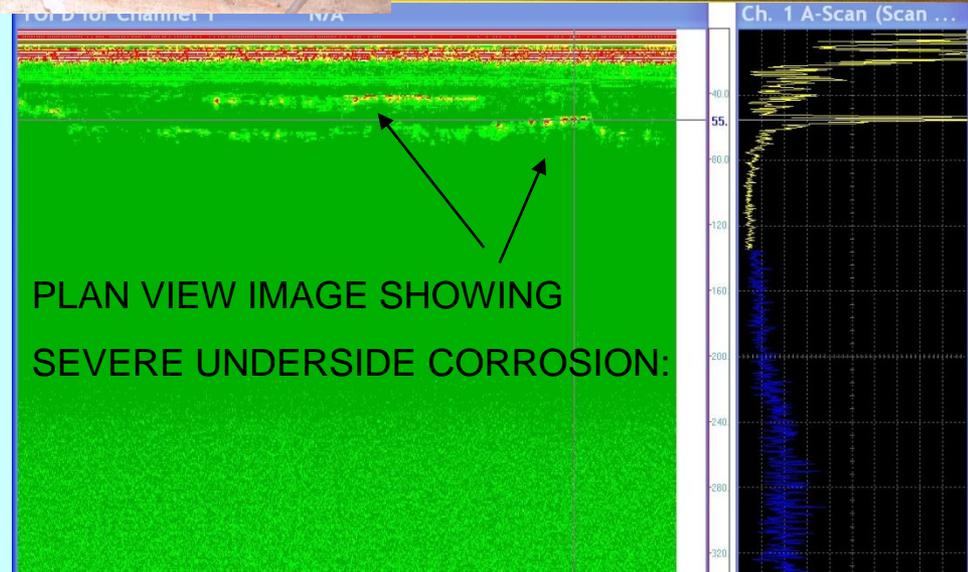
PLAN VIEW IMAGE SHOWING SEVERE UNDERSIDE CORROSION:

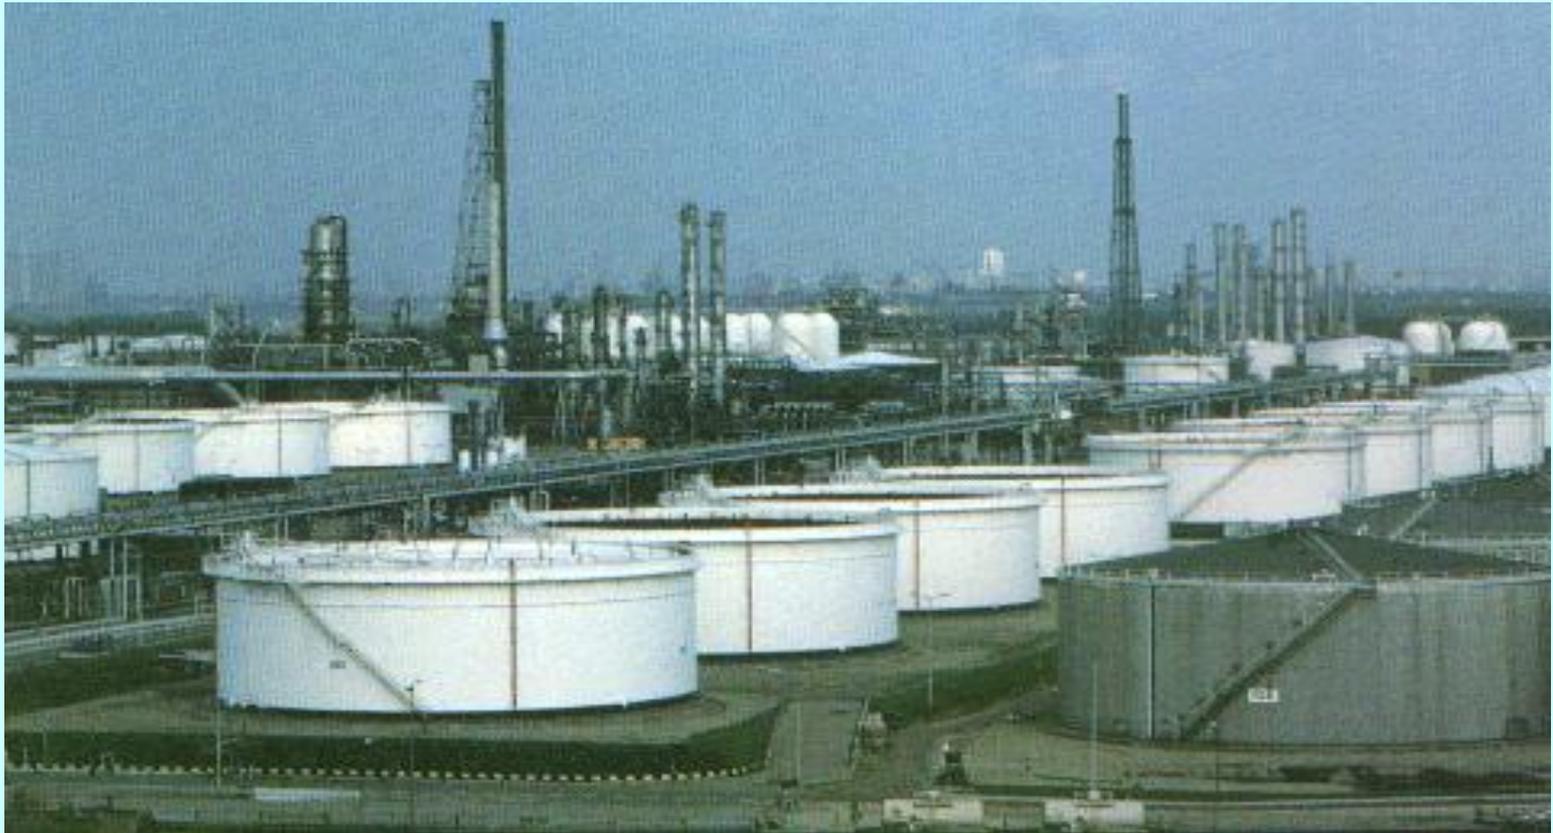
Tank Floors are the only structural part of a tank with no access for inspection during operation

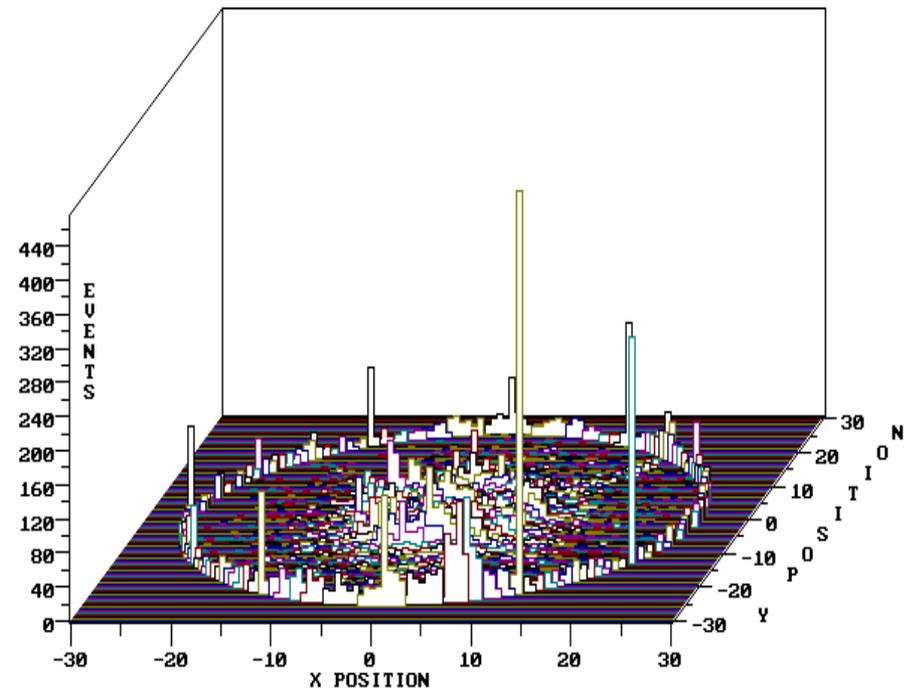
# Hot Fuel Oil Tank 50m

- “E” grade overall.
- Annular ring very active.
- Dug underneath annular ring in most active areas:
  - » Up to 8mm loss of metal on 15mm annular plates
- Tank shut down immediately, avoiding failure (see next slide).

**3D LOCATION FOR "ALL DATA"**

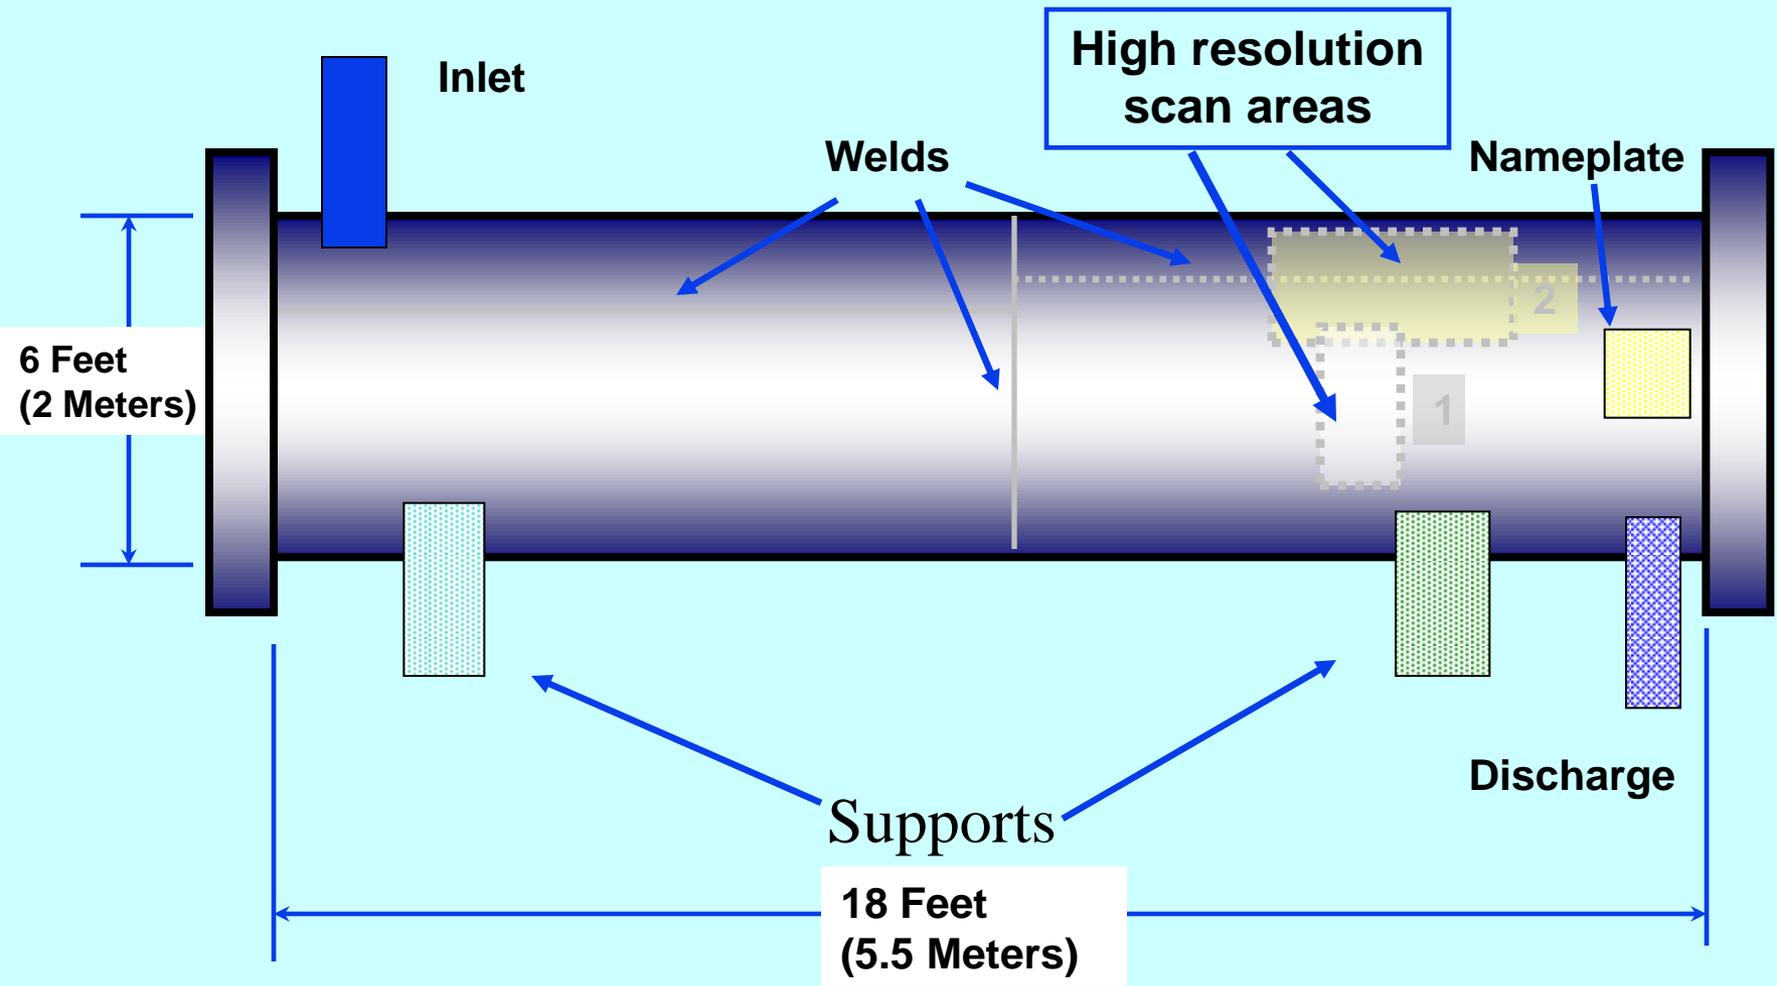
# Example of Heat Exchanger Shell Inspection

## 100% Area C-Scan plus selected High Resolution scans

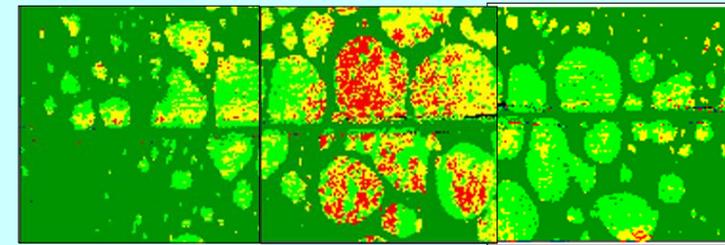
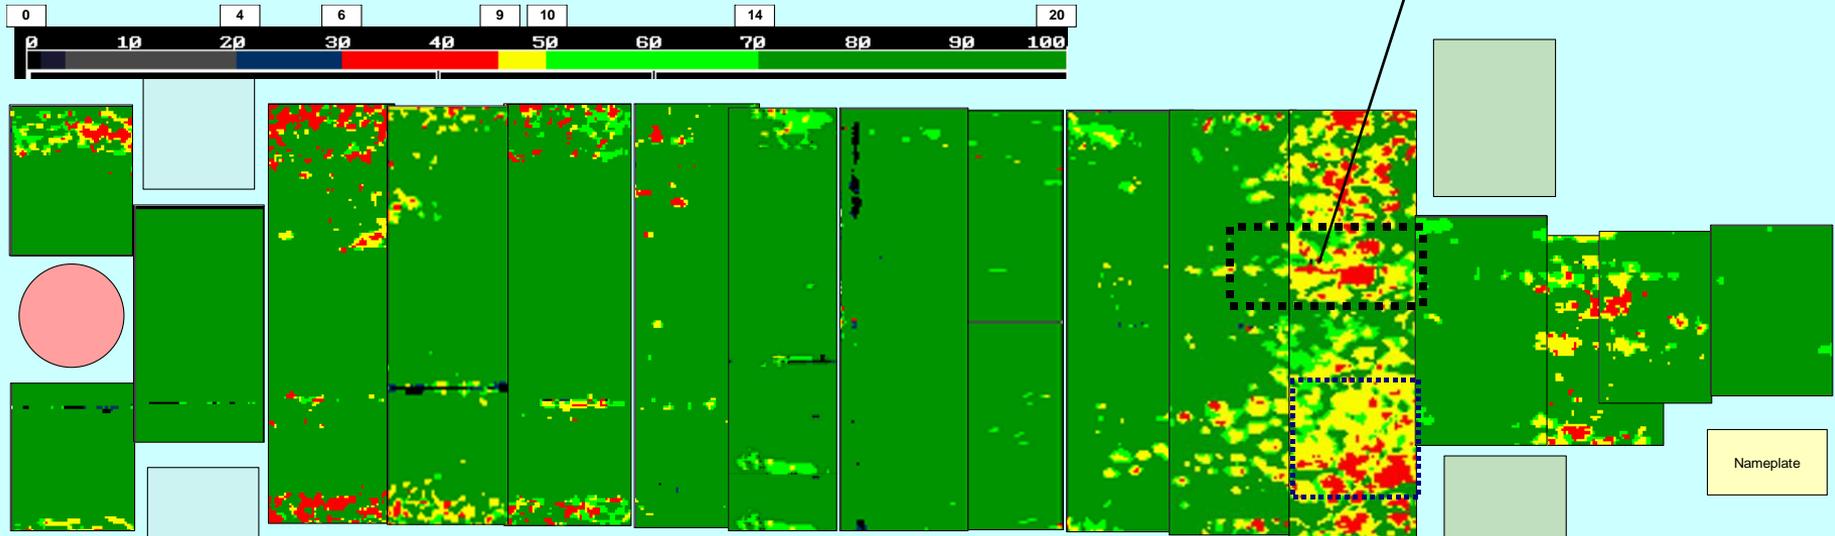
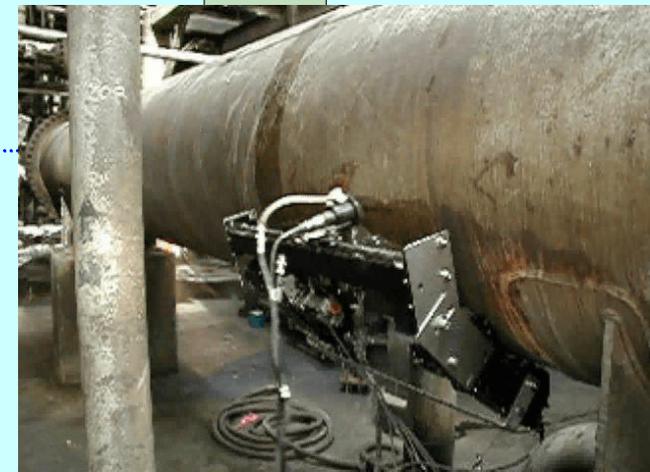
# Example of Heat Exchanger Shell Inspection Imaging Results with LSI System

## 100% Surface Area C-Scan

Scan Time: One shift

HR scan 1 x 1mm, 750 x 250 mm area

100% UT Coverage at 5 x 10mm resolution

Color-coded thickness map – also showing location of obstacles and supports – top of tank is at center of scan. Vertical axis is tank circumference.

1mm x 1mm high resolution follow-up scan.

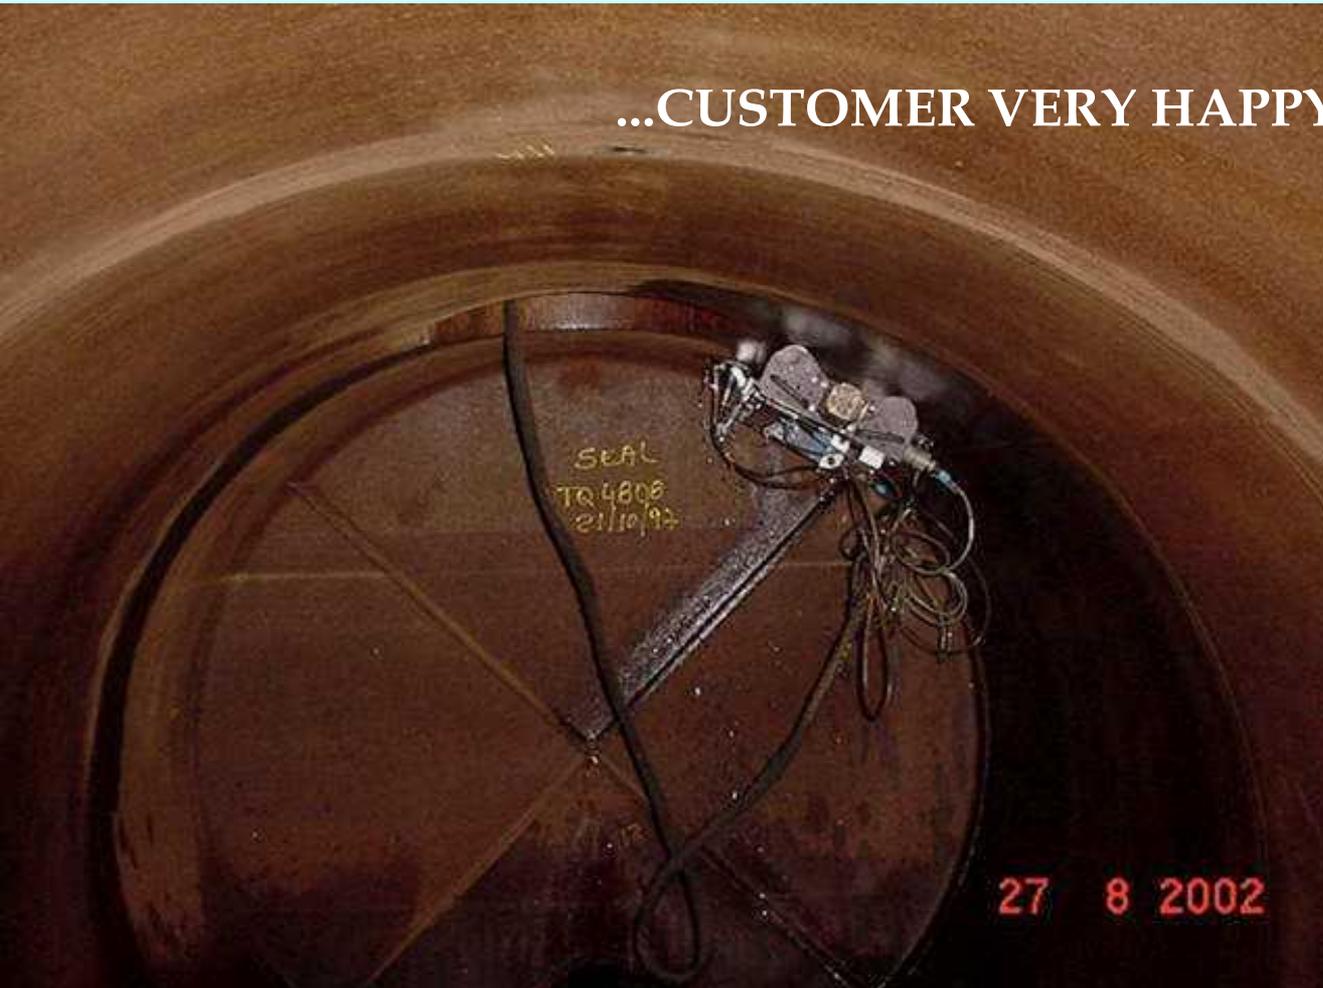
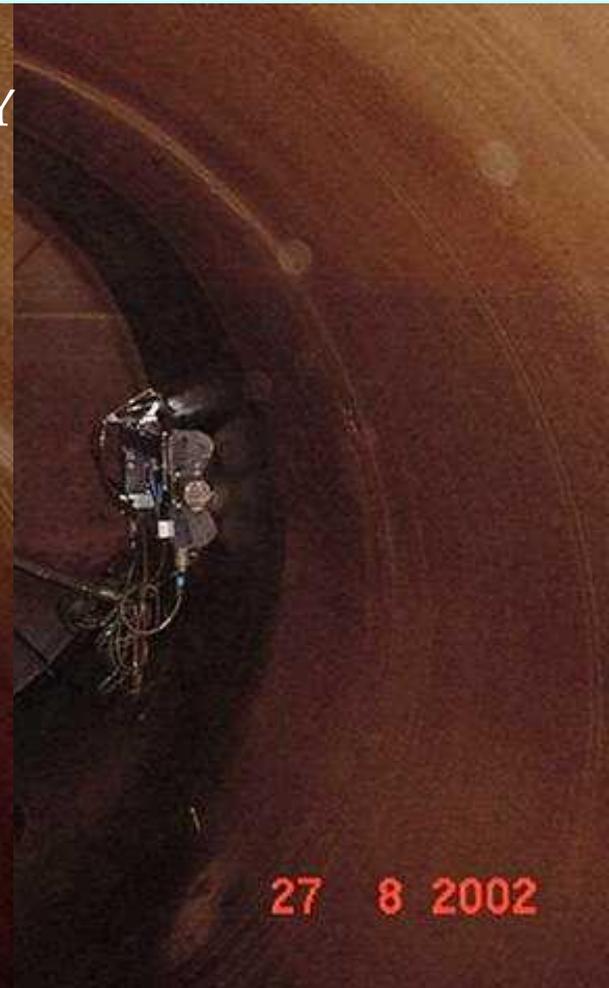
# LSI APPLICATIONS - INTERNAL INSPECTION

USED FOLLOW UP AE TESTS ON THE 1500 BURIED PRESSURE VESSELS.....COMPLETE SOLUTION.....

- Buried 5m diameter, 35m T-T.
- Nominal 32mm with 3mm corrosion allowance.
- LSI scanned from inside.
- 840 scans 500mm x 1300mm (65,000 readings each, total 54,600,000 thickness measurements).
- Measurement resolution 0.1mm.
- Dual range gates, 3-33mm and 28-33mm.
- 10 days scanning time.
- Indications:
  - » Grinding marks
  - » Plate inclusions.

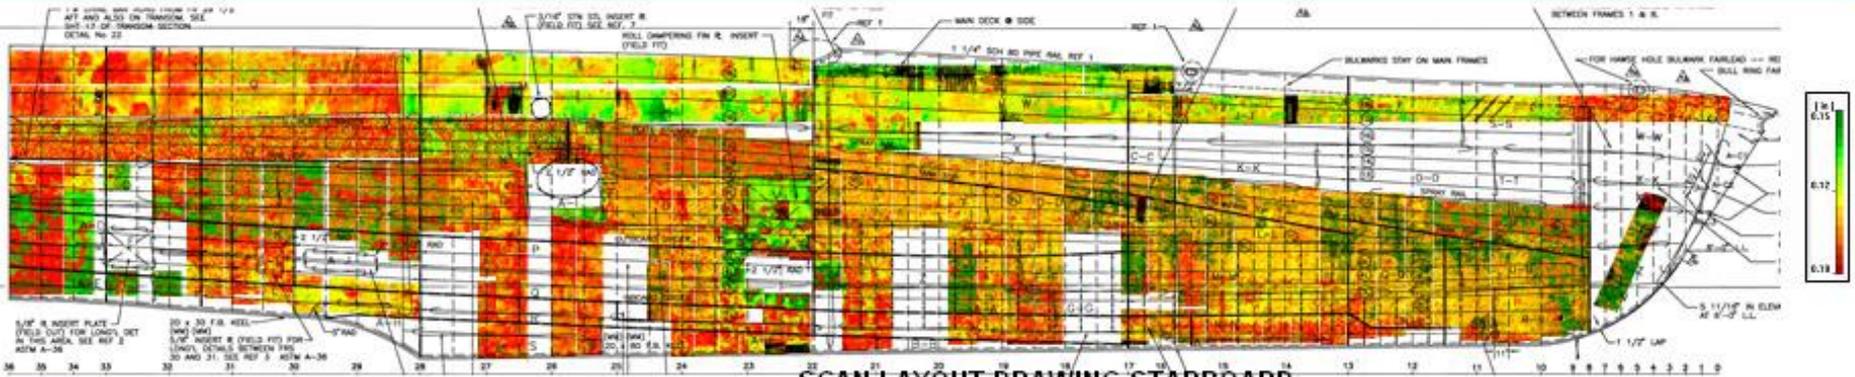
# Corrosion Mapping On Ships and Vessels

SCAN LAYOUT DRAWING STARBOARD  
USCGC SITKINAK 110 FEET HULL

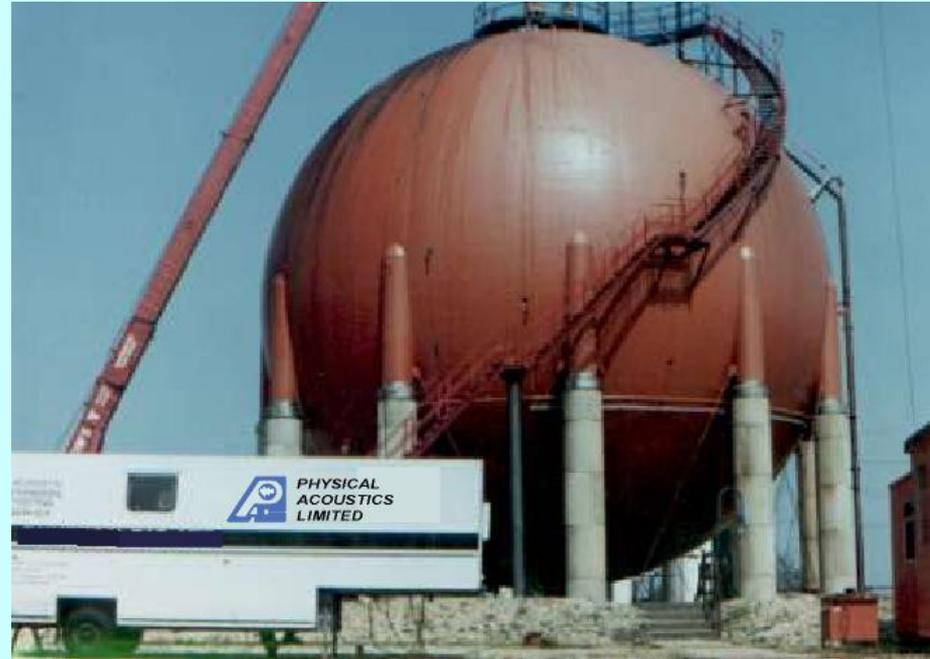
# AE-Storage Spheres and Bullets

- Majority tested on-line using MONPAC™ procedure (Monsanto licence based on >1000 tests).
- Pressure raised by product or gas injection.
- Abseilers used for sensor placement.
- 95% “good” resulting in continued operation.
- >1000 tests in Europe.
- Procedure adopted by ASME for new vessels.

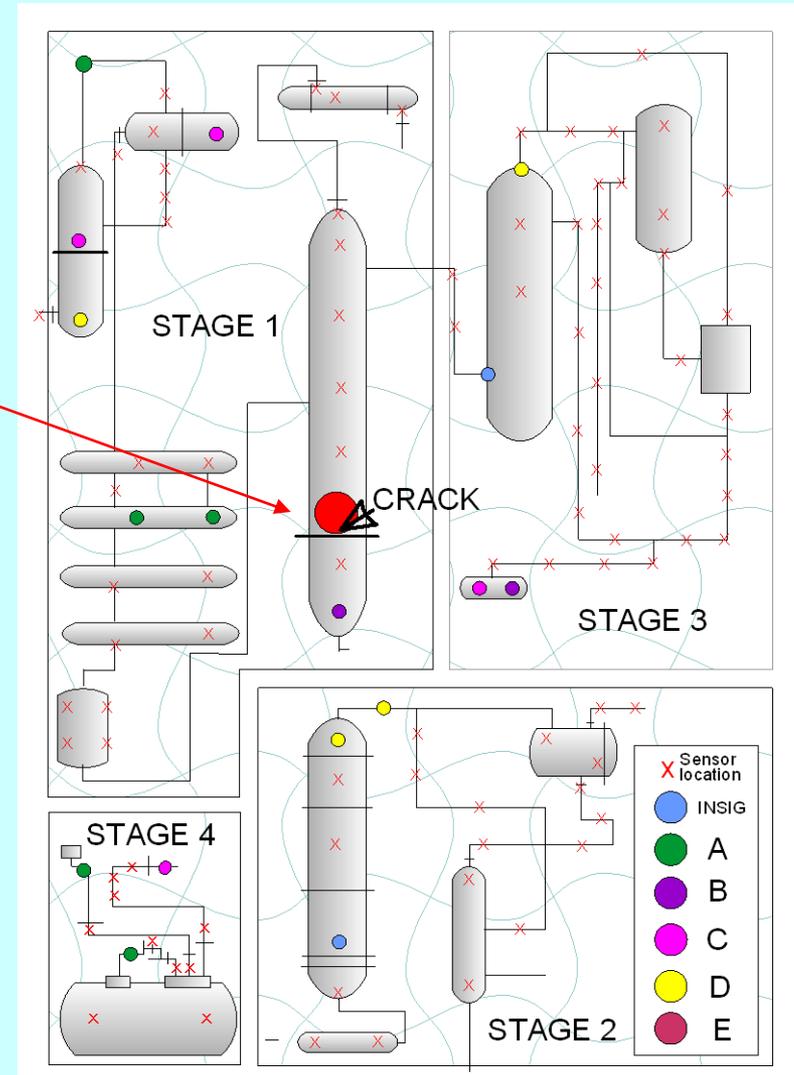
# 134A Process Plant Schematic showing MONPAC grades.

Hastelloy Process System.  
Pneumatic test with MONPAC AE Monitoring.

CRACK Confirmed by local inspection at “E” grade location 12 months later when Column was separated at flange.

To Date test Carried out on entire process system on Four Occasions at start of Planned Shutdown.

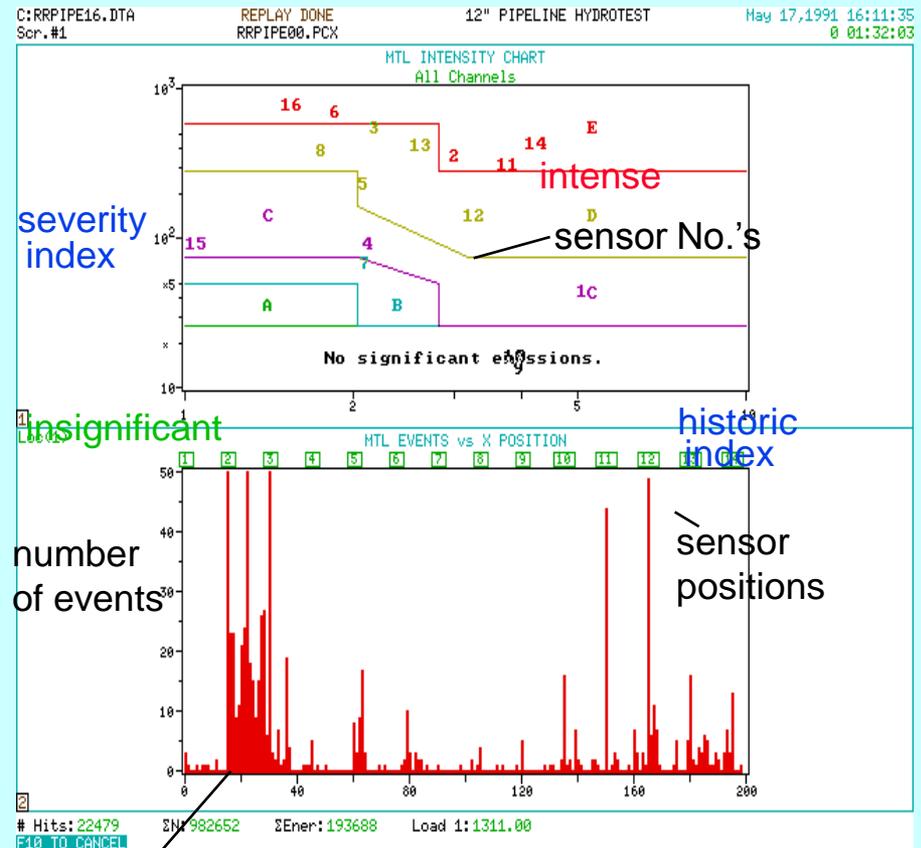
- Sensors spaced 10-50 metres apart.
- Procedure “A” requires pressurisation.
- Procedures “B” requires line to be “dead” and in a quiet area of plant.
- “A” gives direct integrity
- “B” highlights active corrosion.
- Leaks also detected if turbulent.

Intensity evaluation showing major damage

AE sources along 200 metres of line

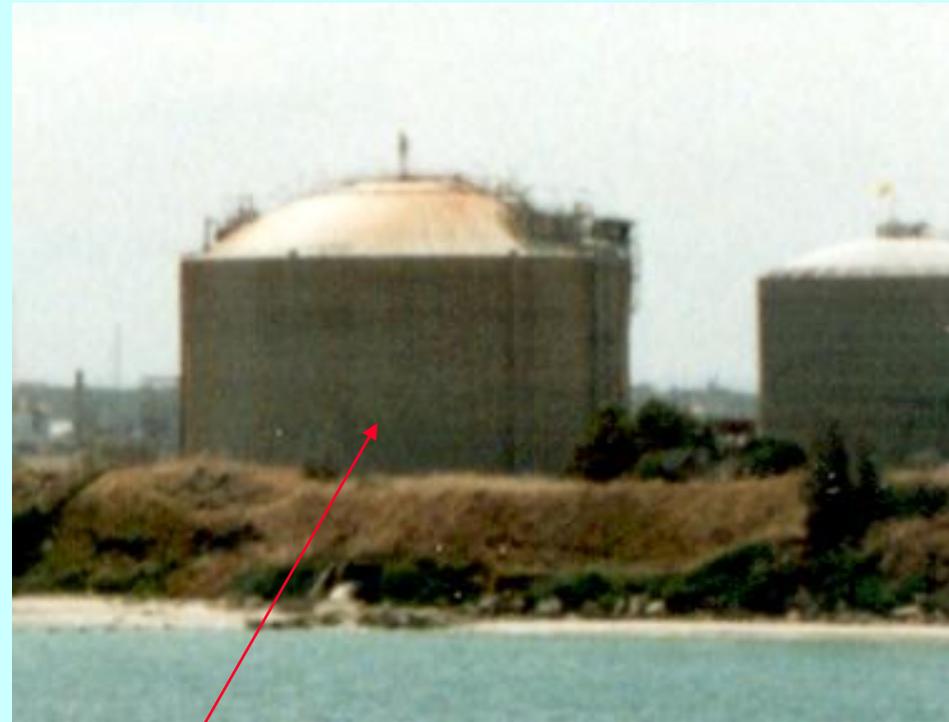
# 30,000 ton Cryogenic Tank

- 10 year Re-certification:
- Design review.
- In-service AE test:
  - » MONPAC™ procedure.
- Other NDE:
  - » ACFM for roof welds and hold-downs.
  - » C-Scan for roof corrosion.
- Savings >>\$1m.

*Concrete Bund Wall, inner steel tank.*

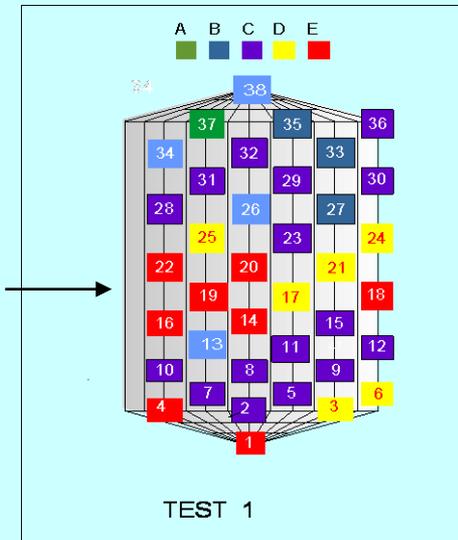
- 30m x 4m, concern about ext. Chloride SCC under insulation.
- MONPAC test using nitrogen:
- Follow-up NDT (DP) found through-cracks.
- Repaired by patching, cleaning and treating.
- 2 years later follow-up MONPAC test indicated further problems:
- Knifeline corrosion on internal weld HAZ.
- 16 shifts of welding to repair.
- Corrosion was caused by process running column “lean” to save \$’s.
- Major incident avoided.

External SCC,  
(through-wall)

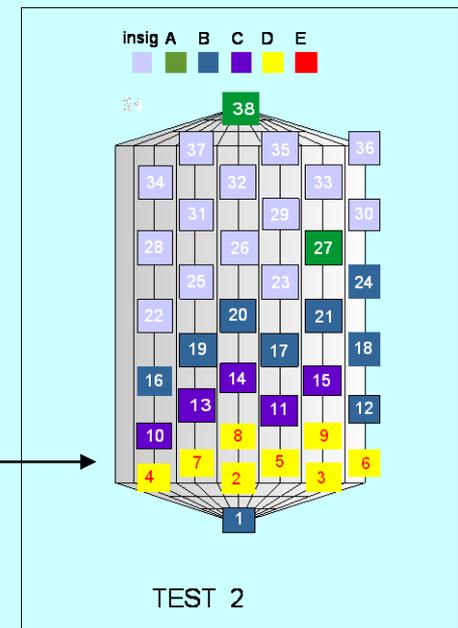
Knifeline corrosion  
of weld HAZ  
(internal to 40%)

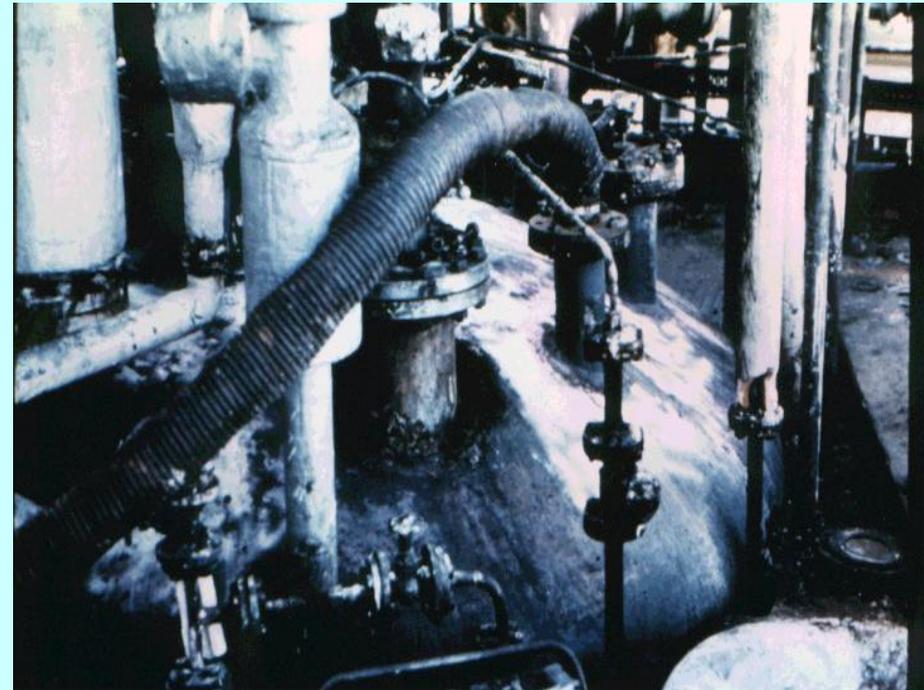
# Stainless Reactors with SCC

- Operating 0.5 bar:
  - » AE test 0.55 bar.
  - » design 6 bar.
  - » Nitrogen injection during temporary process stop.
- MONPAC “E” grade on top heads of two reactors. (five tested at same time).
- At shutdown SCC from inside, 80% through wall, confirmed. Top heads were replaced.
- Advance warning saved >\$2 million production.

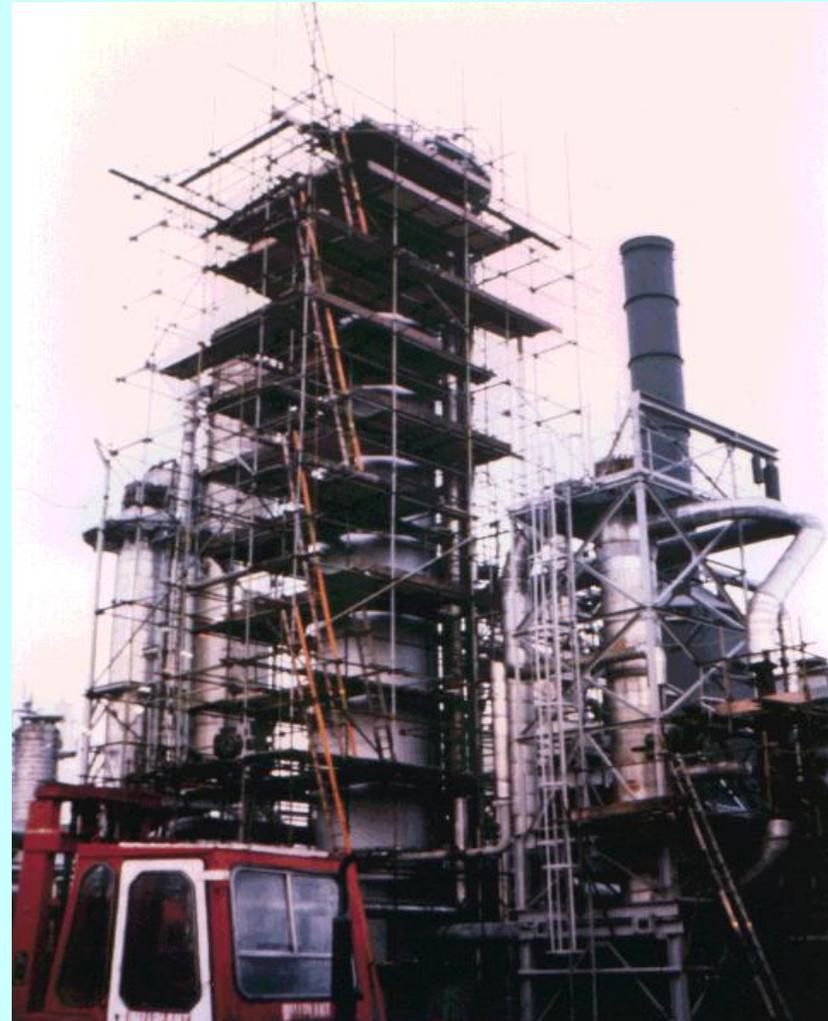
# Ammonia Converter

- Multi-layer construction not inspectable conventionally, layers transmit LF sound at higher pressures.
- Thermal stress during startup/cool-down is main concern.
- Waveguides used due to the temperature.
- “Signature” from AE source location is compared at each startup/shutdown.

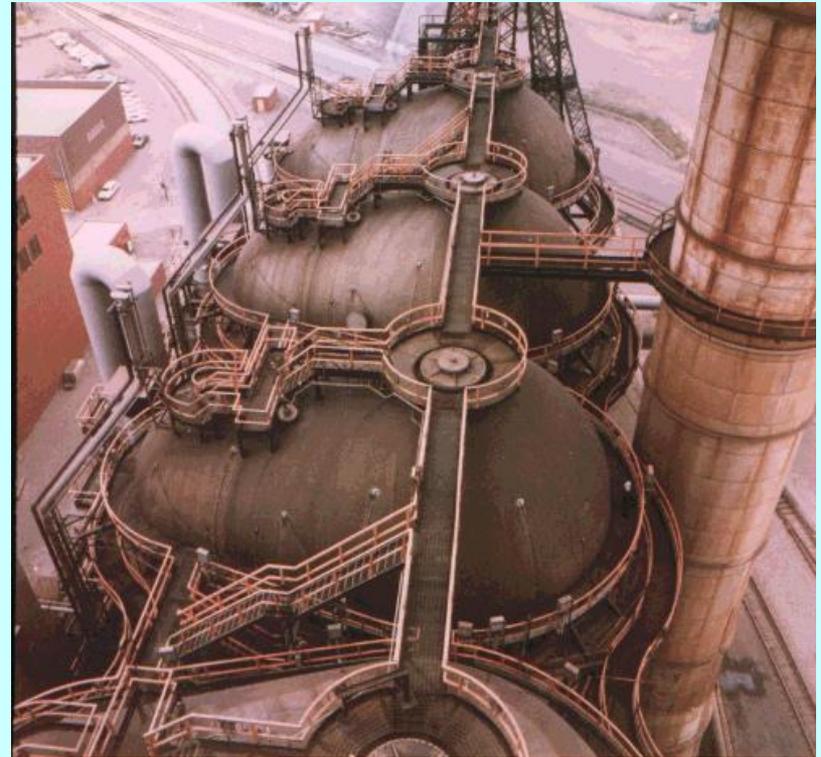
# Hot Blast Stove Domes

- Concern about nitrate SCC.
- 32 AE sensors on each of four stoves.
- 32 channel AE system switches between stv.
- Manufacturing defects and fatigue cracks located (cycle 20 mins.)
- 24 hrs./quarter gives sufficient data.

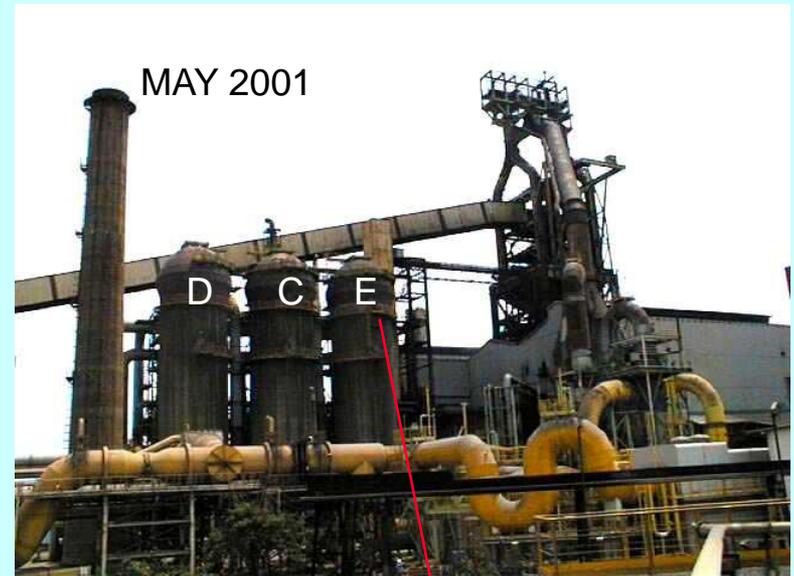
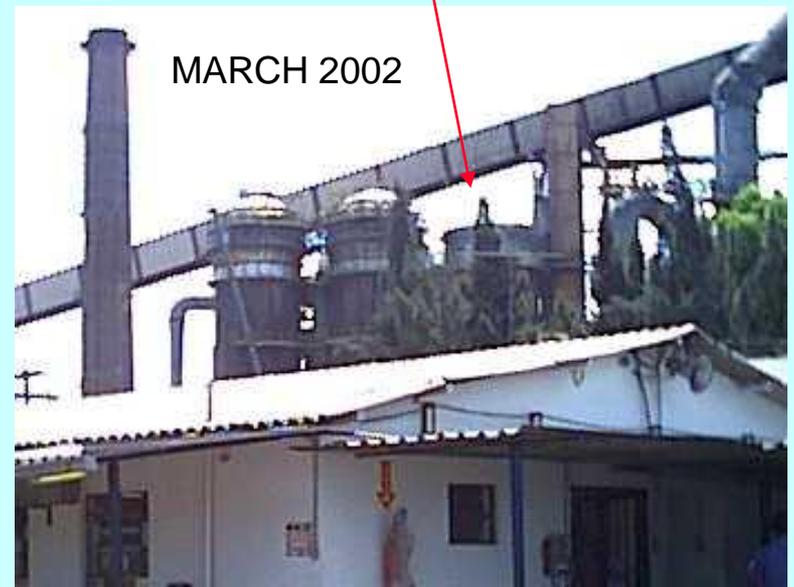
# Steel-Hot Blast Stove Dome-Example (or “don’t ignore E- grades”)

- Concern about nitrate Stress Corrosion Cracking.
  - » Stove Dome has blown off in several countries!!
- ~32 AE sensors on each of three stoves.
- In-service monitoring for 24 hours per stove.
- Serious problems identified by AE test, c/d/e grades.
- Results not acted upon.
- Stove dome blows off 10 months later!!!

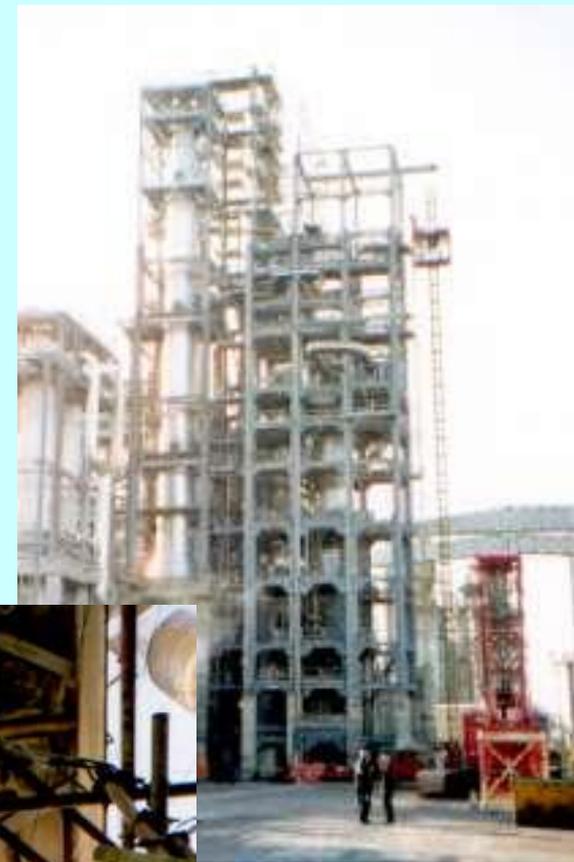
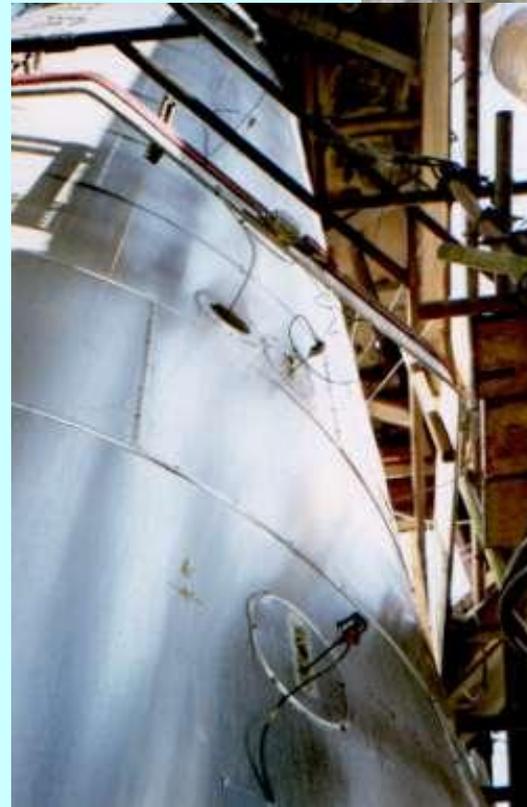
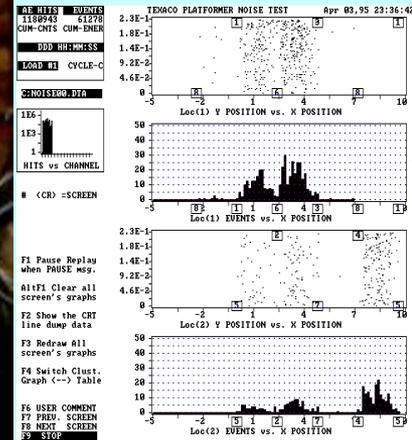
# Platformer Reactor

- 48m high, 3m diameter
- 3 vessels “stacked” on top of each other.
- Continuous process with catalyst.
- Stainless internals and lining.
- 550 degrees C operation, 64 welded waveguides.
- High thermal stresses:- cracks during start/stop.
- AEM during shutdown.

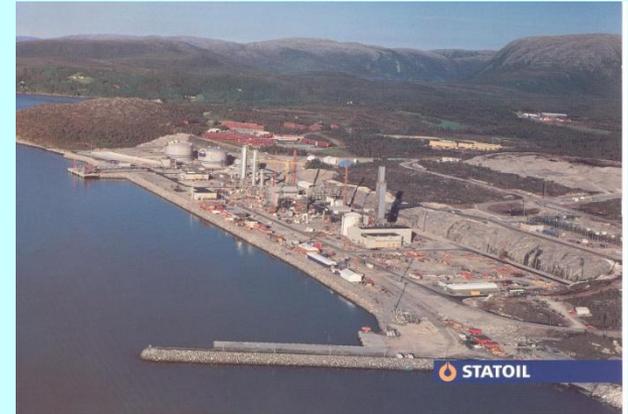
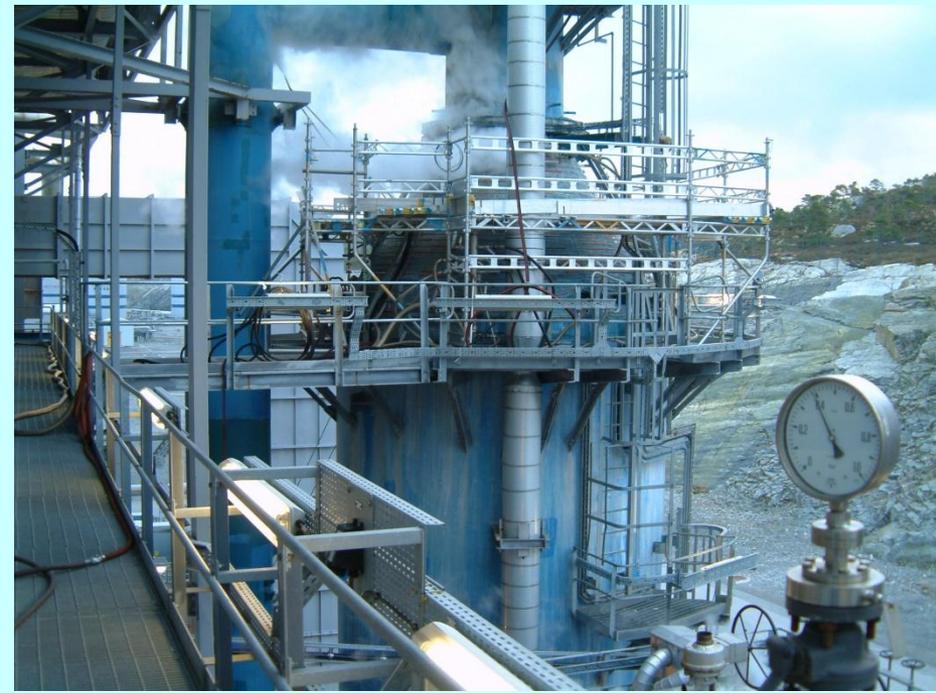
# Methanol Secondary Reformer Continuous “Alarm” Monitoring

- Refractory lined vessel.
- Hydrogen and steam at 40 bar and 780>1300 deg.C.
- 100mm thick shell.
- “Blow-Out” at another unit is reason for alarm system.
- Refractory failure results in shell burn-through in less than 2 minutes.
- Thermal monitoring too slow to stop burner.

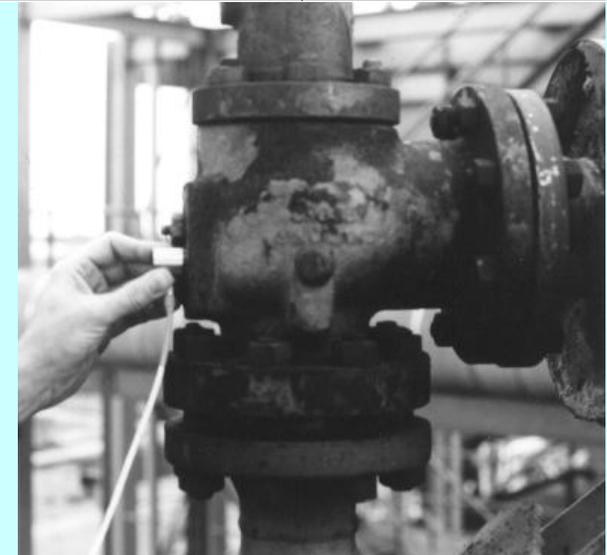
# VPAC-Quantification of through-valve leakage

- BP Licence.
- Intrinsically safe.
- Simple/quick.
- Quantitative: litres/min.
- >500 systems in use.
- Savings:
  - » BP Kwinana 14k tons/yr.
  - » Mobil US \$3m to \$12m/site.
  - » Shell UK 3-5 systems/site.

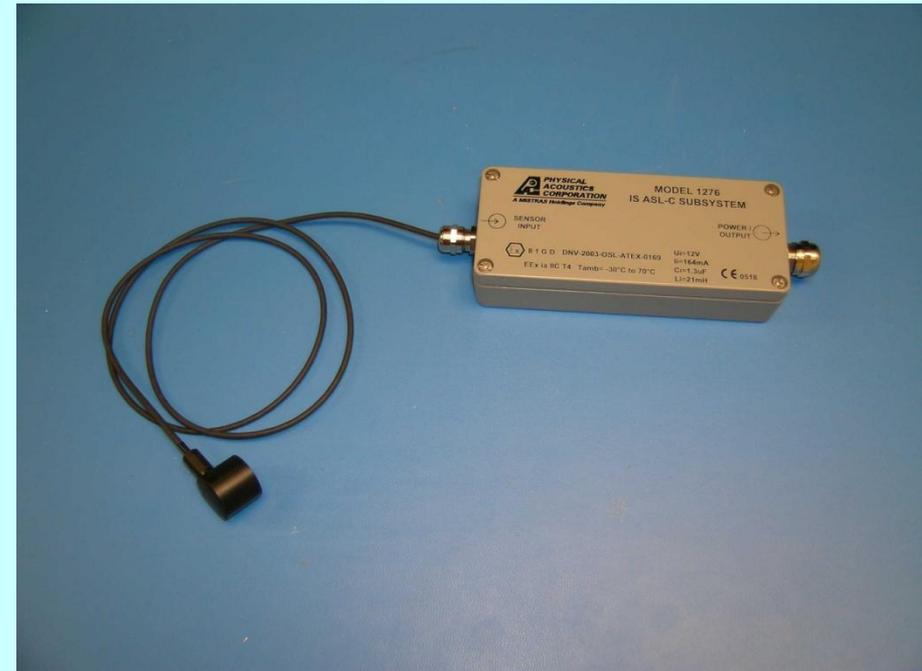
## 1276-IS-ASL (Series of I.S. systems)

- ASL series has 4-20ma output to DCS or PIE.
- Intrinsically Safe, uses standard barriers.
- Custom configurations for:
  - » Leakage through valves.
  - » Leakage in pressure systems.
  - » Airborne leakage in boilers.
  - » Airborne leakage in offshore modules\*.
  - » Simple Particle Monitoring to control erosion.
  - » Pig detection and monitoring.
  - » Burners.
  - » Mixing and blending operations of minerals and pharmaceuticals.
- 1276 I.S. pre-amplifier and sensors for AE monitoring.

\* 5mm diameter methane leak at 10 bar, detected at > 35 metres
