# Composite Solutions for Returning Strength to Damaged Assets

By Peter Johnson  
Belzona Polymerics

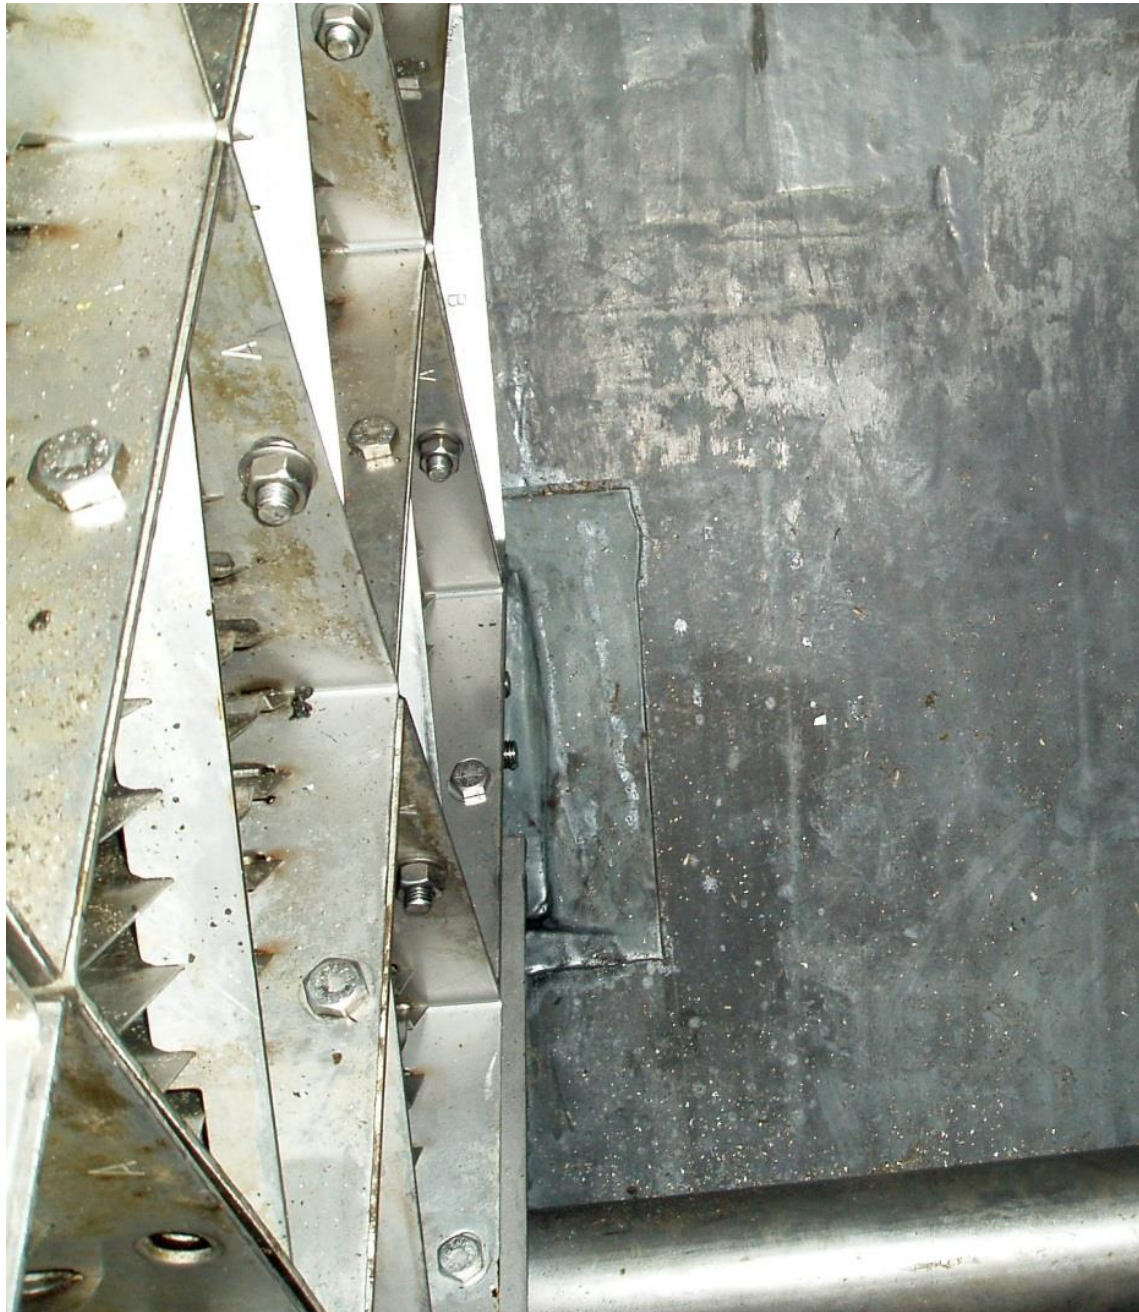
Inspection after 8 years in service, flawless

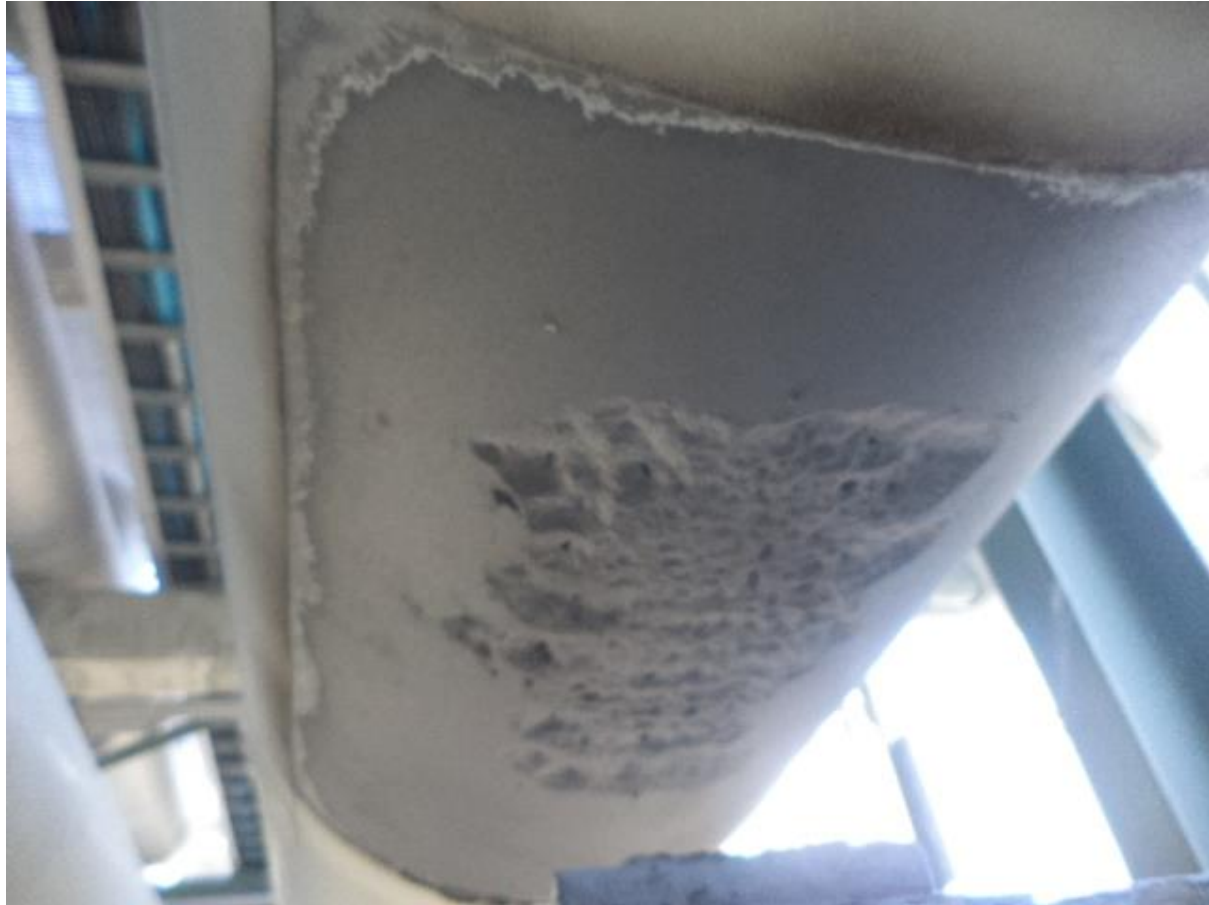
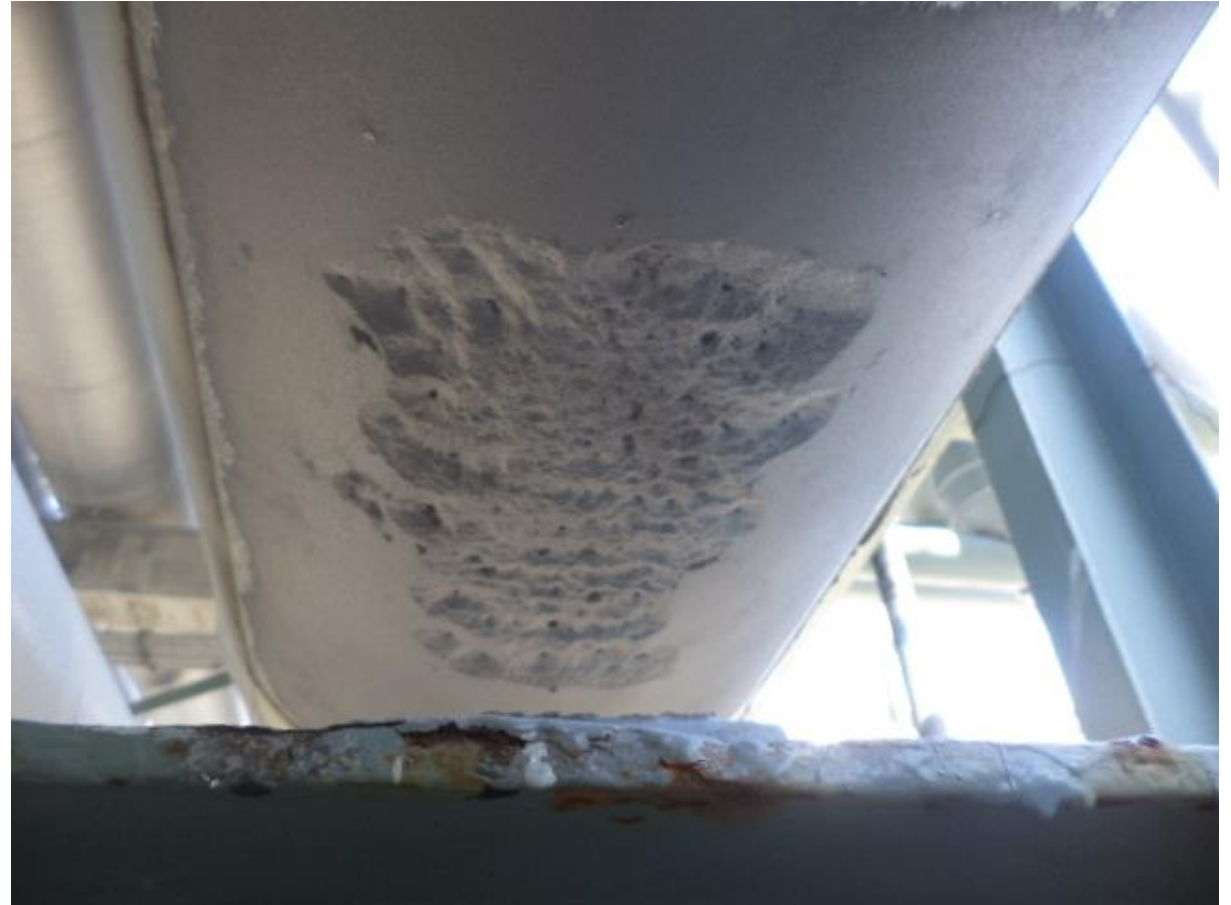
Condition of Corrosion Under Support – After Wet Blasting  
Severe metal loss revealed

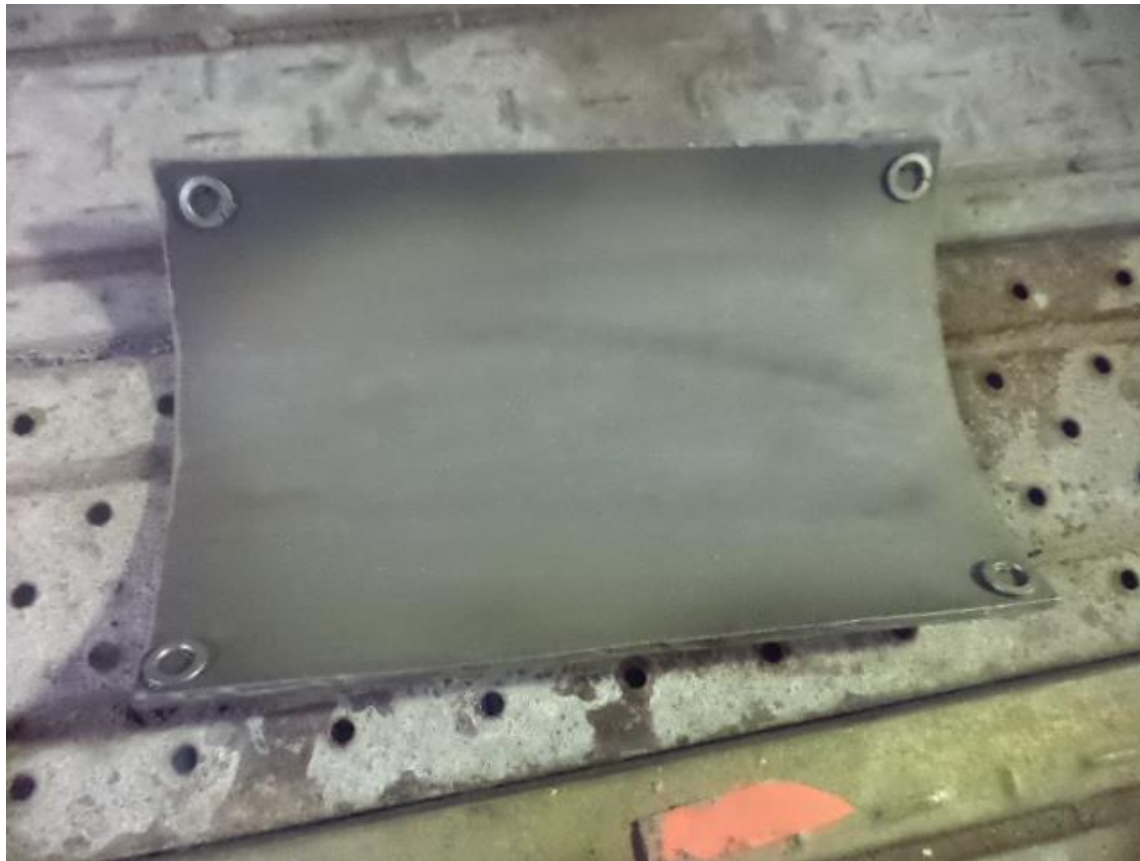
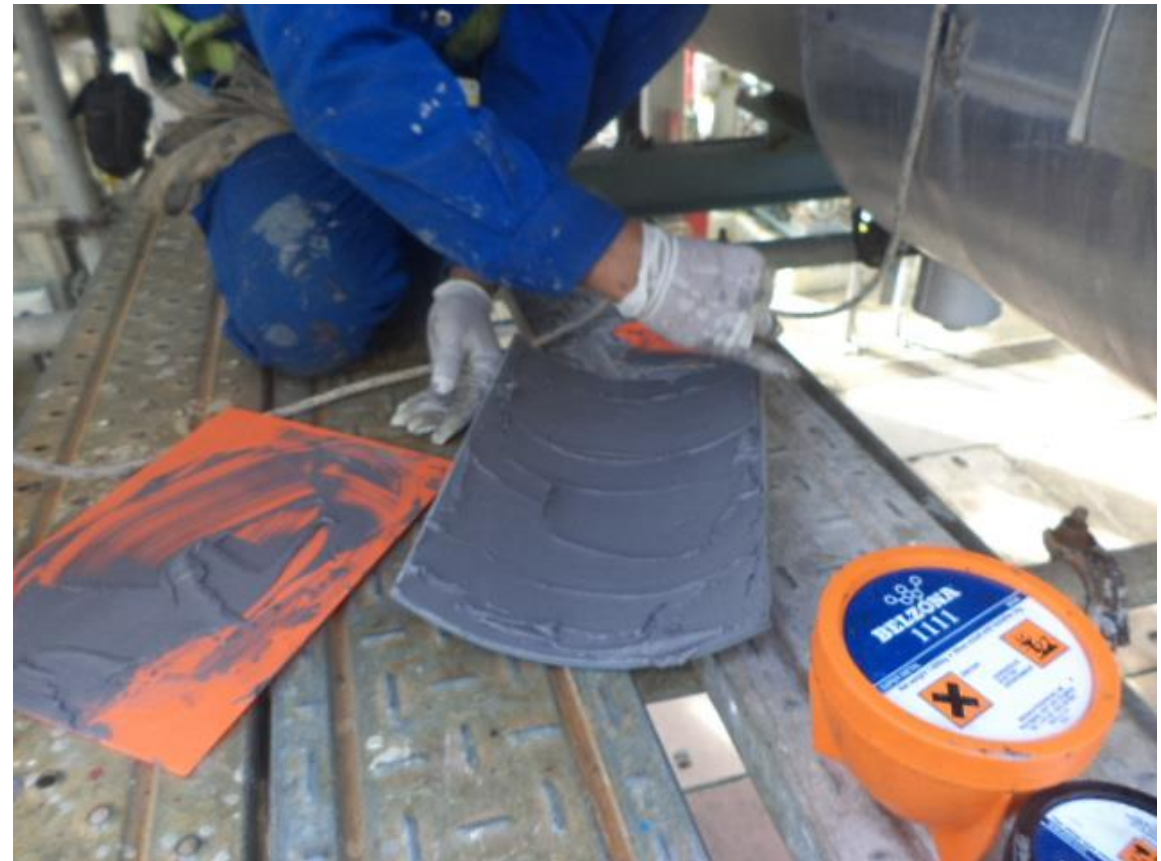
Belzona 1111 Supermetal was used for bonding metal plates provided by customer  
Plate size was 350 mm.x 250 mm. Bonding thickness was 2 mm.

Apply Belzona 1111 on the metal plate

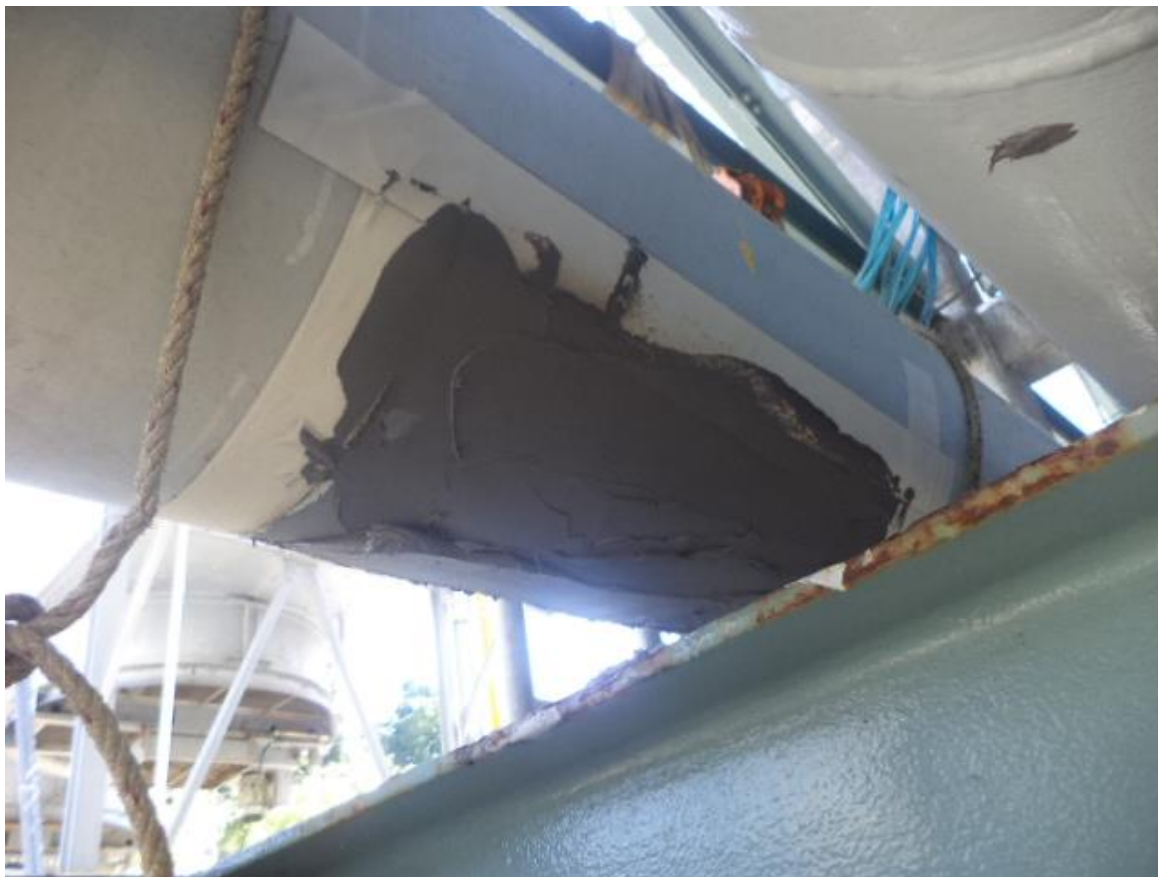
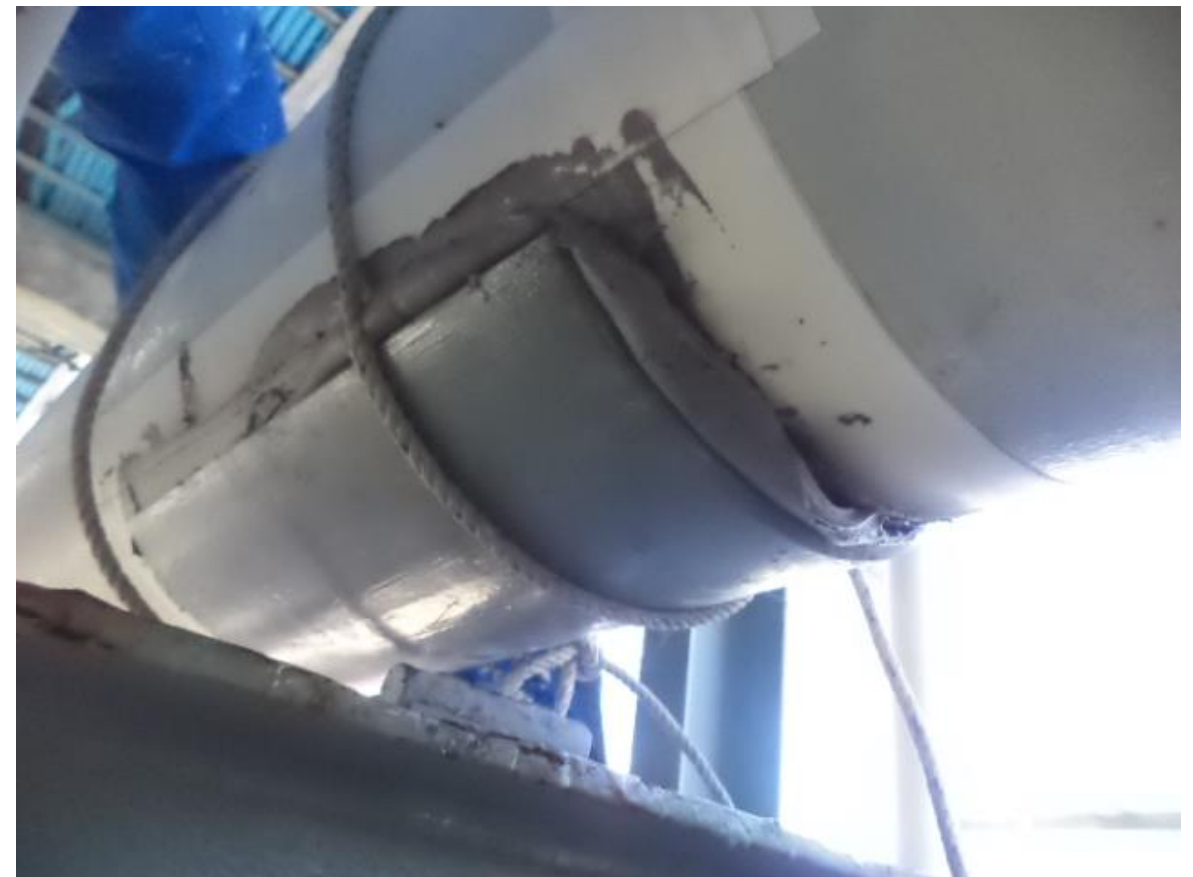
Pipe section was lifted up , bonded with metal plate securing with strap.

Bond metal plate with corroded pipe

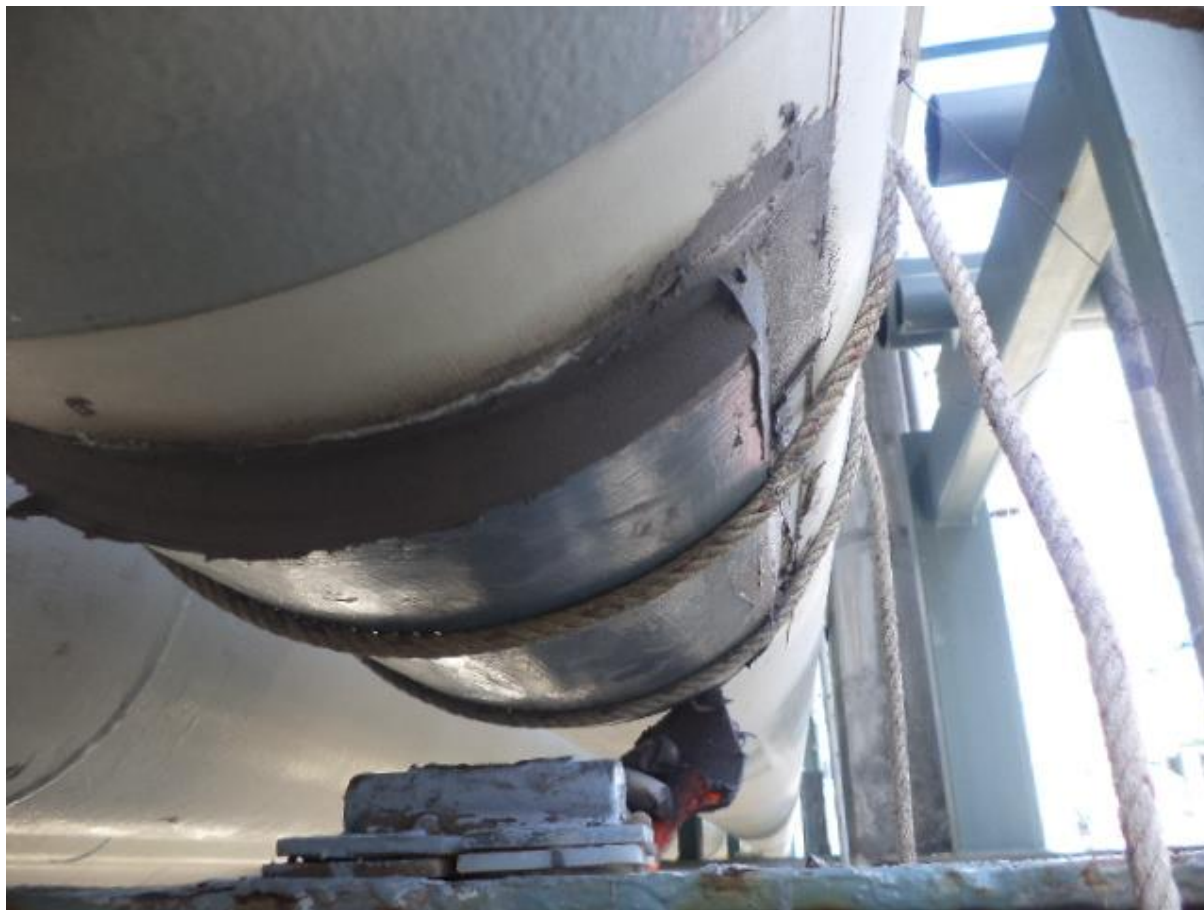
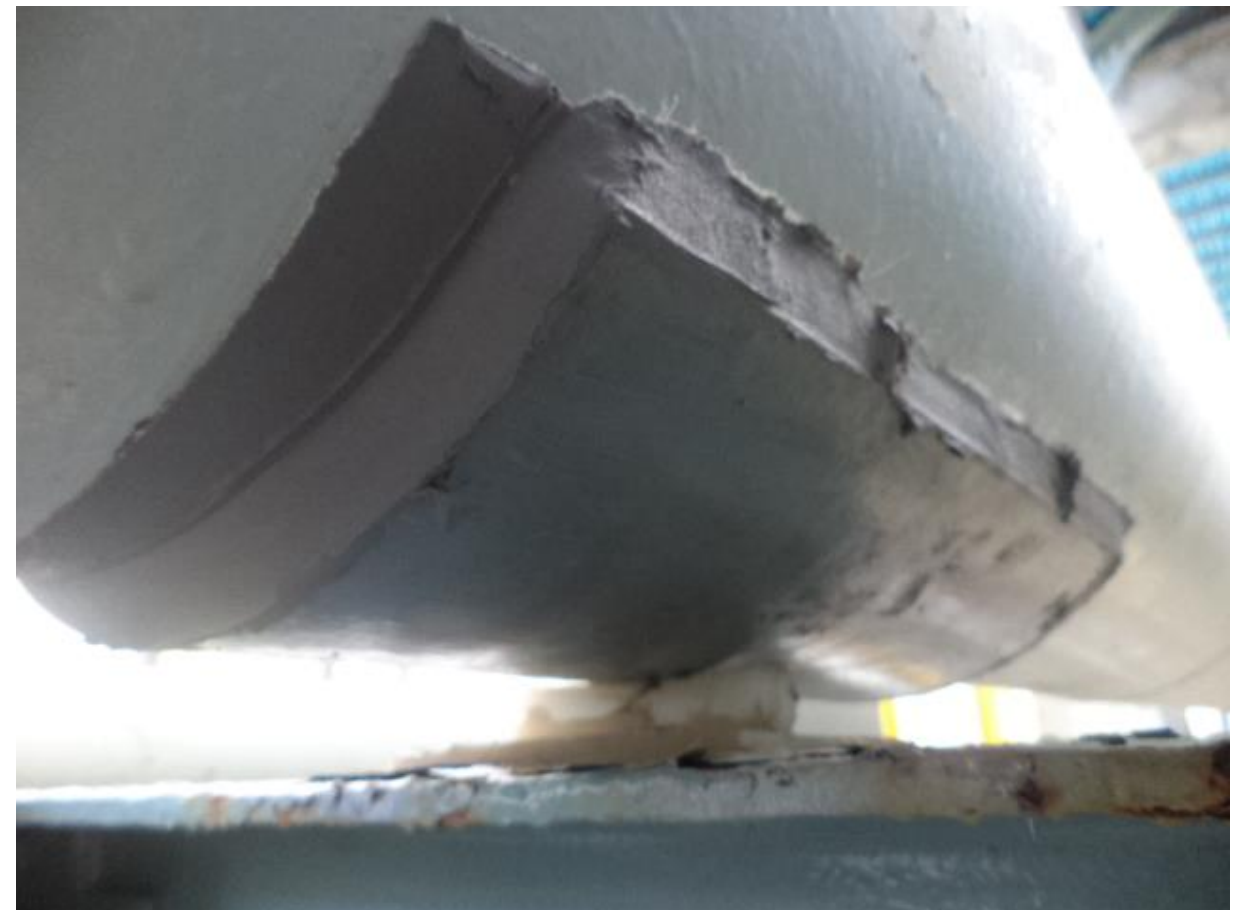
Pipe section was lifted up , bonded with metal plate securing with strap.

Bond metal plate with corroded pipe

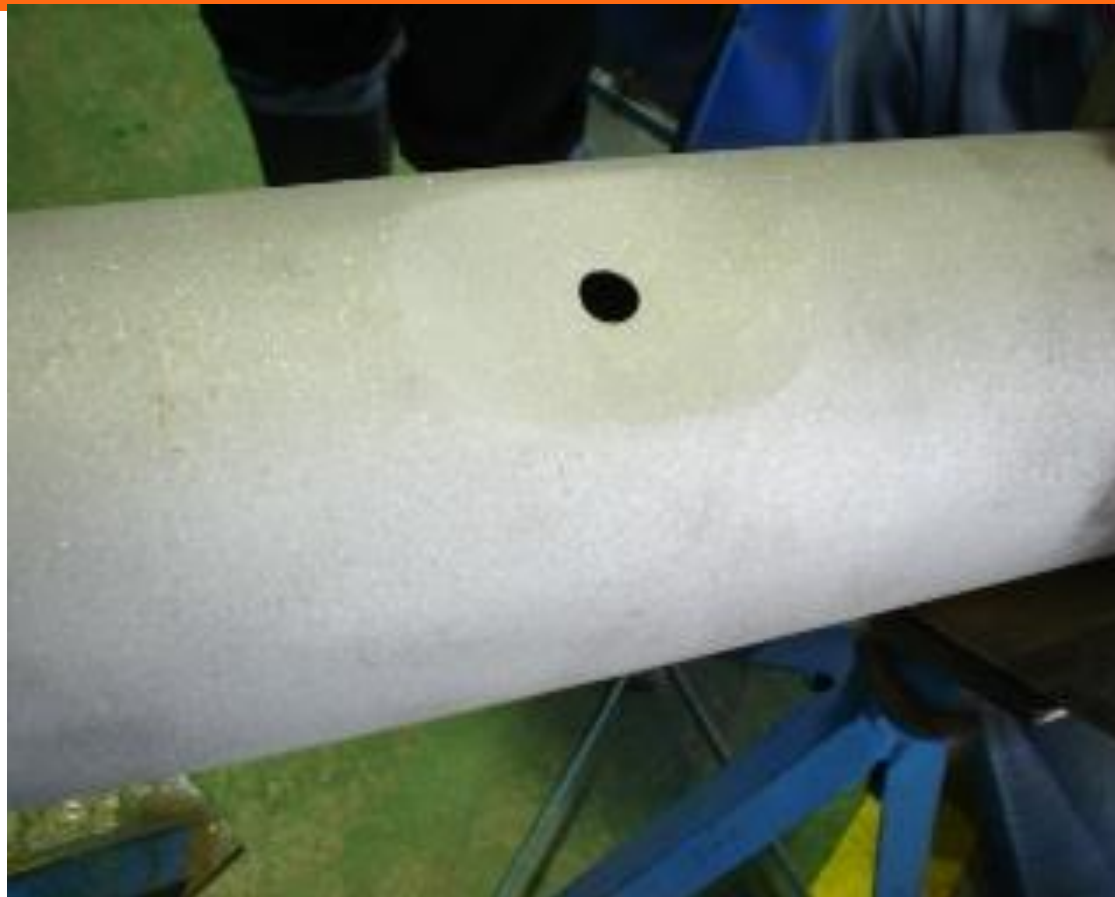
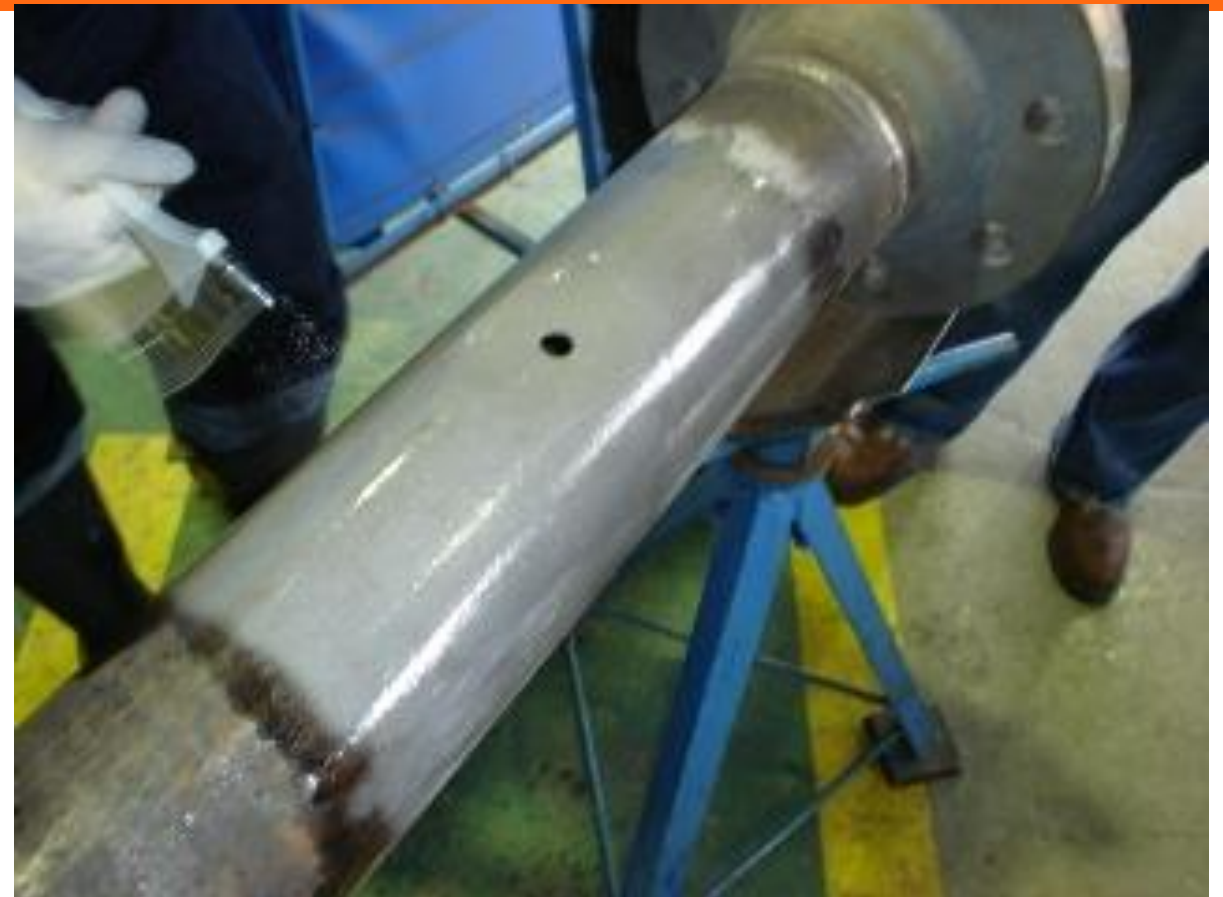
- Prepare another 2 x pipe spools, specification as follows:
  - 4-inch pipe, API 5L Gr. B, Sch. XS (8.56 mm)
  - Pressure-Temp Rating = 1,350 psig at -20 to 100 F.
  - Drill small hole (approx. 10 mm Dia.) and grinding of metal wall to imitate the leak and corrosion.

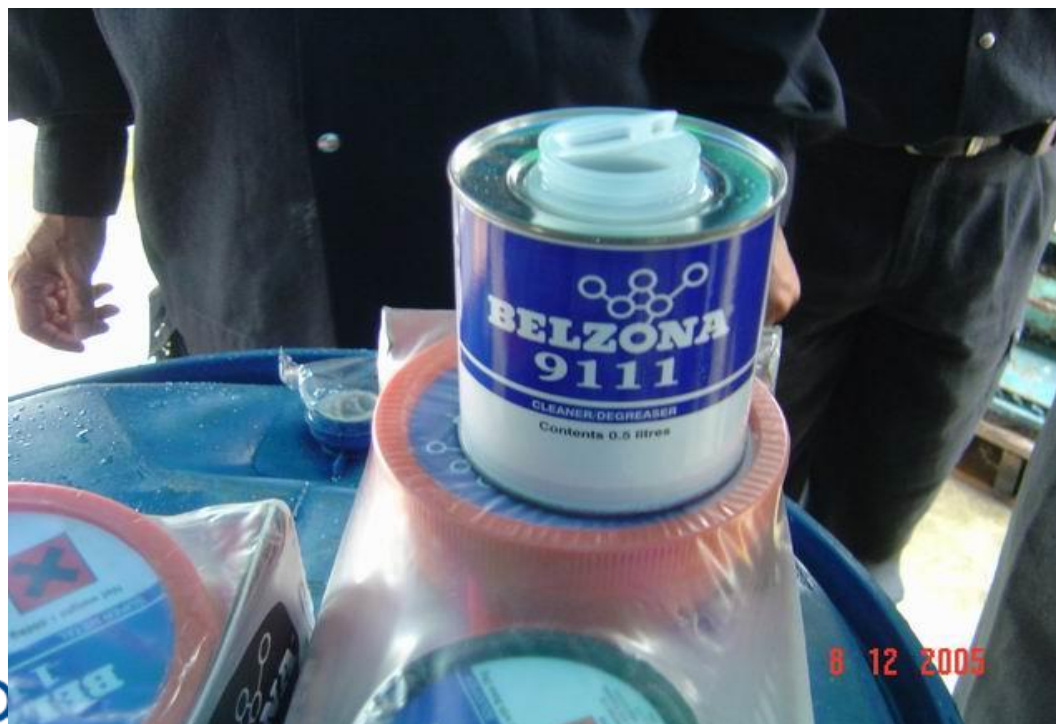
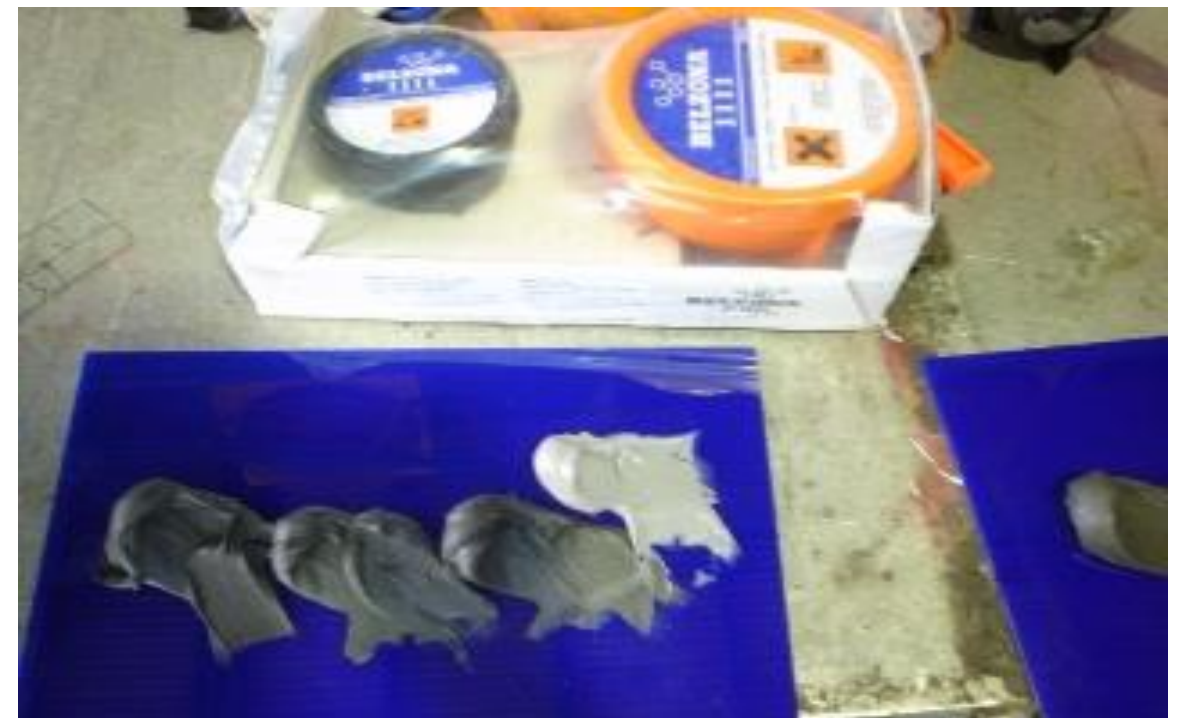
- Follow the same procedures for Abrasive Blasting and Cleaning Surface with Belzona 9111 (N.F. Cleaner/ Degreaser).
- Followed by application of Belzona 1111.

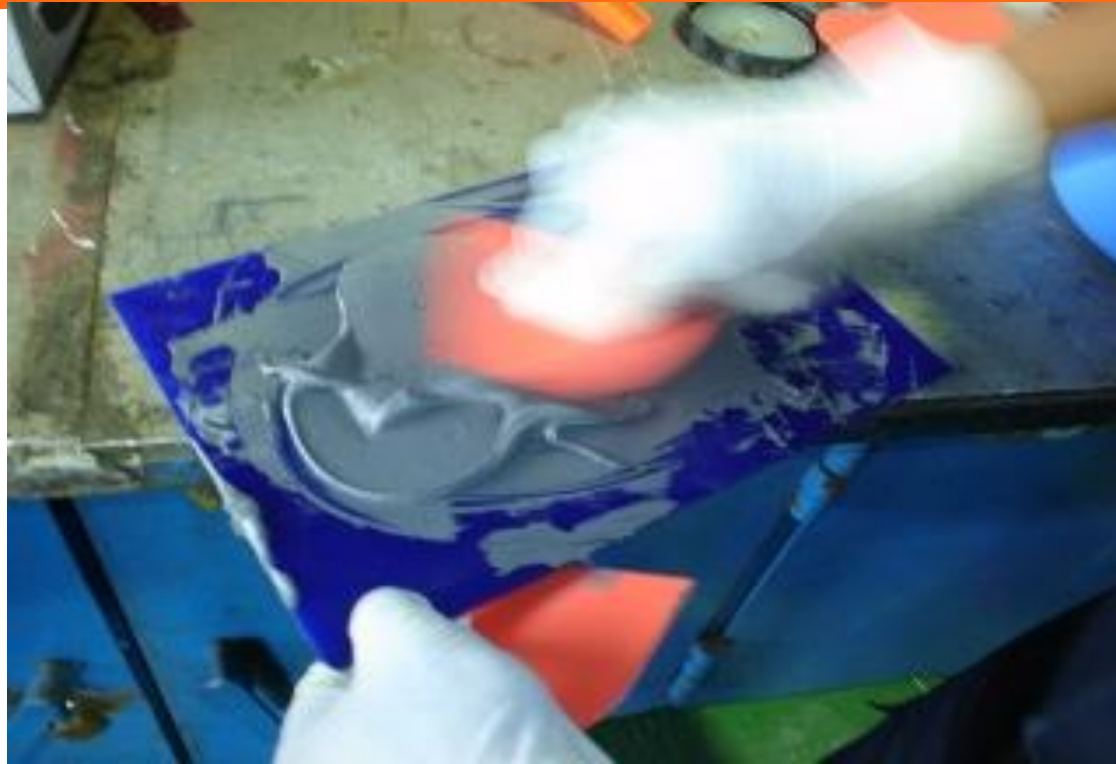
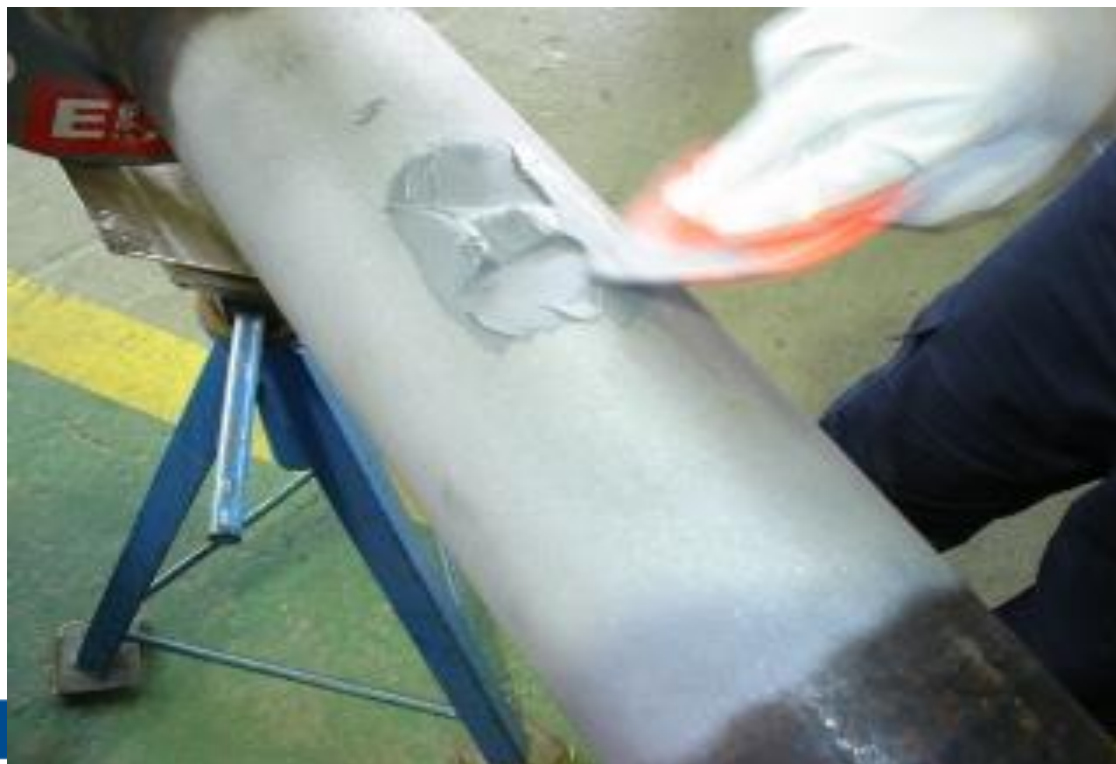
- Belzona 1111 was mixed and applied to the defect area

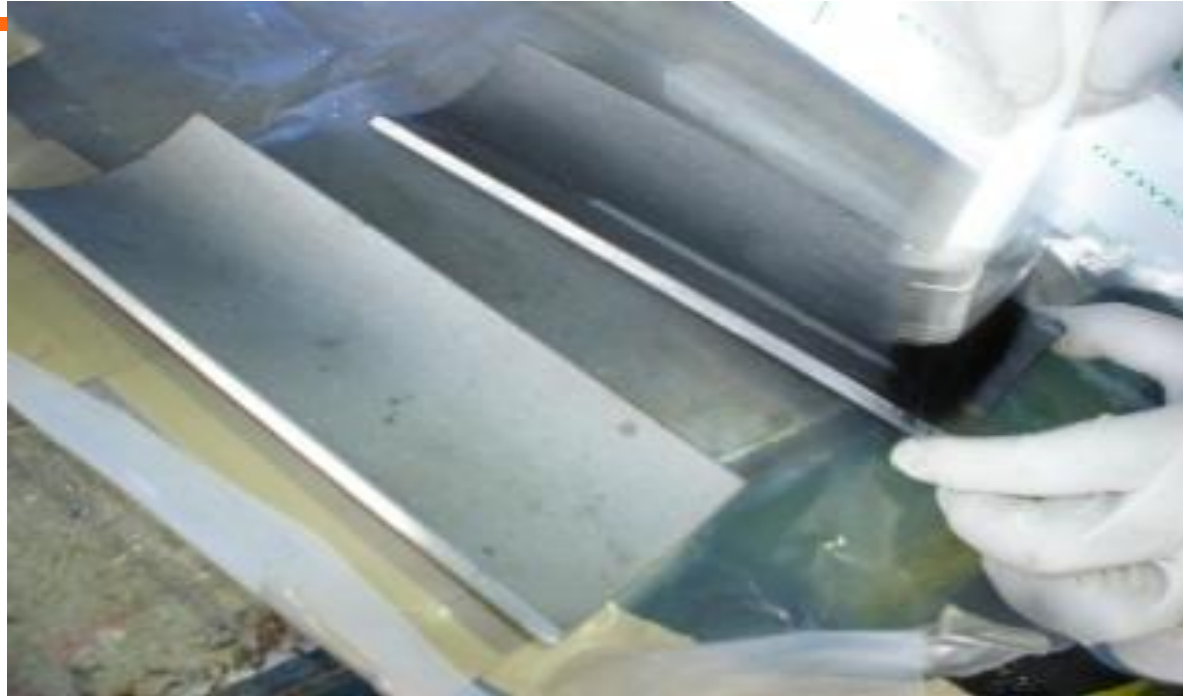
- **Plate bonding spool:**

- 6-inch pipe sleeve, same wall thickness at 1/4 of circumferential was blasted and cleaned prior to Belzona 1111 application.
- Belzona 1111 was then spread over pipe surface and internal area of plate sleeve.

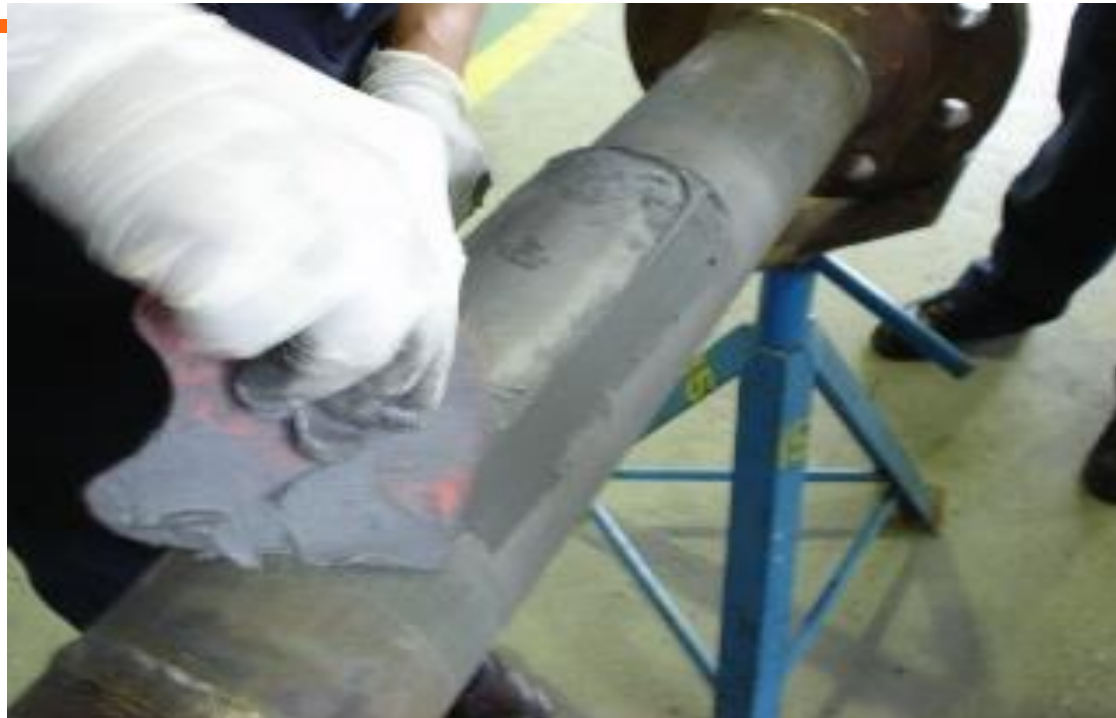
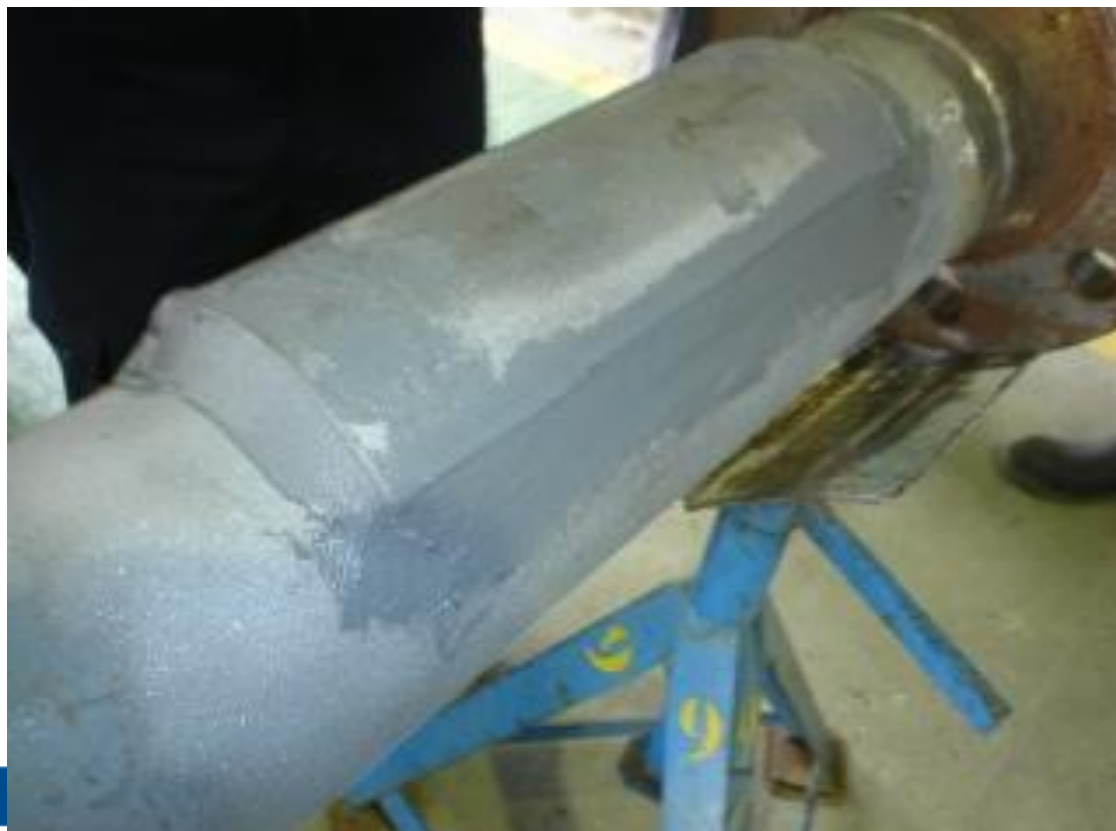
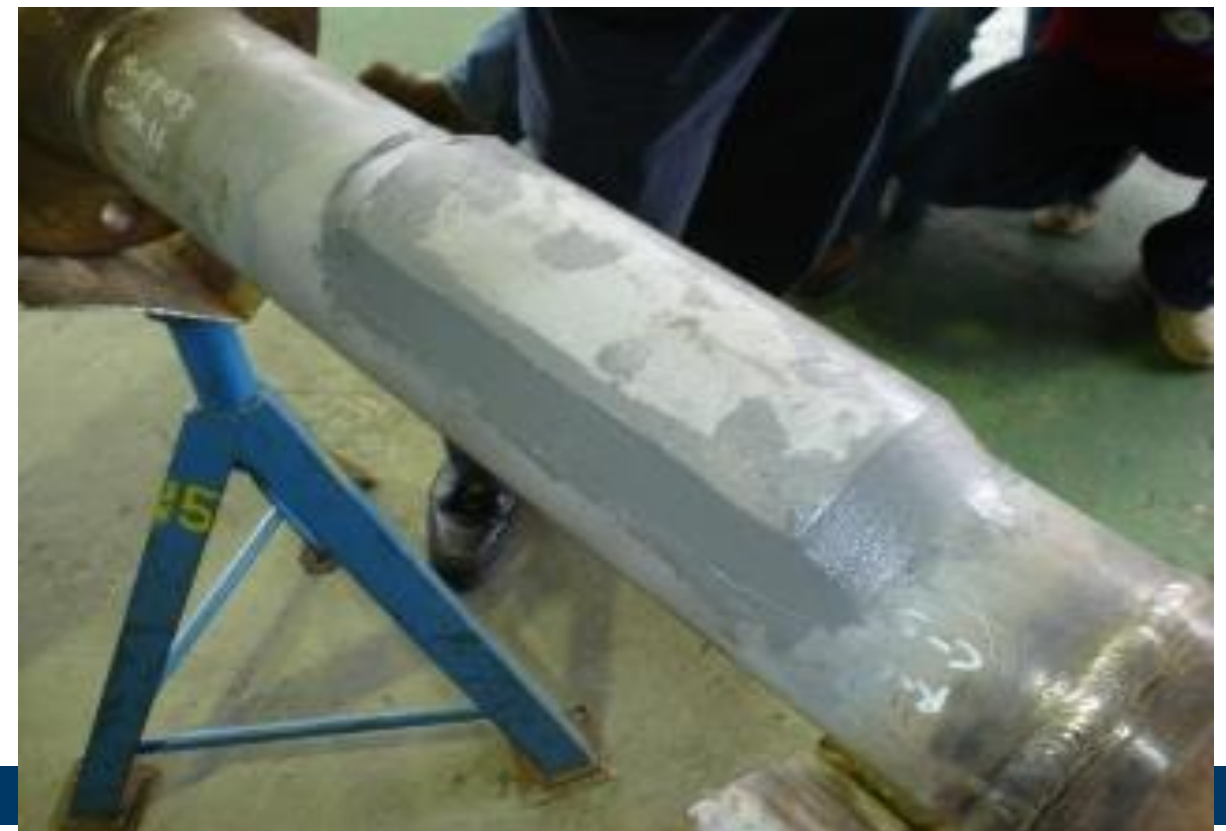
- **Plate bonding spool:**
  - Edges chamfered to ensure Belzona 1111 spread with 45 degree at base of pipe.

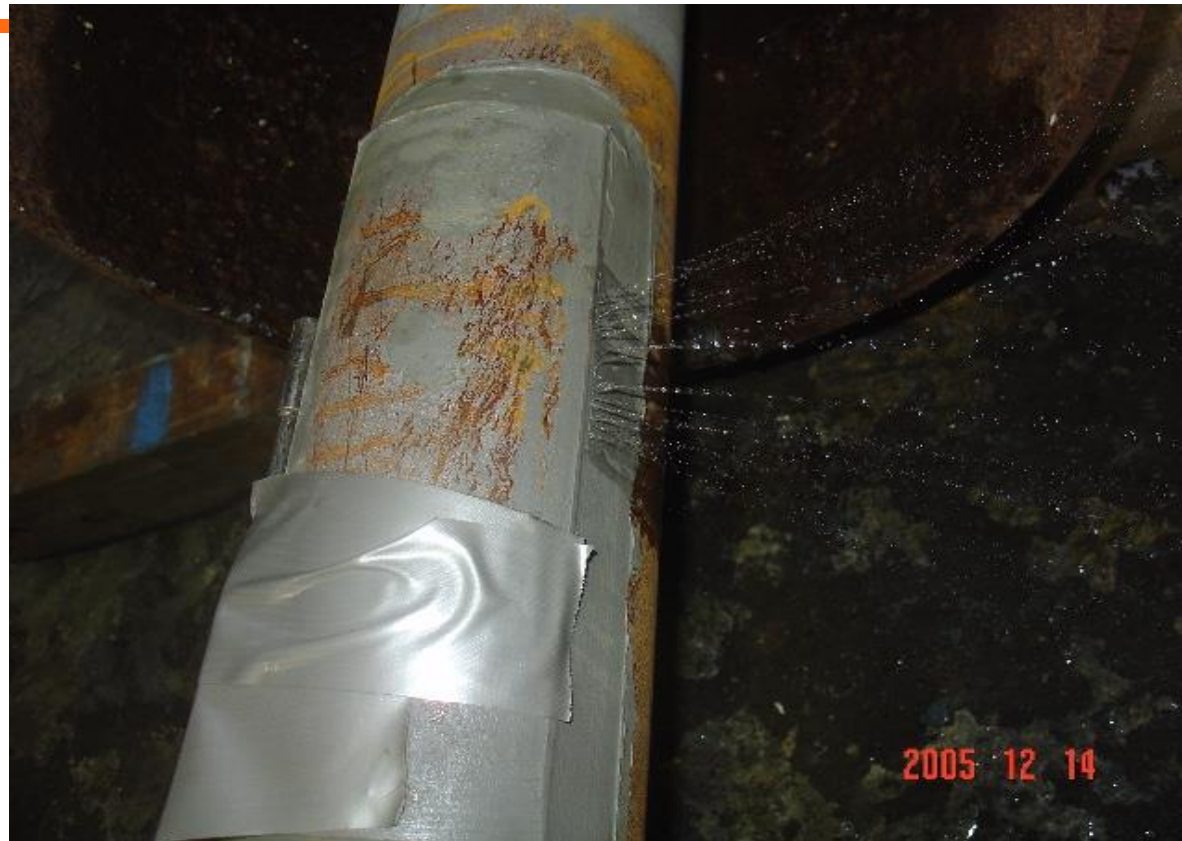
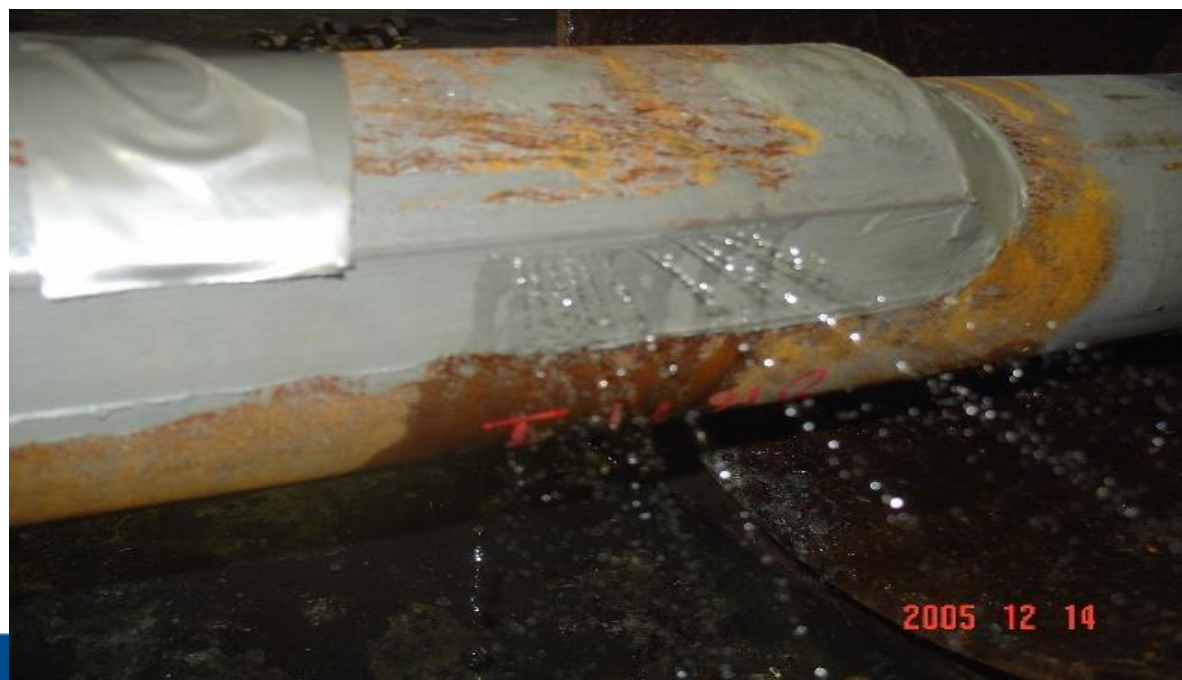
- Hydrostatic Test
- Adhesive failure between plate and product
- Pressure retention 200 bar

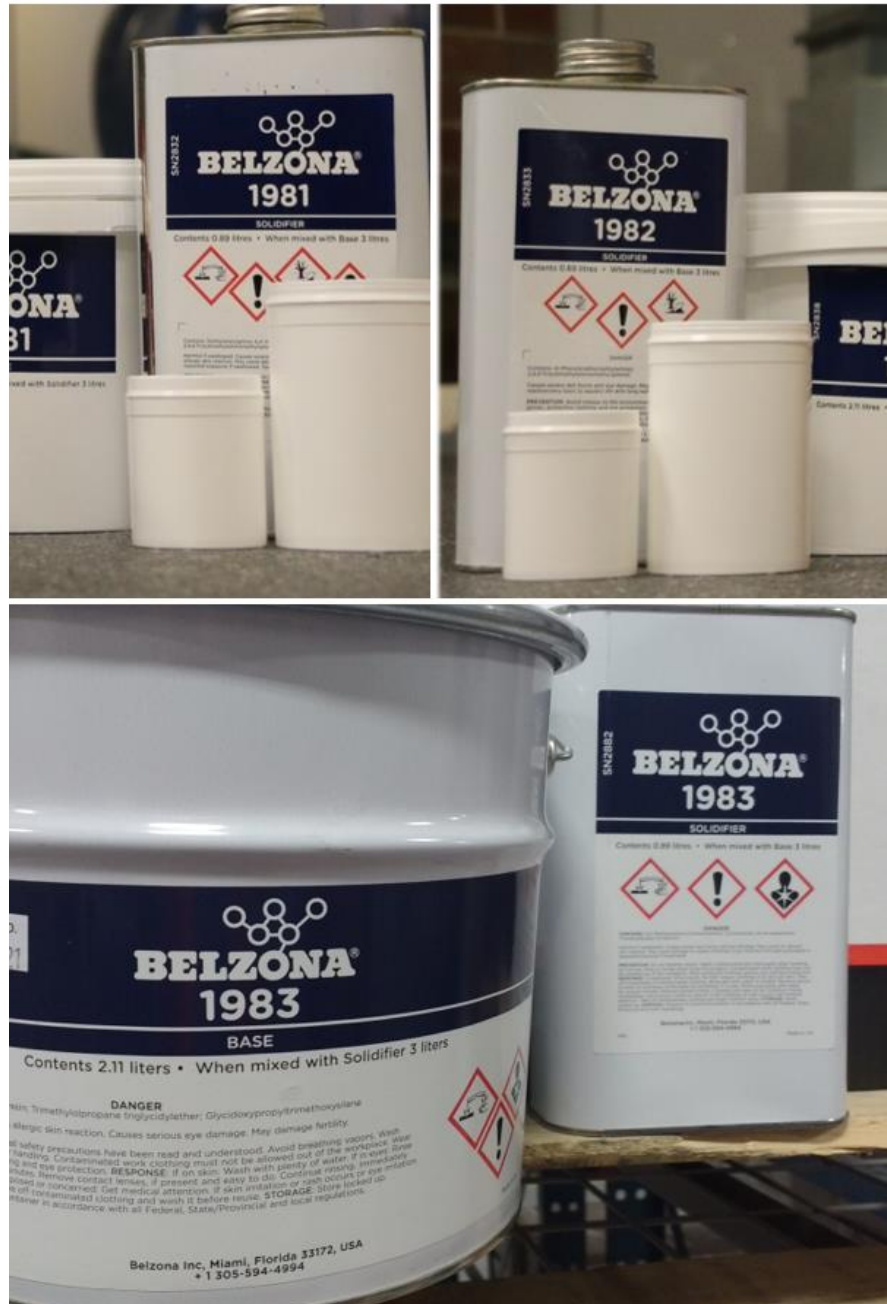
### Belzona 1981

- Fast curing resin designed for application in cold environments
- Application temperature 5 – 20 °C

### Belzona 1982

- Long working life resin designed for application in warmer environments
- Application temperature 20 – 40 °C

### Belzona 1983

- Resin designed for application at service temperature levels up to 150°C (302°F)
- Application temperature 5 – 40 °C
