# Composite Solutions for Returning Strength to Damaged Assets

By Peter Johnson  
Belzona Polymerics

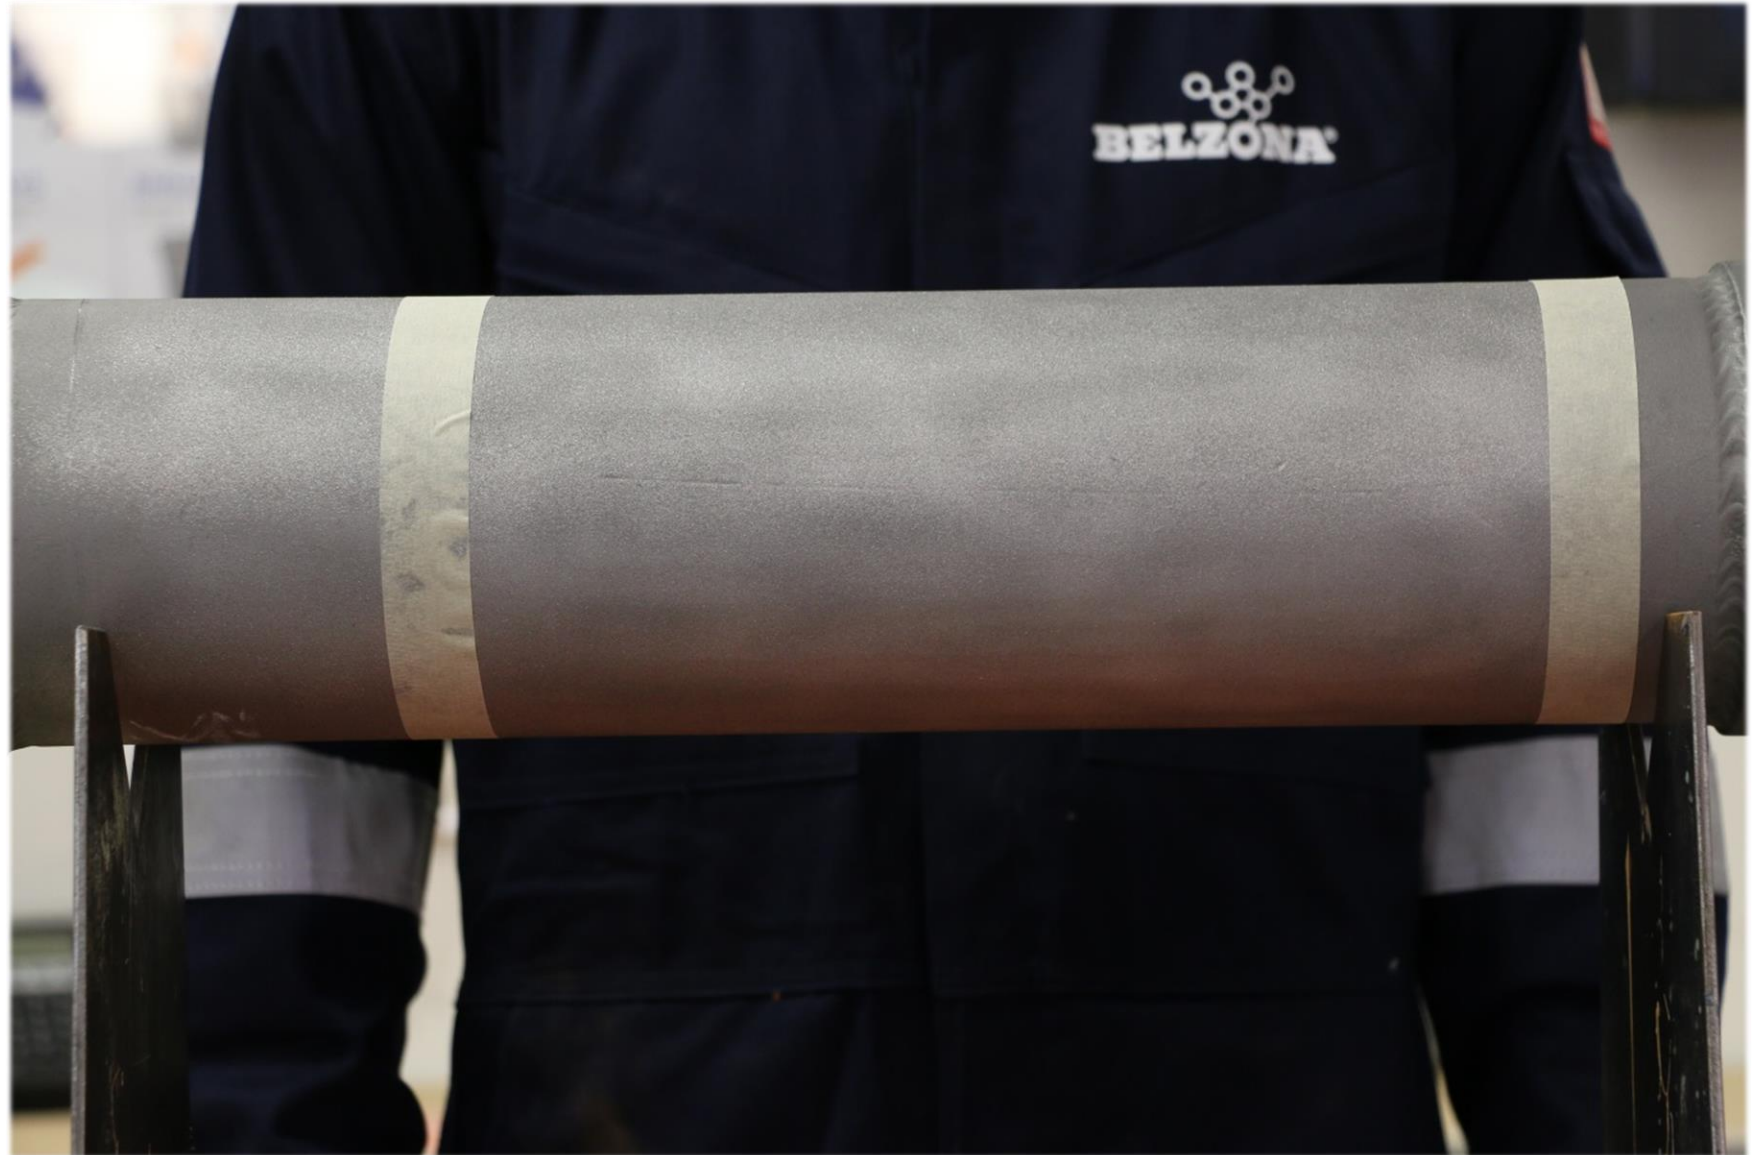
- Treat the defect Area
  - Plate Bond
  - Live Leak
- Prepared beyond repair area
  - Sa 2.5 or SP11
  - 75 microns or 25 microns
- Degrease

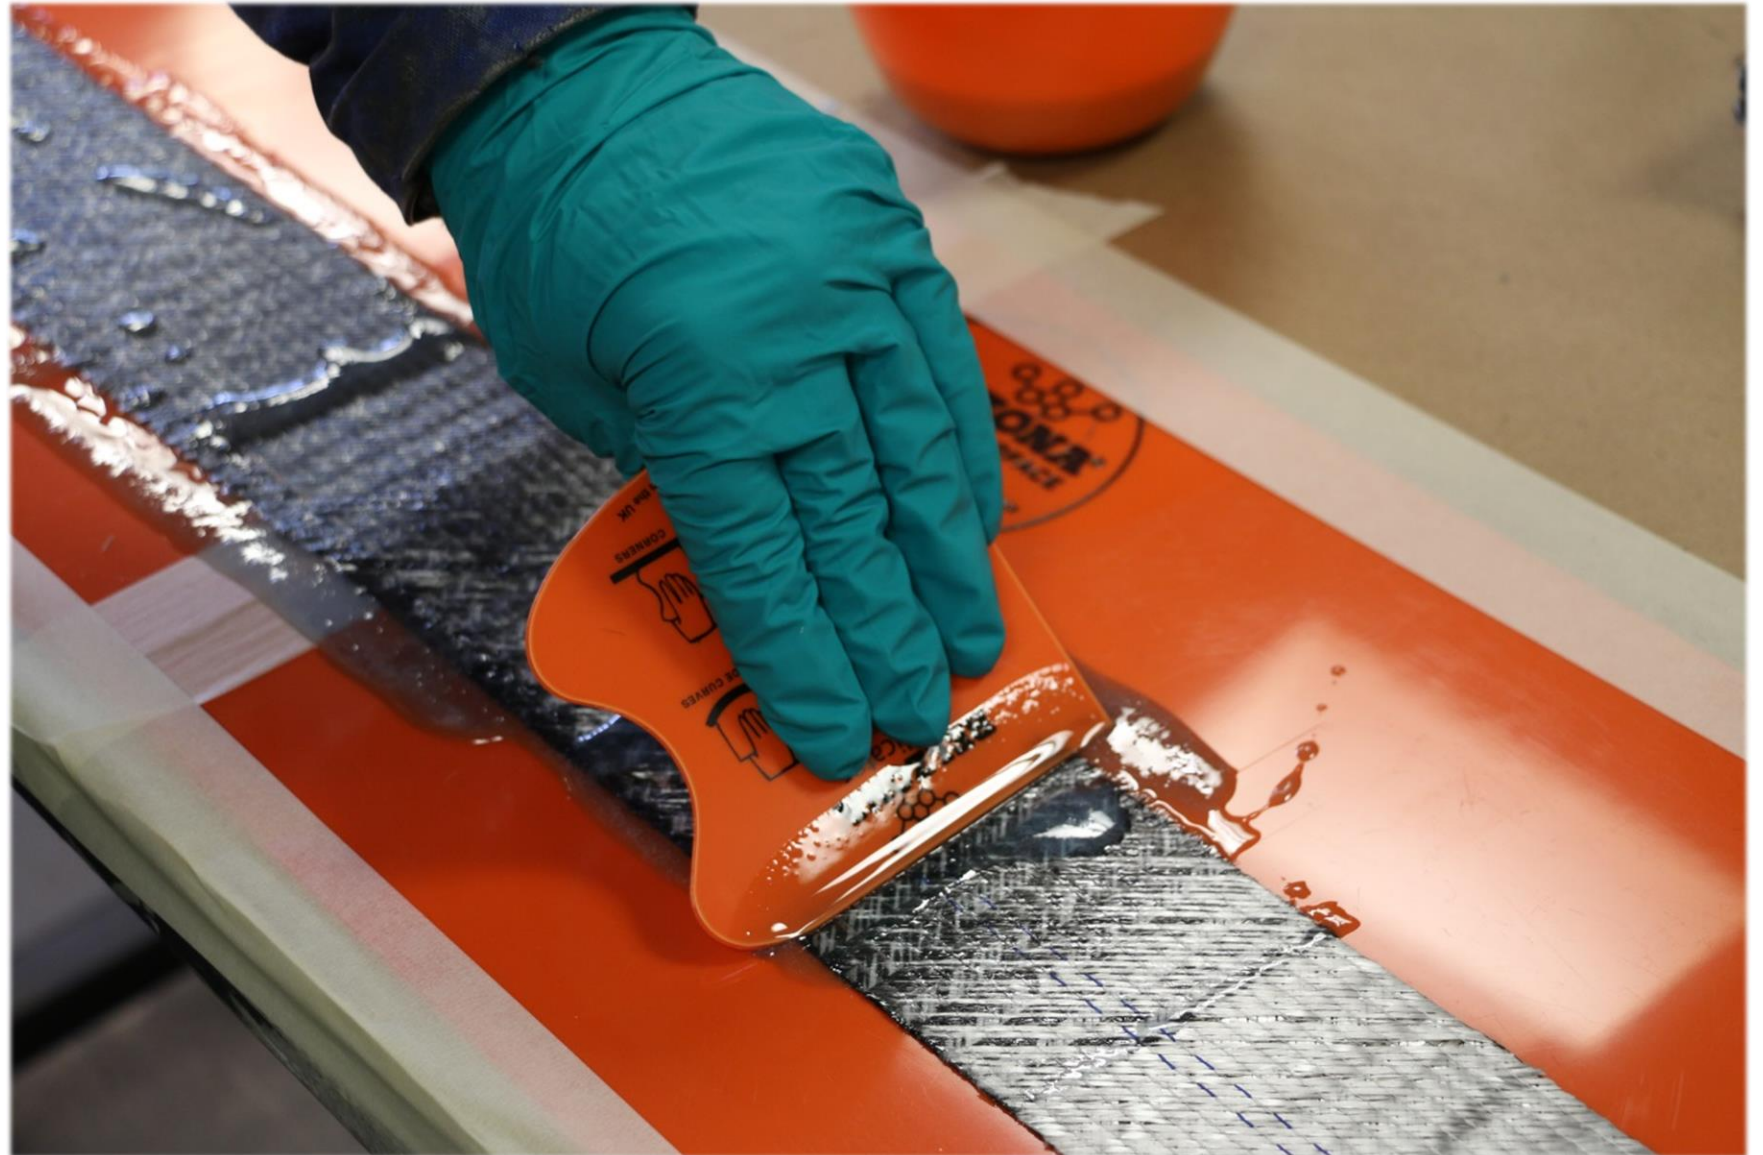
Wet out Belzona  
9381  
Reinforcement  
sheet with same  
resin

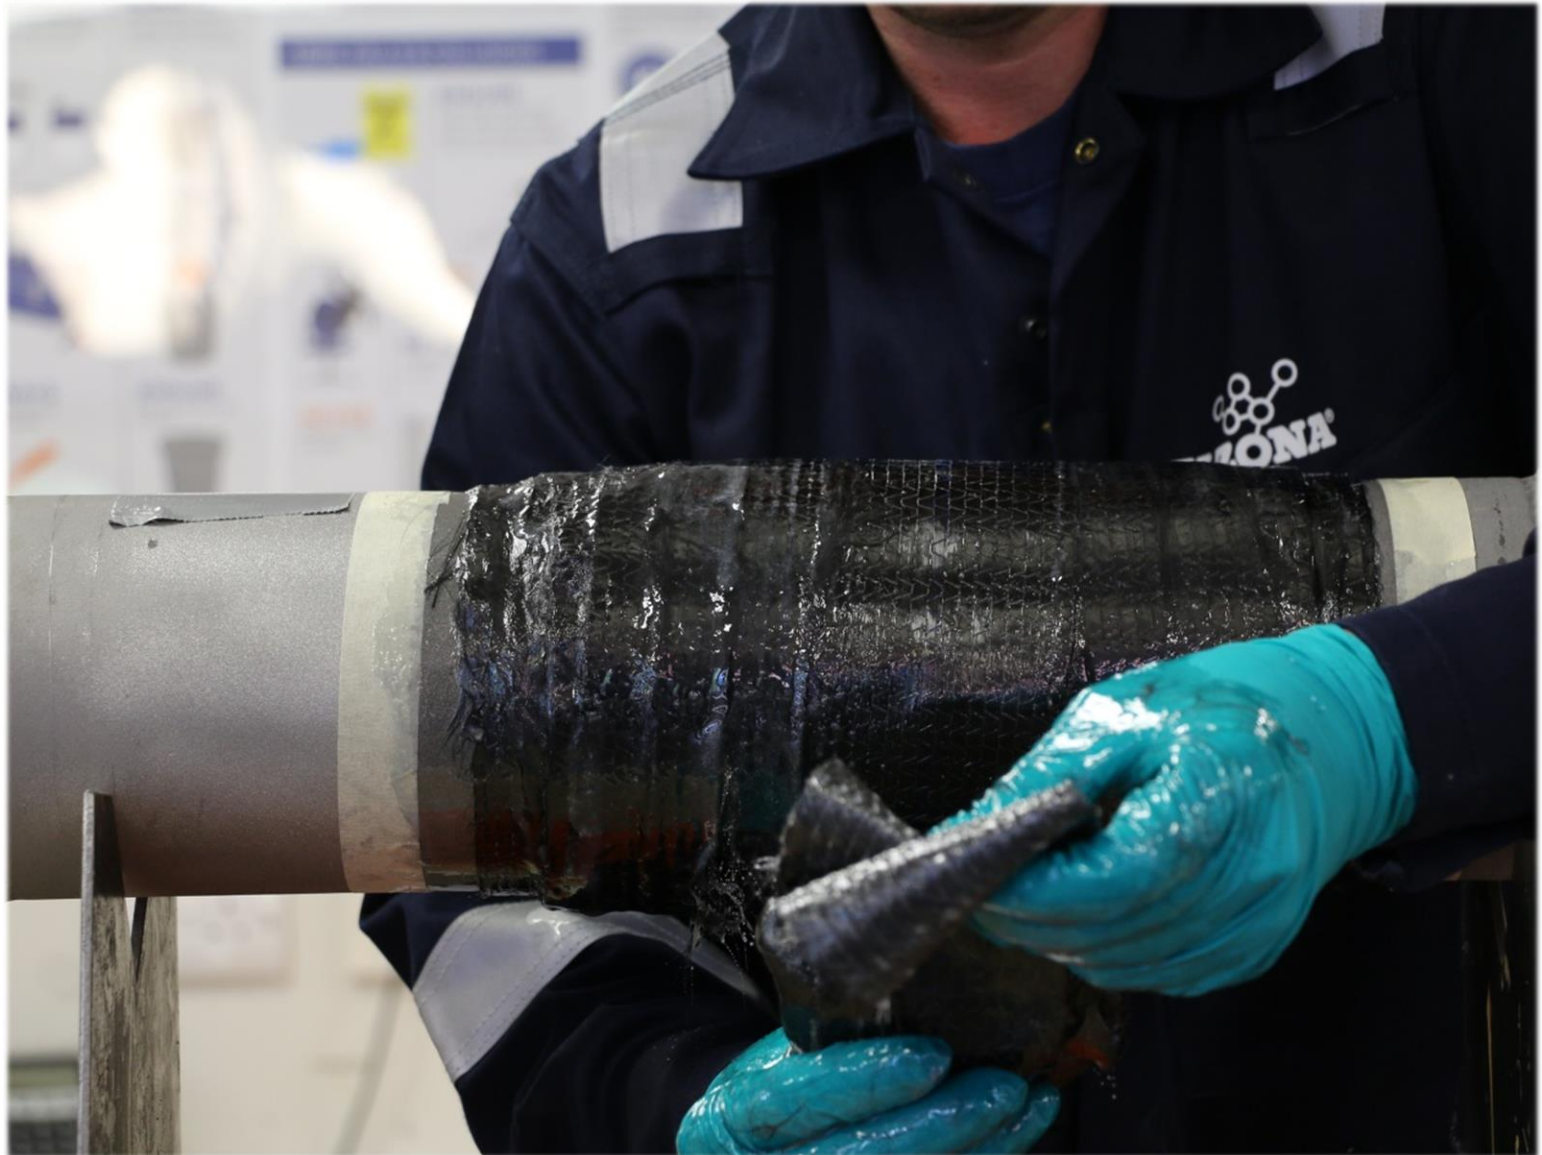
Repeat this  
Process to build up  
the required  
number of wraps /  
layers

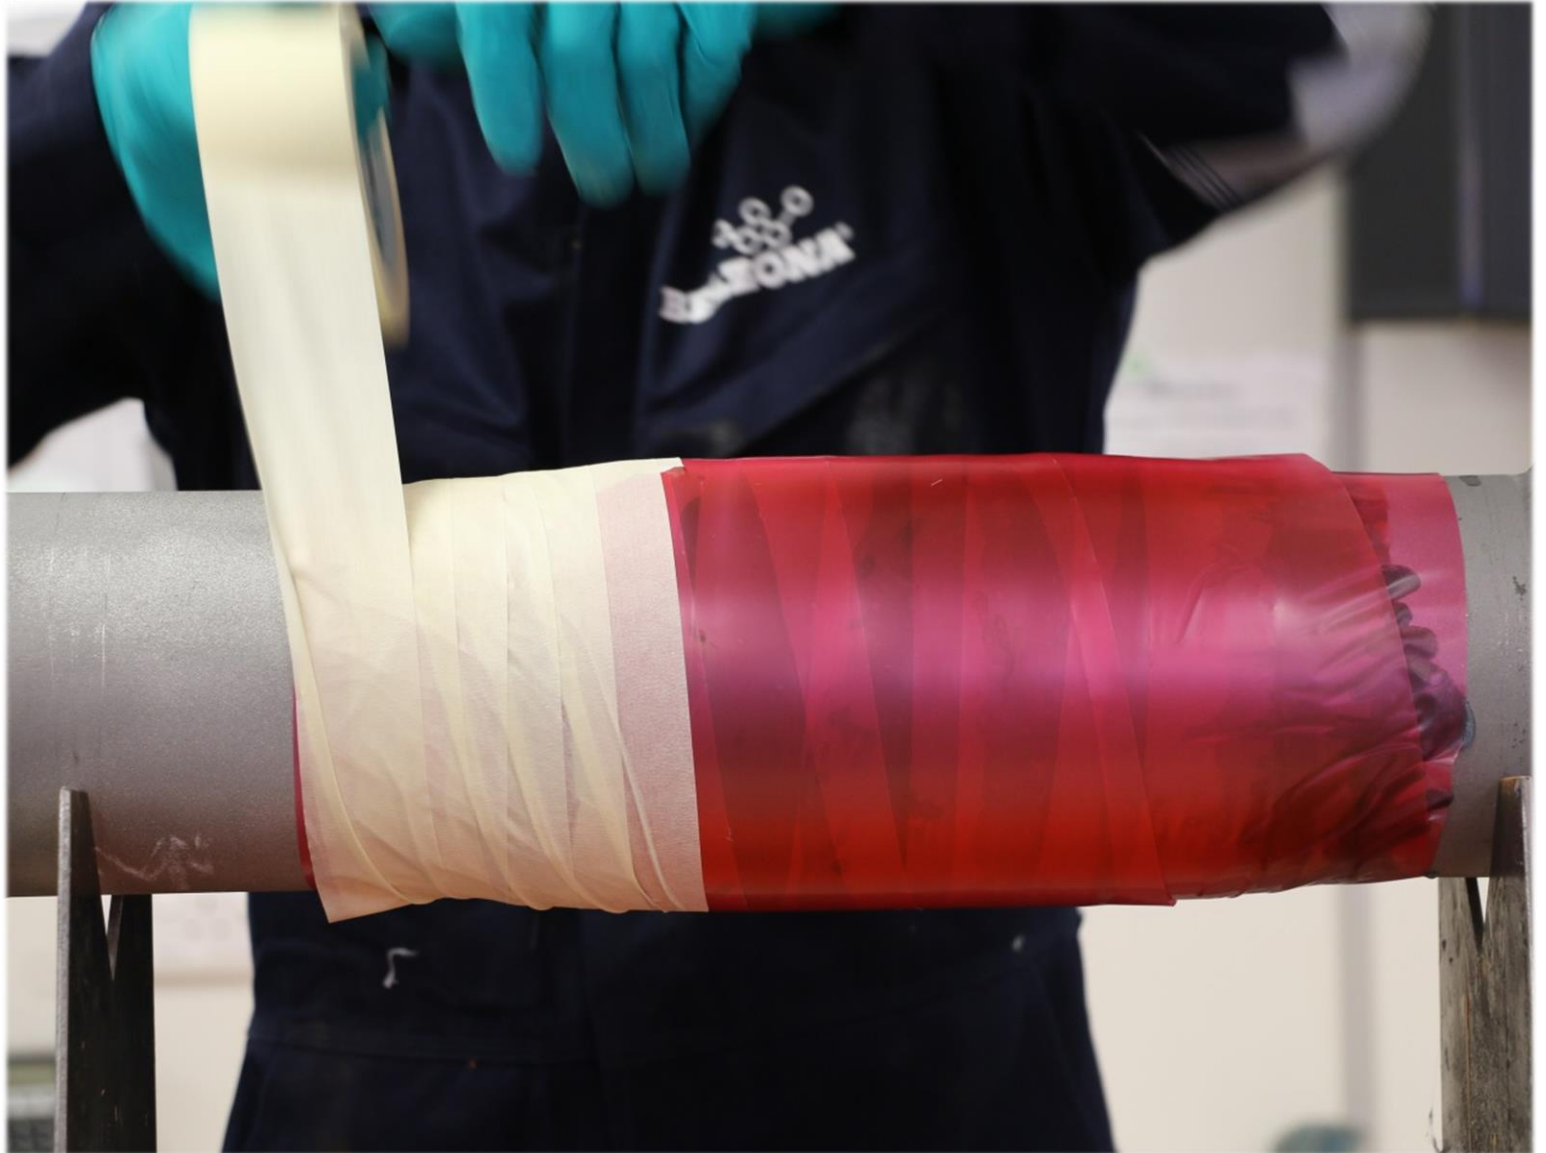
Secure ends in place with masking tape
